Document ID: IK1600245

Title: Cab Door Latch Stuck, Door will not open

Applies To: MV, HV, RH, LT, 2018 LoneStar

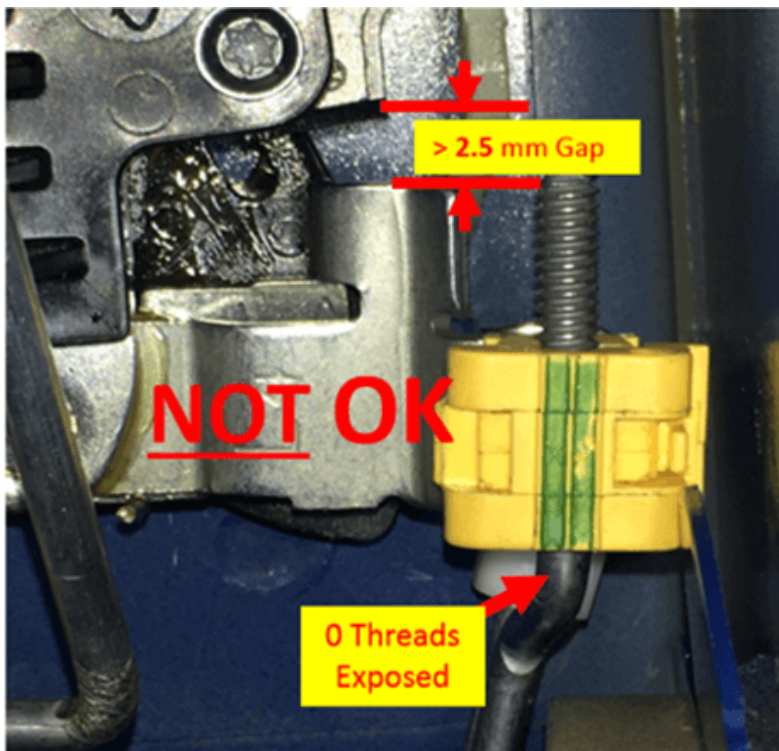
Exterior handle lever has pre load due to improper assembly at the factory. This failure shows up right away after build very early in the trucks life. (Truck Movers finds them on the exit lot) If the yellow clip is fastened to the threaded rod causing the latch lever to rotate down, this can cause the latch to fall into a dead zone where the door cannot be opened from inside or outside.

Step 1: With the door assembly apart including pulling back part of the plastic vapor barrier, check for threads showing on the bottom of the rod under the yellow retaining clip shown below. Trucks built after September 10, 2018 will have a nut under the yellow clip in place of the open threads showing.

See photo below for an example of an **INCORRECT** adjustment. The yellow clip is too low.

Step 3: Undo clip and readjust as shown in step 2; Once correctly adjusted you will need to completely assemble the interior door assembly to properly test the latch.

NOTE: If the yellow clip is damaged or stripped the lock assembly will need to be replaced. The yellow clip is not a separate service part at this time.

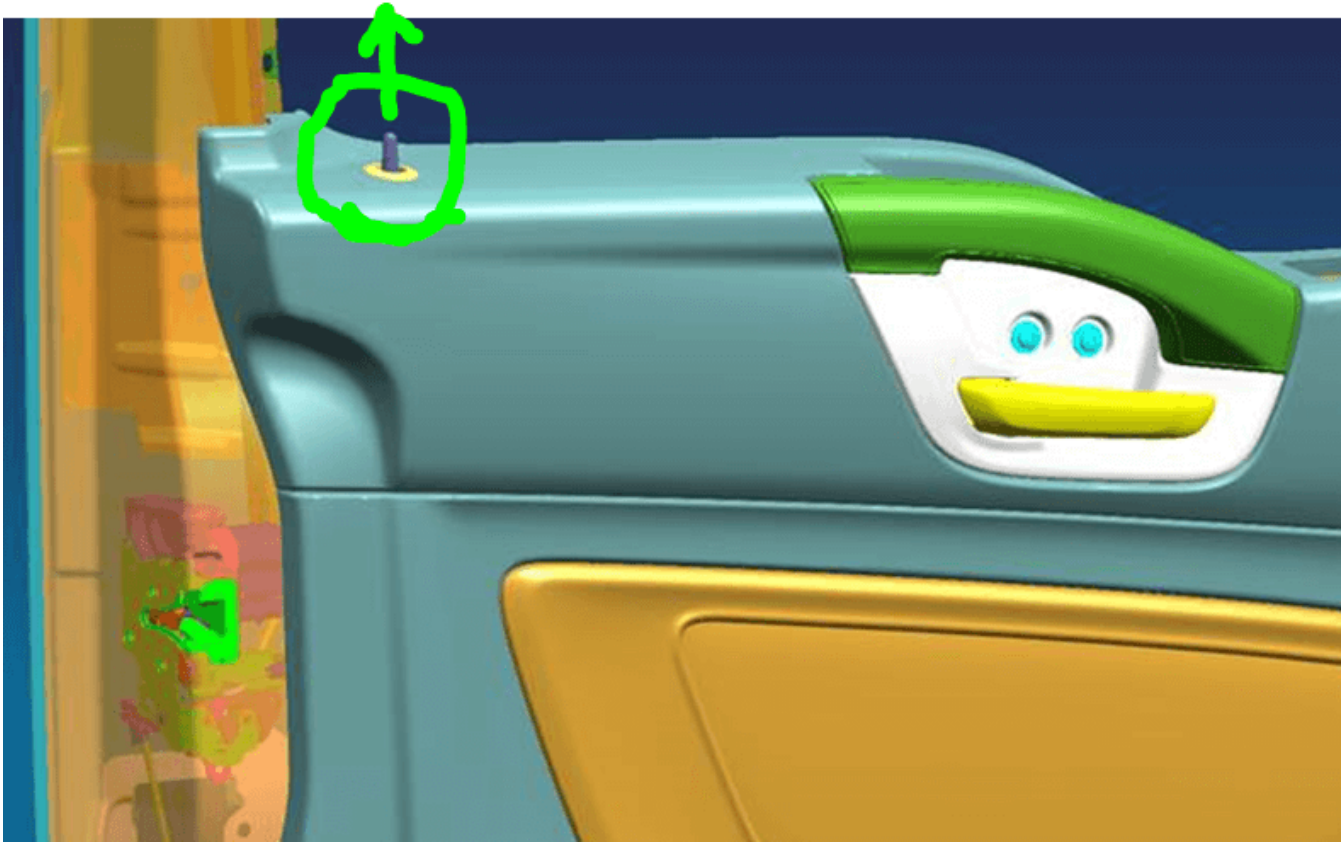
Two levers inside the door latch assembly bind together and jam. There have been reports in which an occupant has pushed down on the lock button at the back of the door where it may get jammed in the locked position; then when trying to open the door from the inside, it causes the internal lock lever to get stuck behind the handle lever (Inside the latch assembly) causing the door to be inoperable. (Not able to be opened from the inside or outside.)

NOTE: Also note that in some cases the trim ring around the door lock knob may have to be removed to be able to grab the knob to pull it up.

Step 1: If a door is not able to be opened using the inside handle or exterior handle, pull up and hold the interior door lock knob/rod in the upper unlocked position while pushing the power door unlock button on the door pod switch. This action should unjam the internal latch levers. If the truck does not have power locks pull the interior door handle while holding the lock knob/rod in the upper unlocked position.

Step 2: Then while still holding the interior lock knob/rod up, pull the interior door pull and the door should open.

Step 3: Once you get the door open follow the interior door panels removal procedures outlined in the service manual to gain access to the door latch assembly to remove and replace with new service part. Once the new latch is installed and correctly adjusted you will need to completely assemble the interior door assembly to properly test the function of the latch.
