### PIT5679 Service Park Assist Message /Hands Free Lift Gate Inoperative

Brand:	Model:	Model Years:	VIN:		Engine:	Transmissions:
			from	to		
Chevrolet	Blazer	2019	All	All	All	All

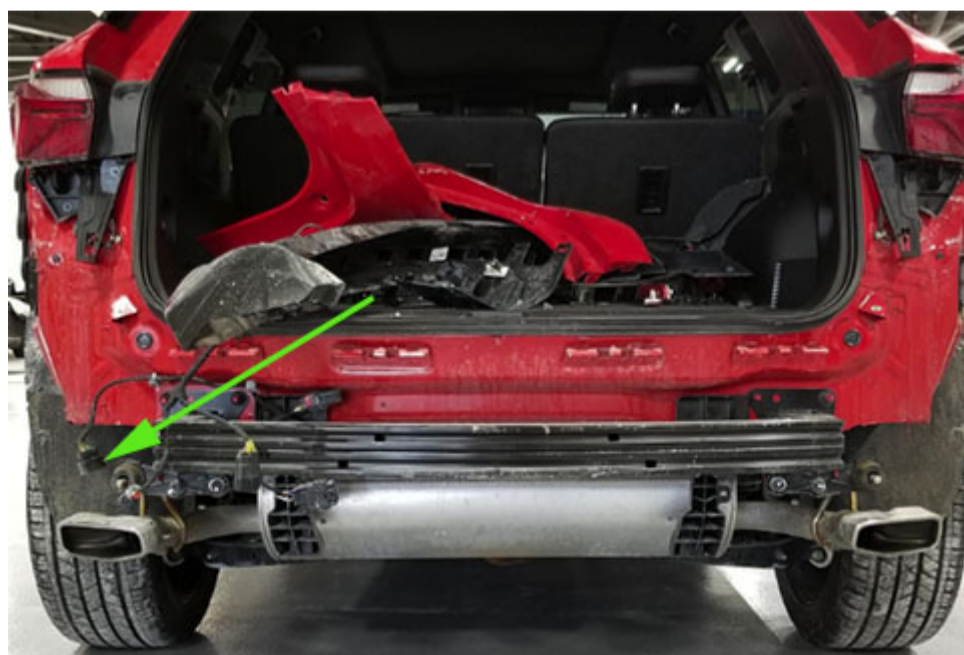
<b>Involved Region or Country</b>	North America
<b>Additional Options (RPO)</b>	UD7, TC2
<b>Condition</b>	A vehicle may be brought to the dealer with a "service park assist message" or a complaint that the rear lift gate will not open passively. It may also be noted that the lift gate closure hands free lamp is inoperative. Upon inspection codes B323A, B323B, B0958/B0959/B0960/B0961 may be found.
<b>Cause</b>	Any of these issues could be caused by water intrusion in the X400 connector.

**Inspect the X400 connector located behind the rear bumper cover on the left side of the vehicle for evidence of water intrusion.**

If water intrusion or corrosion is found replace all affected terminals on the body side with terminated leads and replace the rear fascia wiring harness.

Ensure that the connector is securely attached to the locating stud and is mounted in a horizontal position.
