# Preliminary Information

## PIC6361 Rear Spoiler Is Out Of Adjustment

Brand:	Model:	Model Years:	VIN:		Engine:	Transmissions:
			from	to		
Chevrolet	Corvette ZR1	2019	All	All	LT5	All

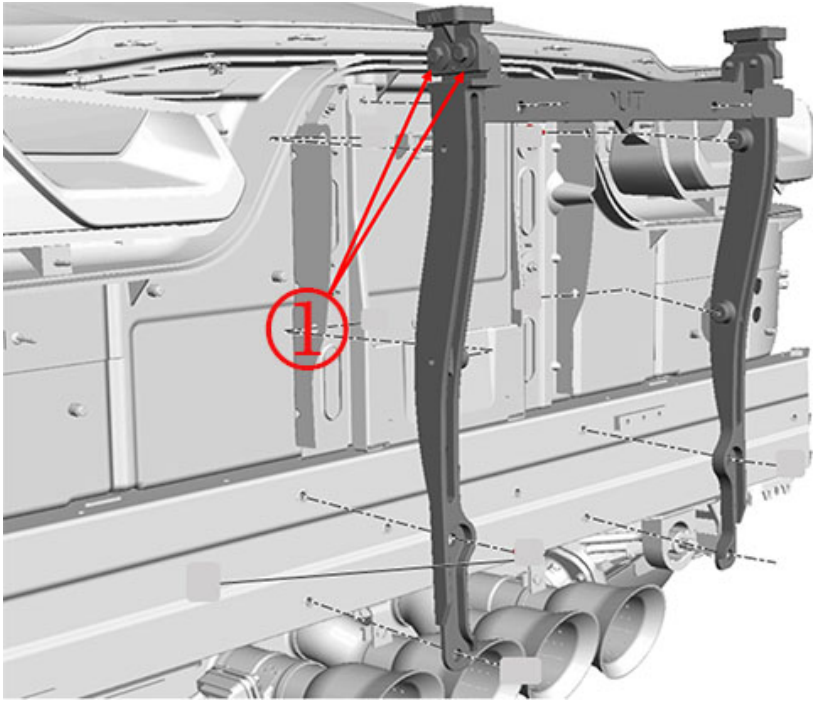
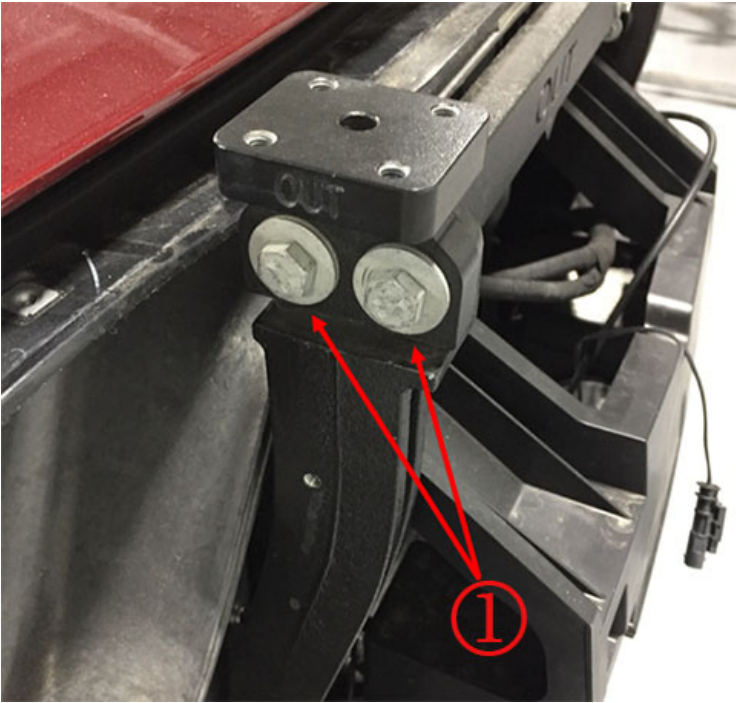
Involved Region or Country	North America
Condition	Some dealership technicians may notice that after the rear spoiler has been attached to the vehicle during the Pre Delivery Inspection (PDI), it may appear to be crooked.
Concern	This concern may be caused by a Rear End Secondary Spoiler Bracket that is out of adjustment.

To correct this concern, remove the rear fascia and adjust the Rear End Secondary Spoiler Bracket (seen below) as needed until the spoiler is level. The bolts that will need to be loosened in order to perform this adjustment are called out by the red arrows in the photos below.

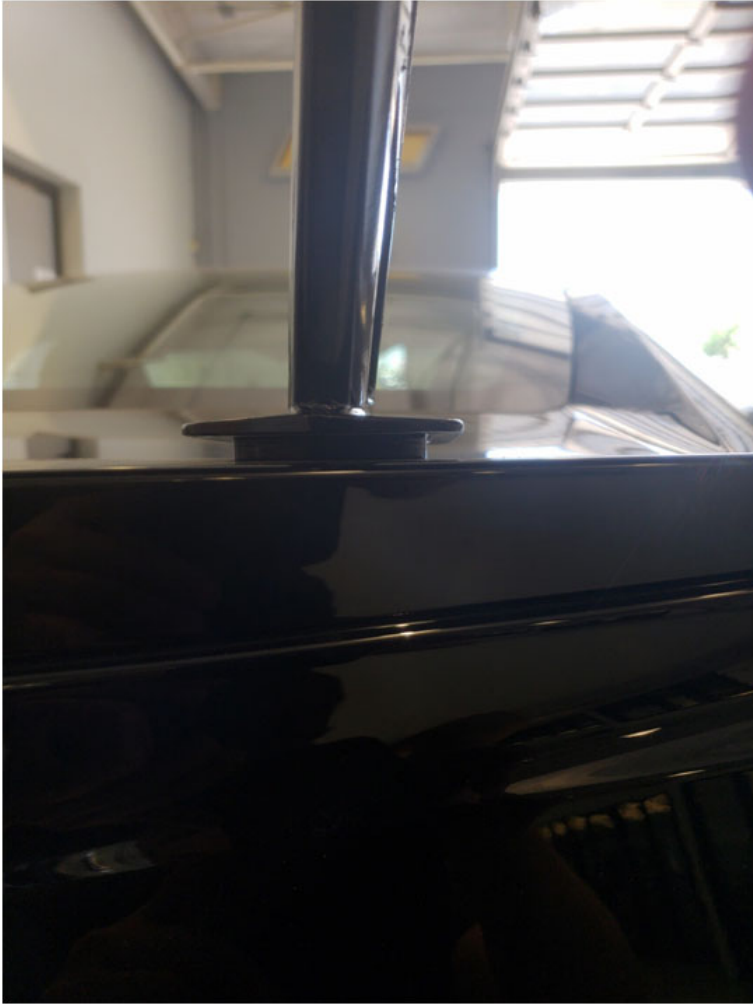
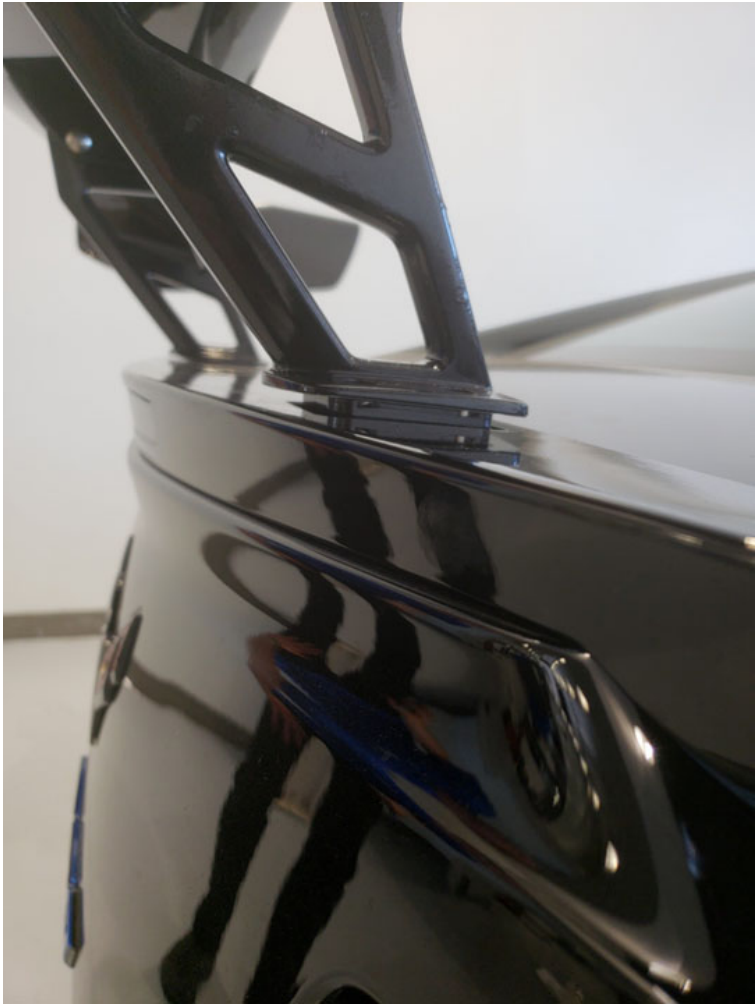
When correctly adjusted, the spoiler mounting piers should be even left to right, and raise a minimum of 3 mm above the rear fascia. If this minimum gap is not achieved, damage to the paint on the fascia will result. The two pictures seen below show a close up of the spoiler stanchions as they attach to the rear of the vehicle. This illustrates the necessary gap above the fascia.
