Preliminary Information

PIT5396C Diagnostic Tips - Water Leaks

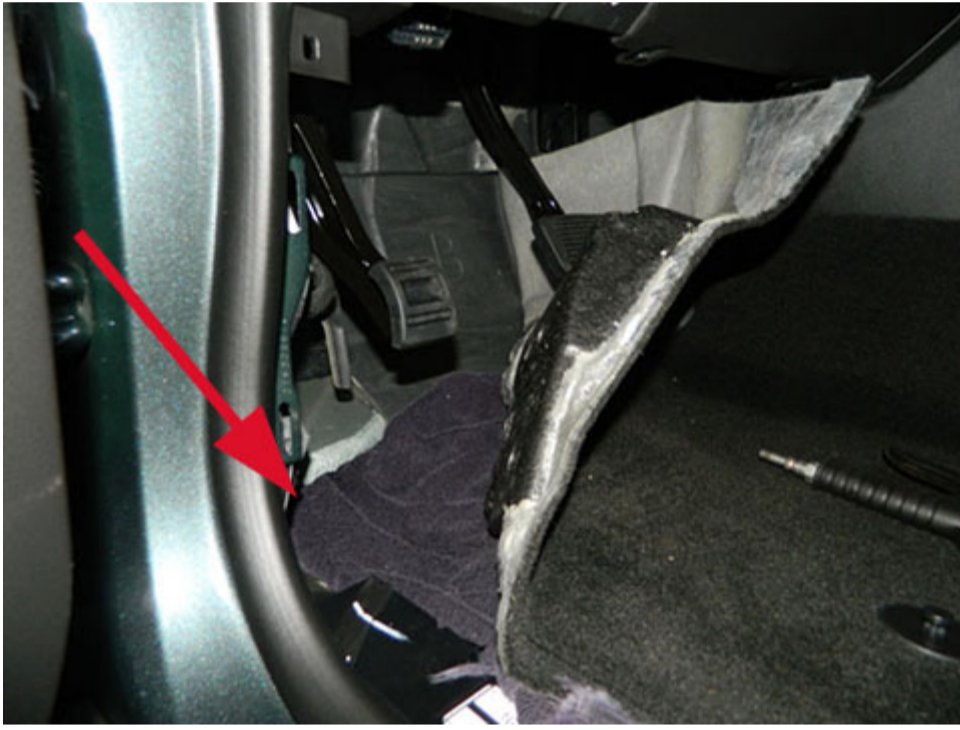
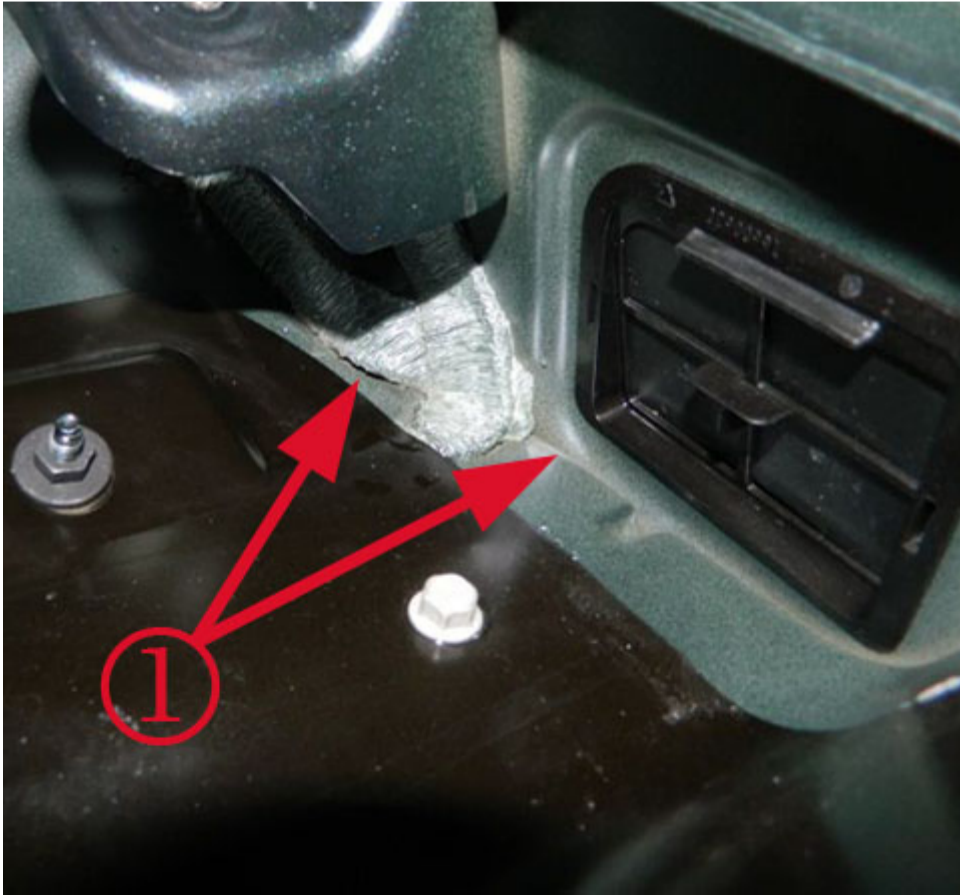
- 5) Cowl seam: May allow water to accumulate on the floor. Water test by cowl drain left and right side. Water may enter from outside cowl area under hood from left and right side add seam sealer.**

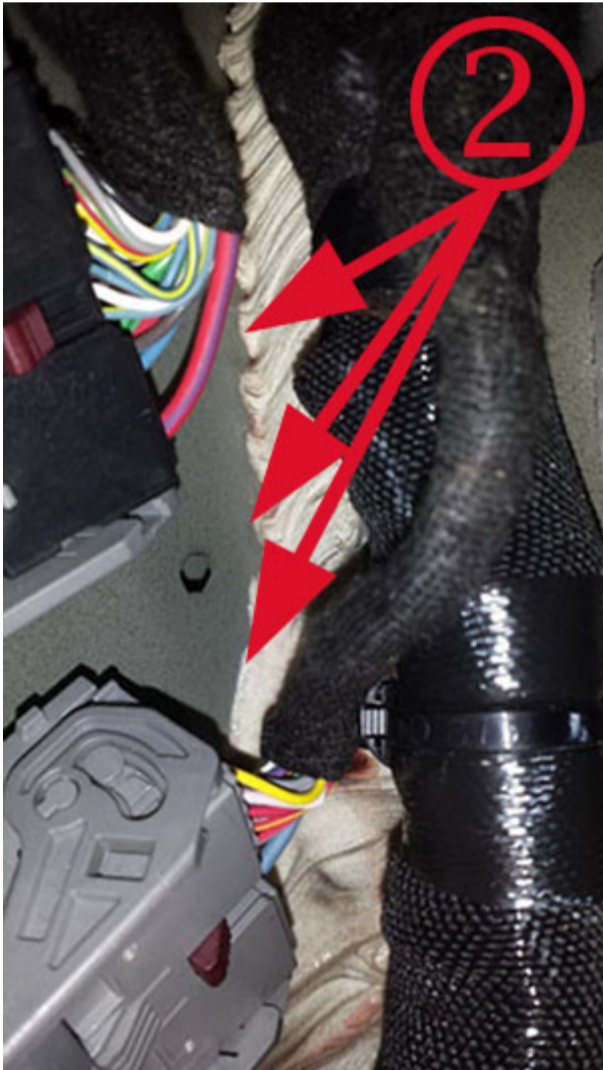
The other area is under dash in the left and right side vertical seams. Reseal as needed
