Preliminary Information

PIC6293C Installation Of the GM Accessory Interior Spectrum Lighting Kit

Brand:	Model:	Model Years:	VIN:		Engine	Transmissions:
			from	to	Engine:	11 011511115510115.
Chevrolet	Camaro	2016 - 2019	All	All	All	All

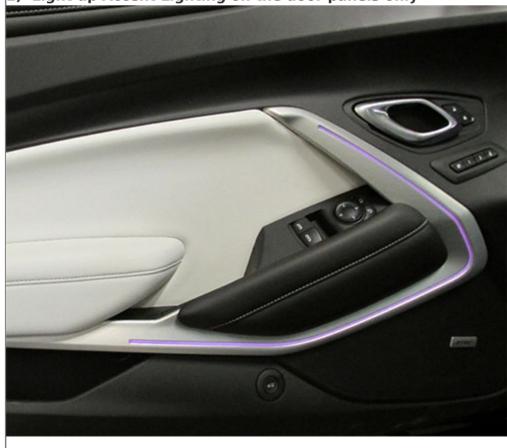
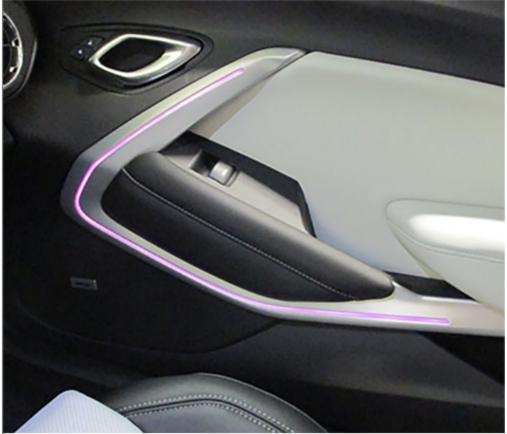
1) Light up Accent Lighting on the door panels only

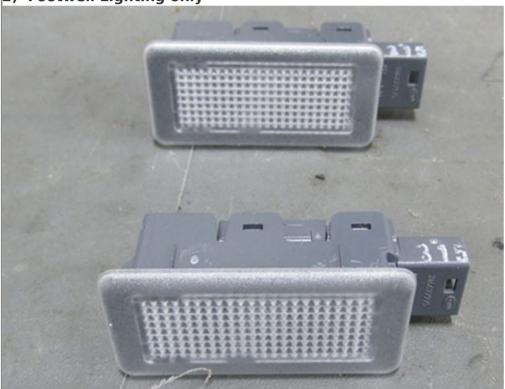
2) Footwell Lighting only

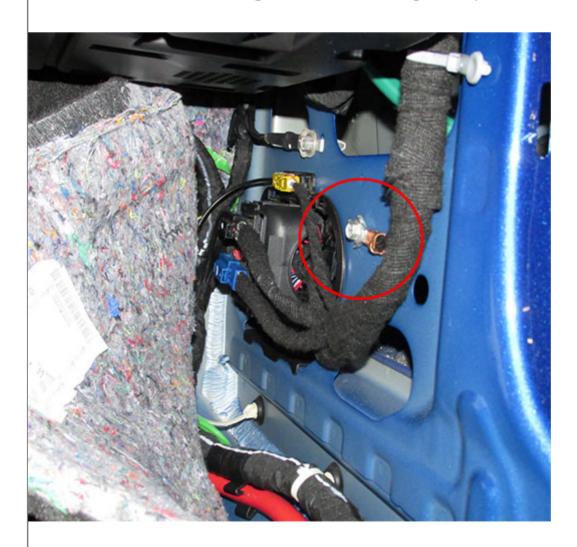
• If the entire kit has been installed and the lighting is entirely inoperative, there are a few things to go back and check. The most common area for concern is G202, which is located at the right hand kick panel. Typically, this ground has paint on it when the kit's eyelet is installed. Just tightening the fastener does not provide a good ground path if there is still paint covering the sheet metal. The fastener will have to be removed, the paint needs to be cleaned or ground off, and the ground path verified.

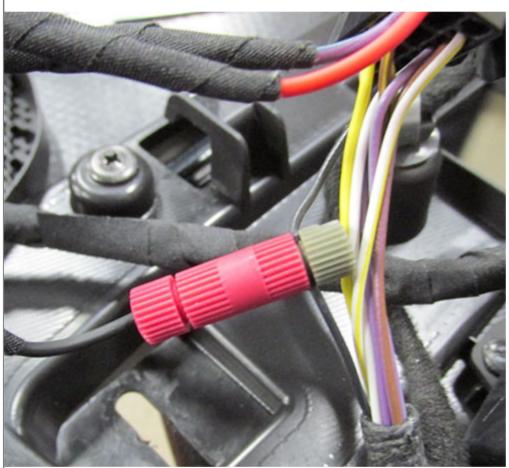
- Another common issue that is seen relates to the Posi-Tap connectors used in the kit. These connectors are used to splice the accessory harness to the vehicle's wiring harness.
 Dealership technicians are to go back through the installation and verify that each connector is tight. If one or more of these connecters is/are loose, this will cause any number of performance issues with the kit. The connector shown in the photo below does not have tape or a zip tie covering it for clarity. Once the connector is properly installed, the instructions have the technician tape back the splice to the main harness using cloth tape. This will prevent the connector from loosening up over time.
