### PIP4825A DTC P0101 P0234 Low Power LAU 2 8L Turbocharged Models

Brand:	Model:	Model Years:	VIN:		Engine:	Transmissions:
			from	to		
Cadillac	SRX	2010	ALL	ALL	2.8 LAU	ALL

#### Supersession Statement

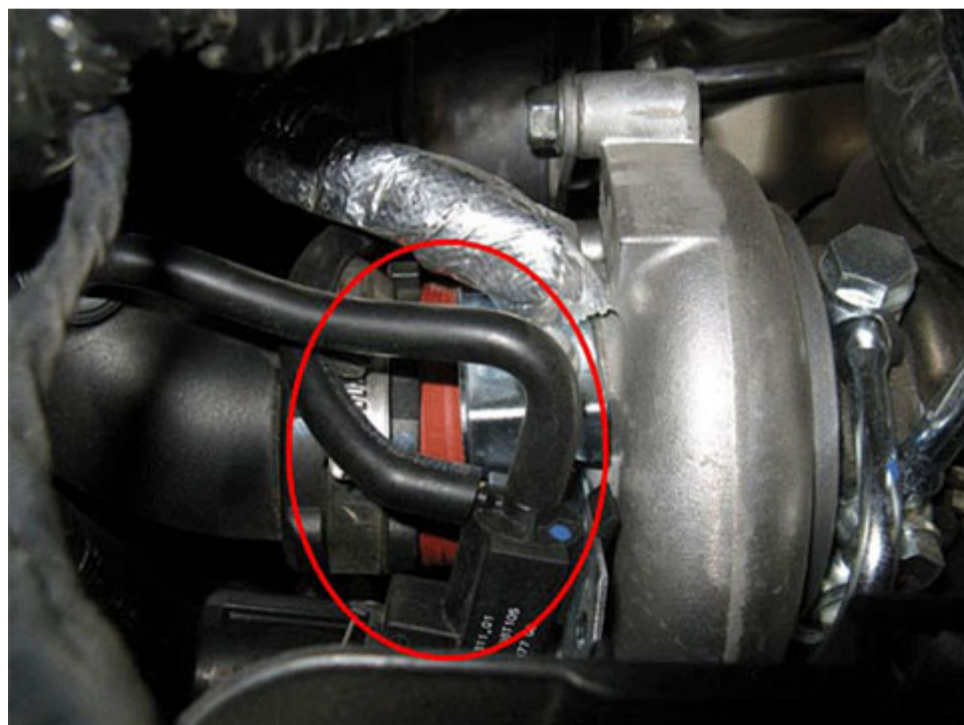
**Air cleaner outlet duct [ tube ] not fully seated to turbo.**

**Vehicle may have DTC P0234 or P0101 (A thin line of the red seal may be showing on all vehicles,**

problem vehicles will have more showing, as seen here).

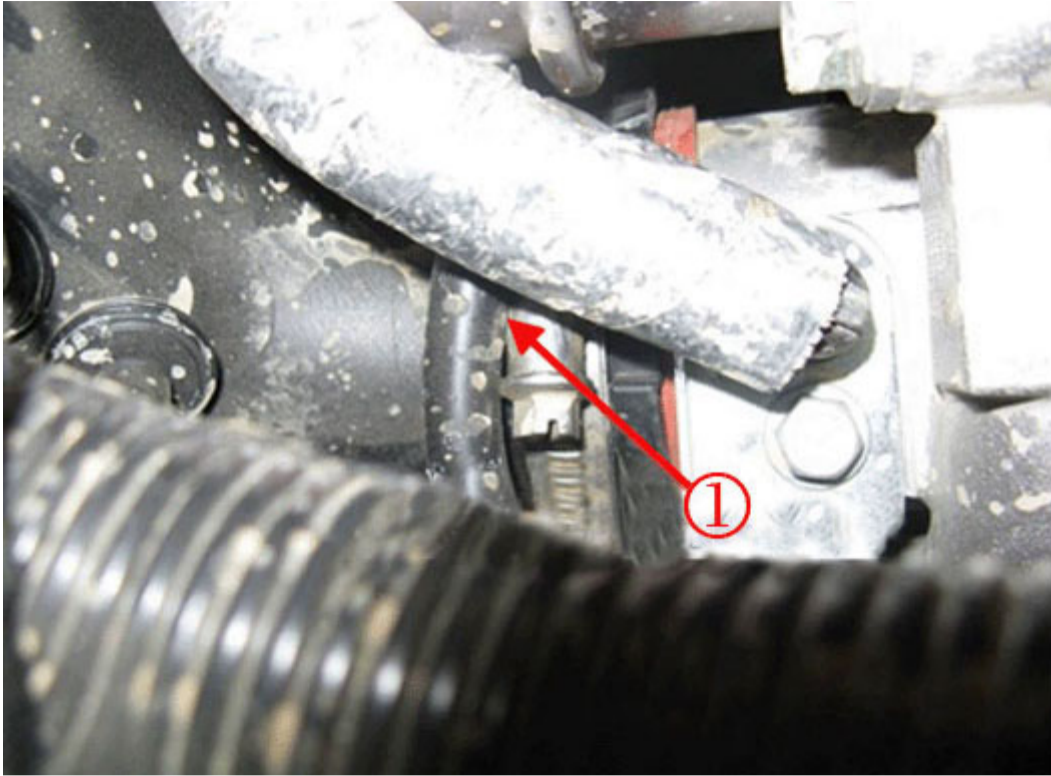
The retaining screw clamp on the Turbo, Air cleaner outlet duct [ tube ] was coming in contact and abrading against the under side surface of the rubber hose (creating hole & leak) between turbo-charger waste gate solenoid and waste gate valve.

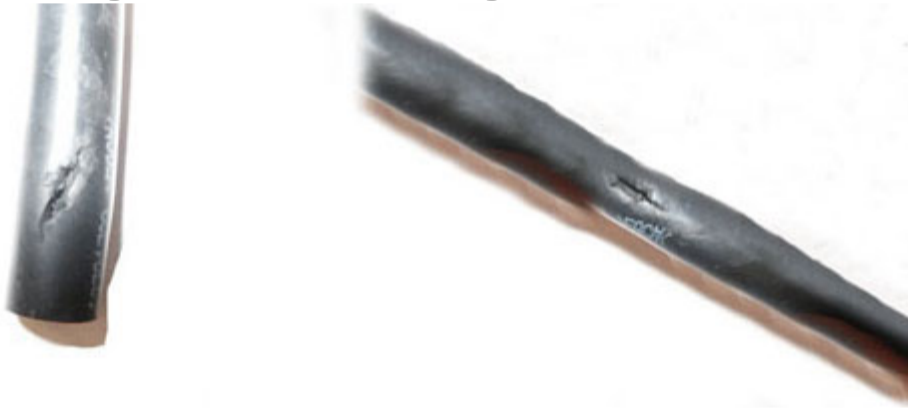
Rubber hose between turbo-charger waste gate solenoid and waste gate valve, abraded and leaking.
