## Preliminary Information

### PIC6249C Cold Air Blowing from Wireless Charging Dock Area

Brand:	Model:	Model Years:	VIN:		Engine:	Transmissions:
			from	to		
Chevrolet	Impala	2016 - 2019	All	All	All	All

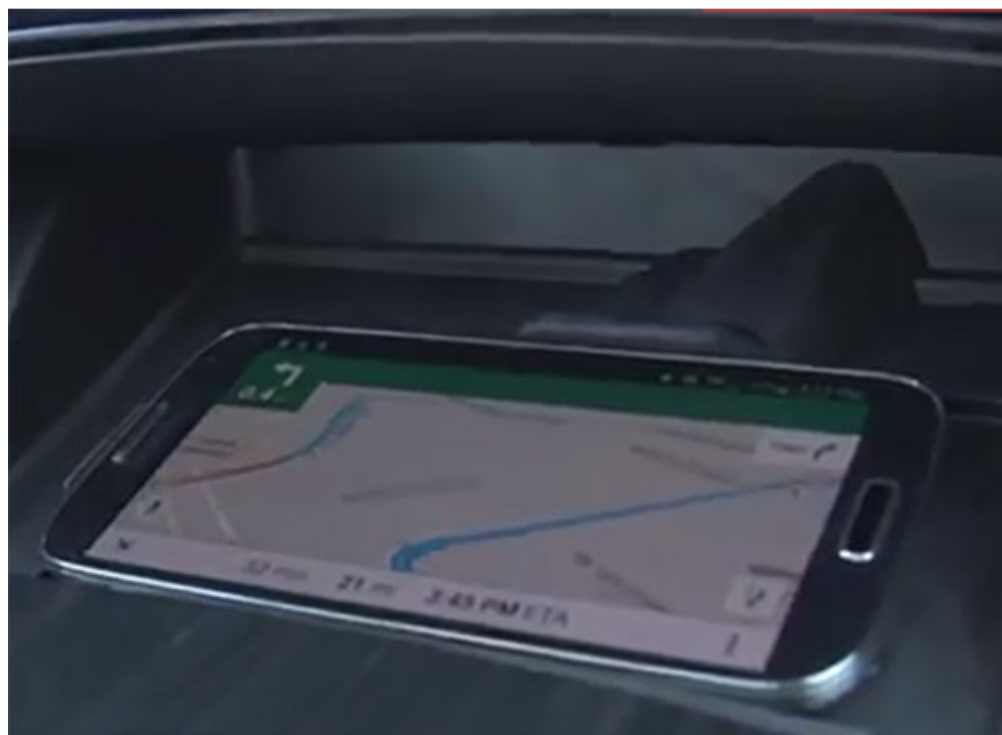
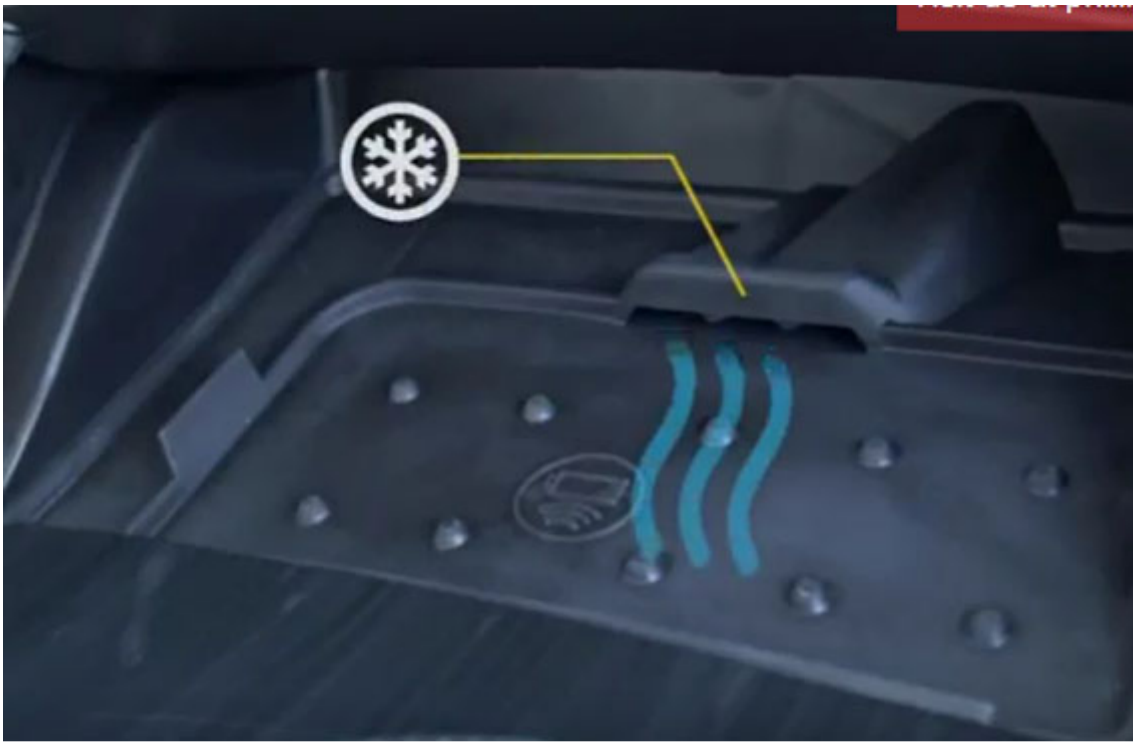
<b>Involved Region or Country</b>	<b>North America</b>
<b>Additional Options (RPO)</b>	<b>K4C</b>
<b>Condition</b>	<b>Some customers may complain of Cold Air Blowing from the Center Console or Cold Air Blowing from the Wireless Charging Mat area. Some customers may also notice that the air flow increases when AC fan speed is increased.</b>
<b>Cause</b>	<b>The cooling of the cell phone from the wireless charger is connected to the HVAC duct work.</b>

This is by design for the cooling of the phone during charging and should be considered a normal operating characteristic of the vehicle.
