# Preliminary Information

## PIP5652 Rattle Noise From Front of Engine

Brand:	Model:	Model Years:	VIN:		Engine:	Transmissions:
			from	to		
Cadillac	XT4	2019	All	All	2.0 LSY	All

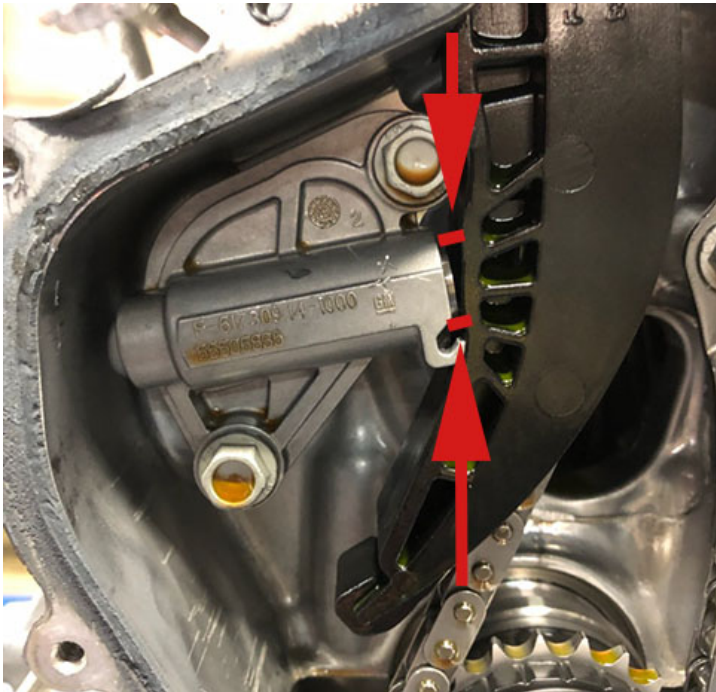
If you encounter a vehicle with a rattle noise from the front of the engine, this may be caused by a stuck or collapsed timing chain tensioner allowing the timing chain to be loose.

Photo below shows a stuck timing chain tensioner plunger allowing an air gap to be present between the tensioner plunger and timing chain guide.

If you find the above issue replace the timing chain tensioner using published Service Information and evaluate.

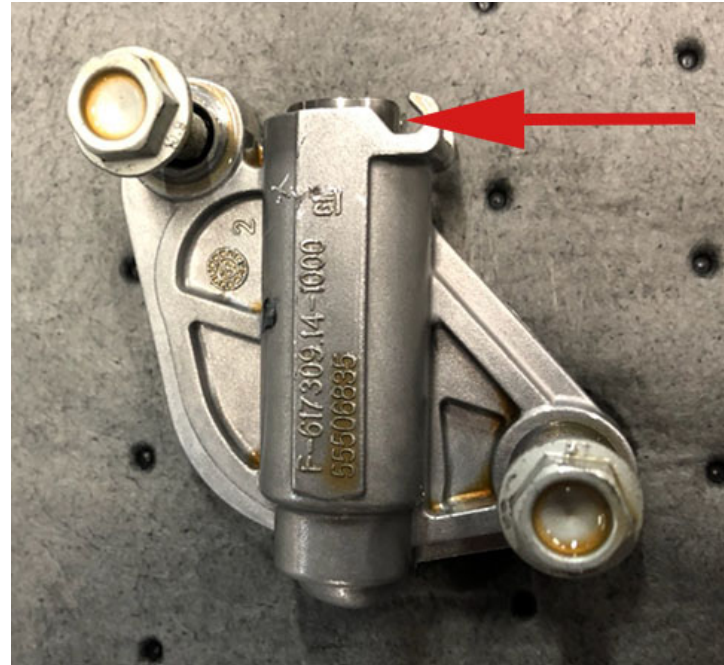
Photo below shows the timing tensioner removed from engine. Note the plunger is stuck in body of tensioner.
