PIP5412A Whine Howl Noise From Under Center Of Vehicle

PIP5412B Supersedes PIP5412A on 5/23/2019 please discard all previous versions.

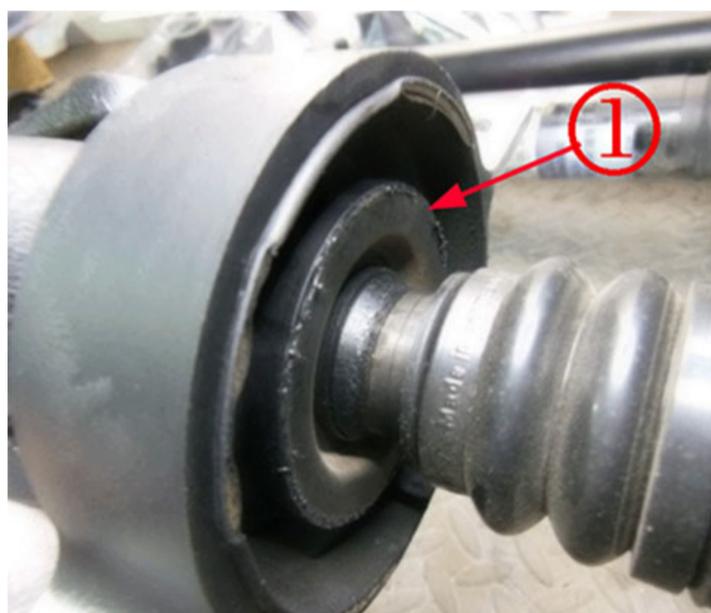
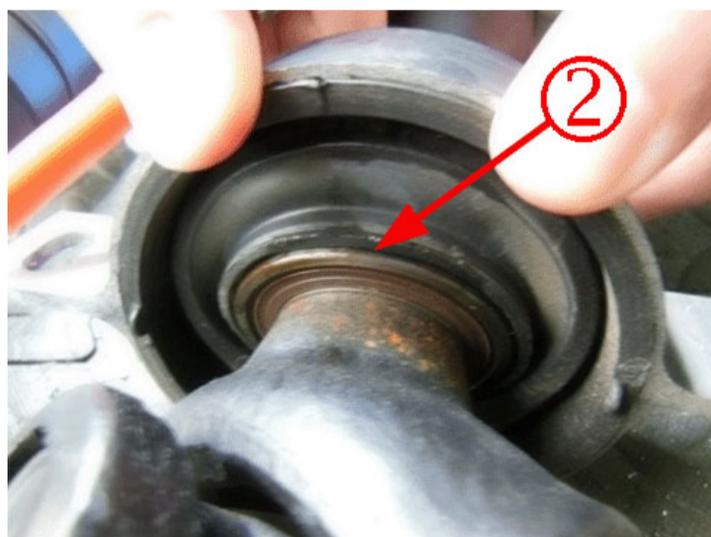
Involved Region or Country:	North America
Condition:	Squeal howl whine noise from under center of vehicle. May be intermittent and more pronounced on acceleration.
Cause:	Contact between the center bearing slinger and the rubber bearing support. Inspect the bearing and slinger for the following conditions. Picture 1. showing contact between the slinger and rubber. Picture 2 showing the backside of the bearing as the bearing moving rearward allows the slinger to move rear ward. Picture 3 shows proper clearance between the slinger and rubber. Picture 4 shows proper bearing installation.

Replace rear driveshaft assembly.

Ensure that when the replacement shaft is installed the bearing support is installed in such a manner to not load the bearing in the rubber mount.

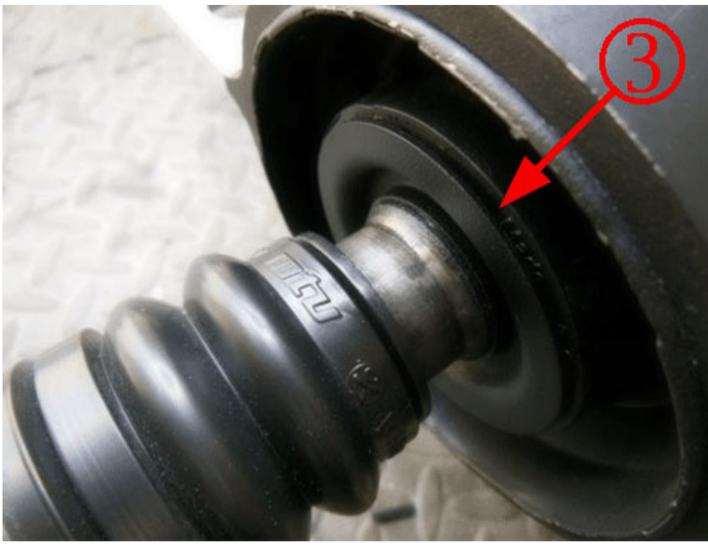
Inspect the replacement drive shaft for clearance between the slinger and rubber mount. Clearance should be between .7 and 1 mm (.027-.040 in).

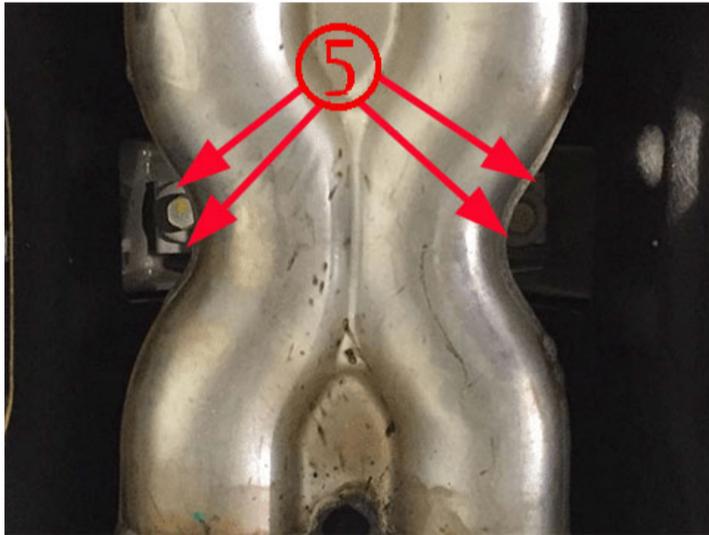
See photos below. Picture 5, make sure bearing mount is in the groove on both sides and centered in the bolt holes on the left and right.
