Preliminary Information

PIP5298B SES Traction Control lamp on and Engine Runs Rough with DTC P0300

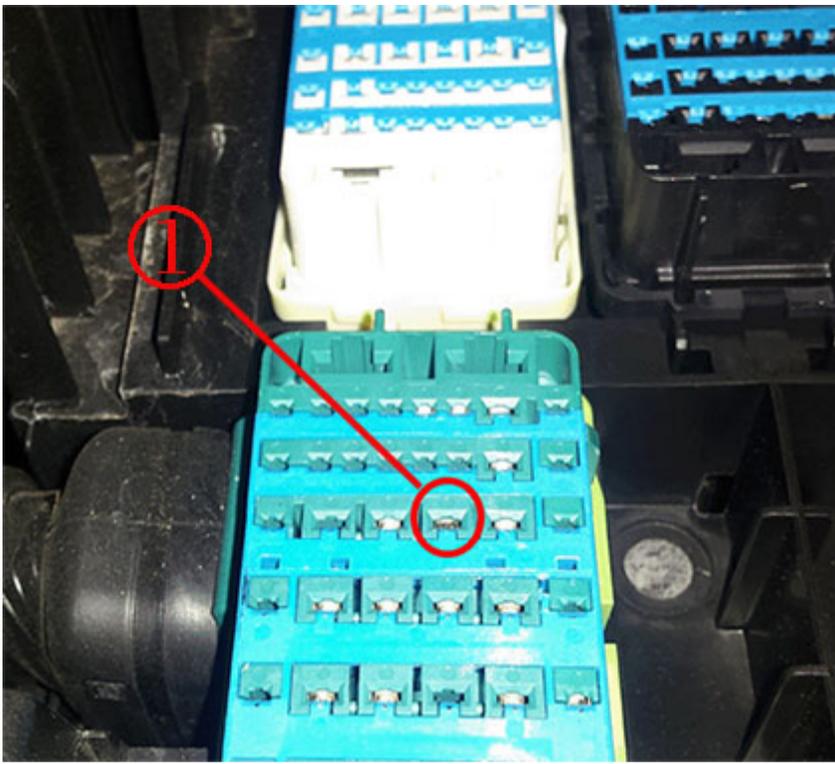
X2 Terminal

If SI diagnostics have been completed with no trouble found inspect for a possible terminal tension concern on both the ignition coil power feed for a possible cause of the DTC P0300 set and/or a rough running engine, and the X2 connector of the UBEC (Under hood Fuse Block) for an intermittent SES Traction control lamp concern and repair as necessary.

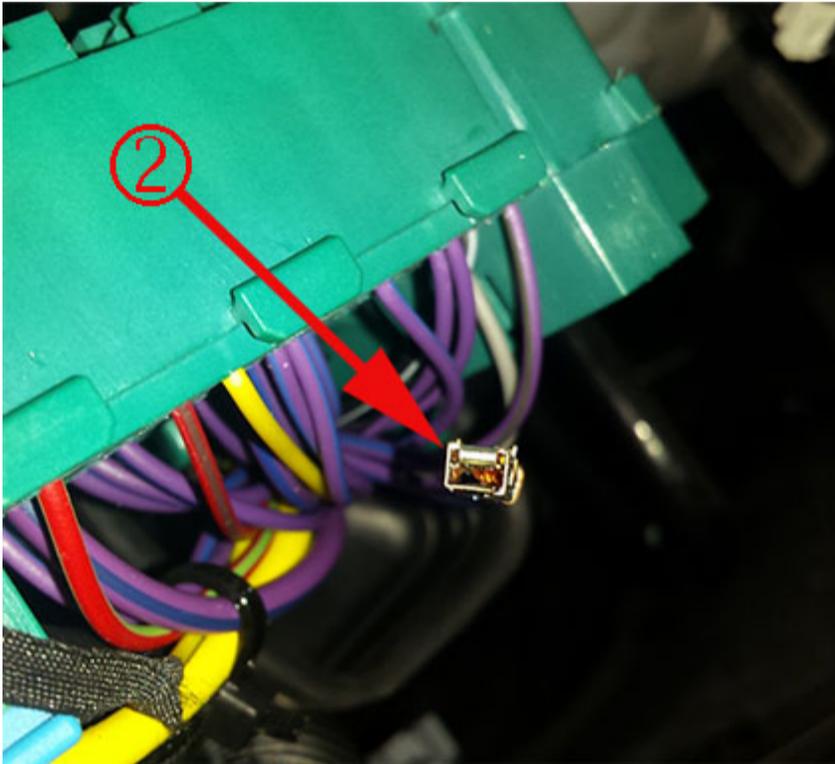
Notice terminal "spread" NO tension
