Preliminary Information

PIT5323B Normal Characteristic - Appearance of Uneven Bed or Accessory Rails after Installation of Accessory Tonneau Cover

Models

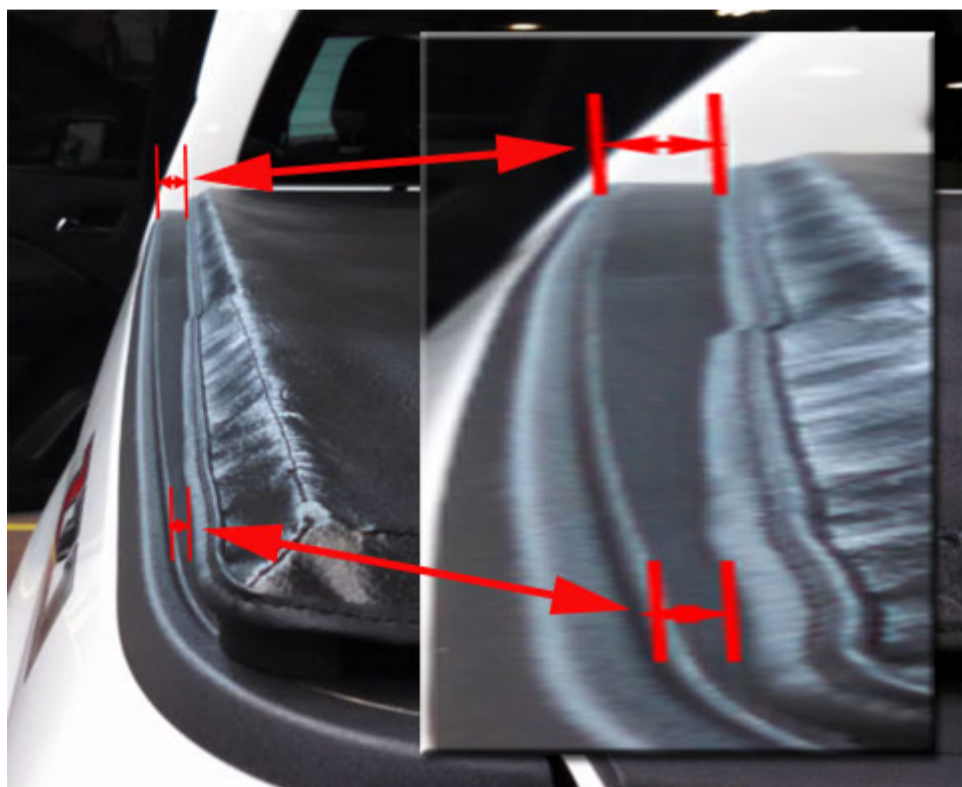
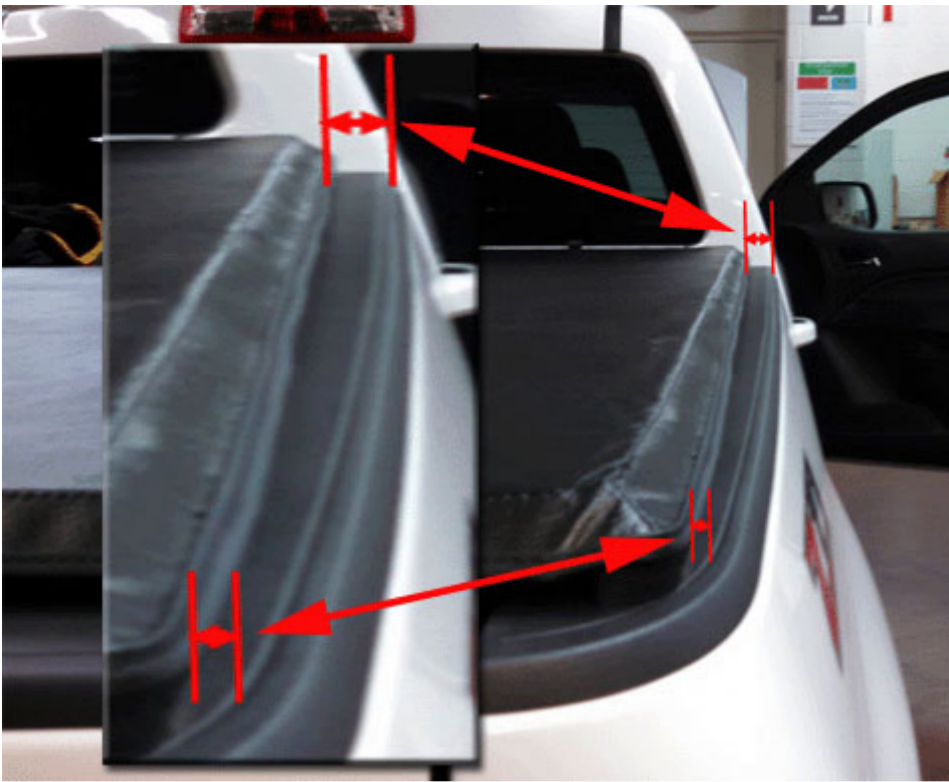
A customer or technician installing accessories on the bed rail caps may notice the rails are not as wide at the rear of the pickup bed as they are at the front of the bed. This is typically noticed after the installation of GM Accessory Soft Folding or Soft Roll-Up Tonneau Cover rails.

Some may think the accessory install was incorrect or that parts of the accessory kit are damaged.

The changing width of the bed rail cap is by design and part of the sleek appearance of the truck; no repairs are necessary to correct it.

Because the bed rail caps narrow as they go toward the rear of the vehicle, and the tonneau cover rails maintain a rectangle shape, the narrowing of the bed rail caps is highlighted and more noticeable.

IMPORTANT: Do not attempt to repair or replace parts for this condition.

Please communicate to the customer this condition is a normal design characteristic of their vehicle. It will not impact the designed performance or reliability of the vehicle. Please share this information with the customer, including a copy of this message.
