SS 1034225 New Cascadia LED Headlight Accent / Park Light Function Disable

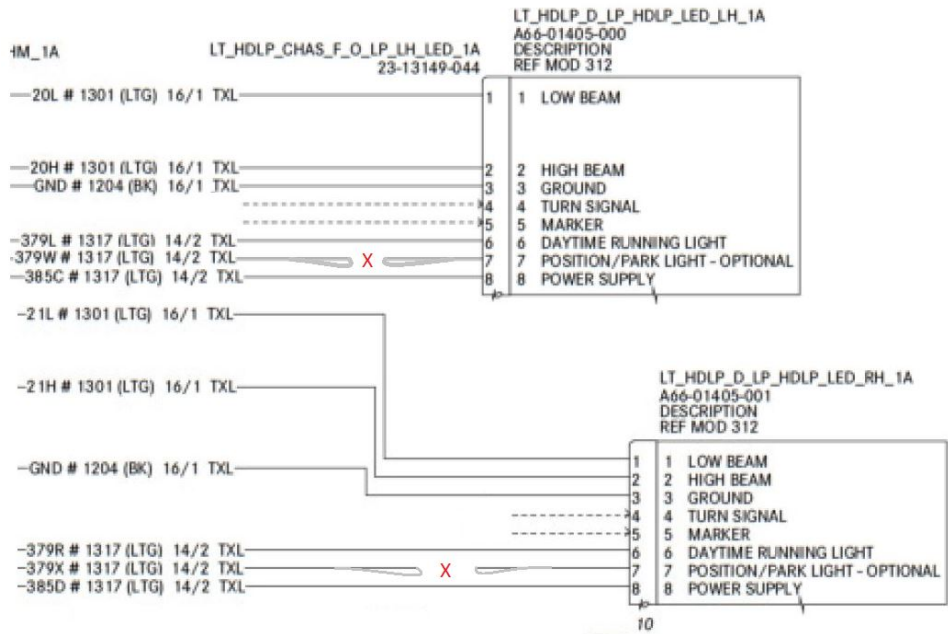
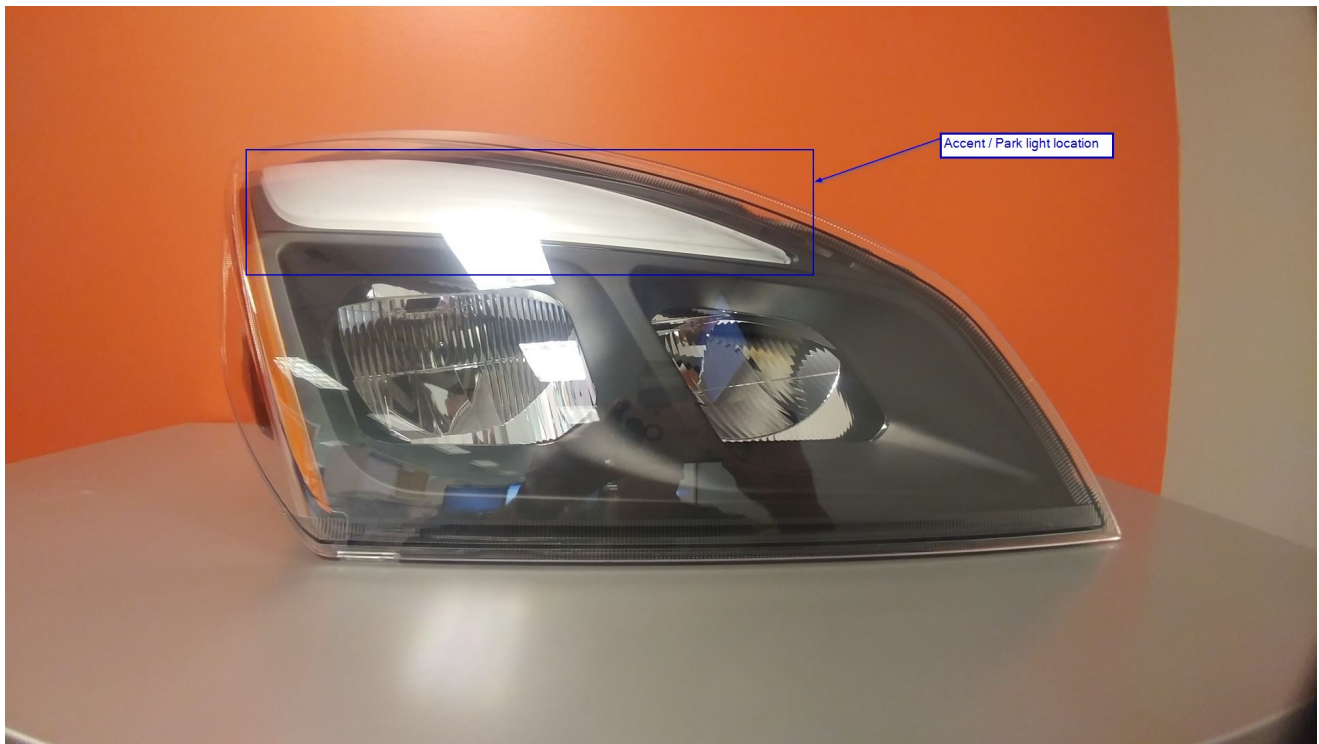
Accent / Park light function cannot be altered to function differently. In several cases the request has been made to eliminate the light's function. Since the Accent/ Park light function was never required (optional light), eliminating the light is acceptable. Since there is no programming available to eliminate the Accent / Park light, the only way to eliminate the light is to cut 379W left side and 379X right side wires about 3" from the headlights, fold all sides of the cut wires back and tape the wire ends to the harness. Images have been added below, documenting the wires that can be cut, along with the location of the Accent / Park light.
