Replace Huck BOM Fastener on Front Seats

Classification Repair Bulletin **Section/Group** 13 - Seats **Country/Region** All

Year 2015-2018 **Model** Model S, Model X **Version** All

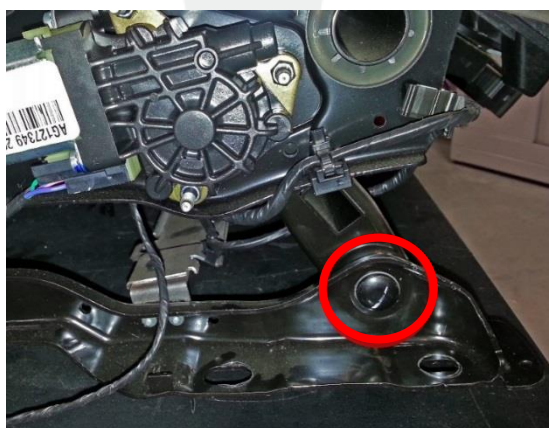
Figure 1

1. Remove the affected front seat (refer to Service Manual procedure 13040101).
2. Move the seat to a clean, flat work area.
3. Remove the front seat memory module (refer to Service Manual procedure 13010602).
4. Remove the seat track (refer to Service Manual procedure 13010102).
5. Remove the Huck BOM fastener:
 - a. Locate the Huck BOM rivet on the inboard side (closest to the center console) of the seat frame (Figure 1).
