SERVICE ADVISORY # 19-353

Fuzion Skylights

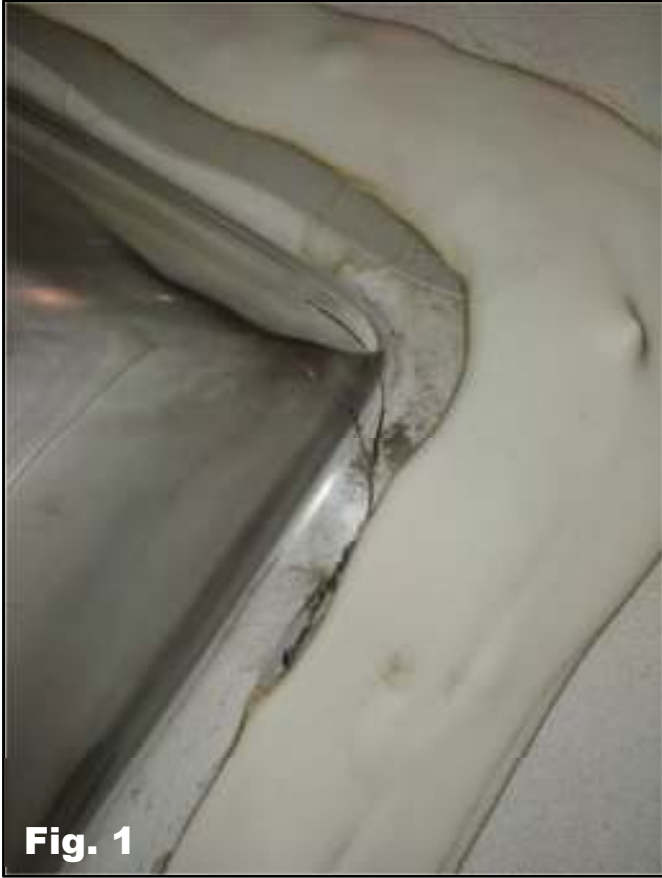
**Fig. 1****Step 1**

It has been determined that Polycarbonate skylights used on Alpha Flex roof systems may crack. The following procedure describes how to identify and replace the polycarbonate skylights.

The remedy is to inspect the clear polycarbonate skylight on the new Alpha Flex Roof system. Inspect the clear skylight for cracks and replace if cracks are found. See Figure 1 as an example. A clear picture is required for authorization and the claim.

Locate the skylight on the exterior roof and inspect for cracks. If the skylight is cracked, take clear pictures for the authorization showing the defect. If no cracks are present, proceed to warranty reimbursement below and submit a claim for inspection. If the skylight is cracked, proceed to Step 3.

If the skylight is cracked, remove the skylight using normal industry standards and replace with the new skylight (KRV # 237000) using butyl tape (KRV # 100292) under the skylight as a primary seal and Alphathane (KRV # 625559) as a self-leveling secondary seal, then proceed to warranty reimbursement.
