Keystone RV Company

6/4/19

SERVICE ADVISORY # 19-353

Fuzion Skylights

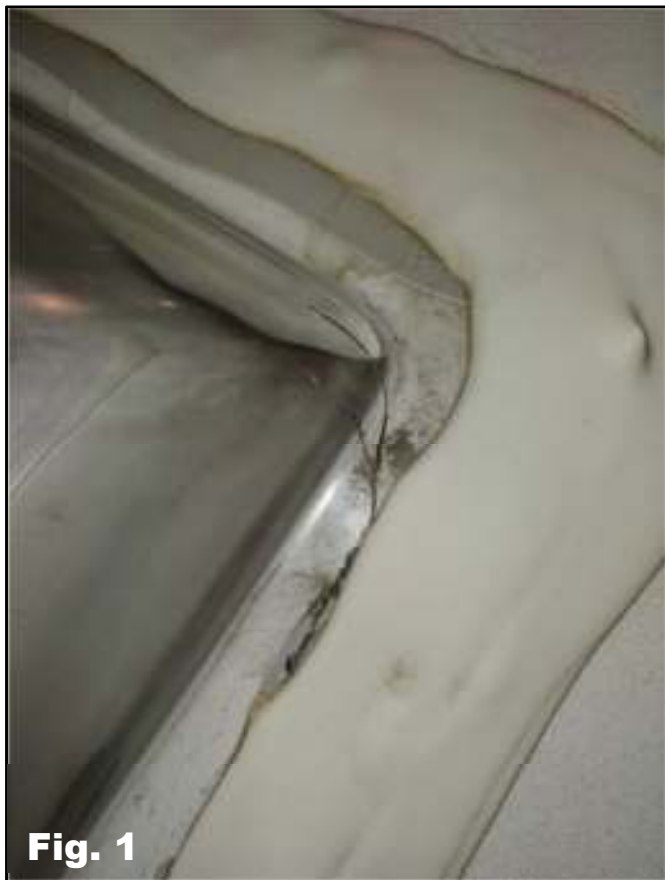
**Fig. 1****Step 1**

It has been determined that Polycarbonate skylights used on Alpha Flex roof systems may crack. The following procedure describes how to identify and replace the polycarbonate skylights.

The remedy is to inspect the clear polycarbonate skylight on the new Alpha Flex Roof system. Inspect the clear skylight for cracks and replace if cracks are found. See Figure 1 as an example. A clear picture is required for authorization and the claim.

If the skylight is cracked, remove the skylight using normal industry standards and replace with the new skylight (KRV # 237000) using butyl tape (KRV # 100292) under the skylight as a primary seal and Alphathane (KRV # 625559) as a self-leveling secondary seal, then proceed to warranty reimbursement.
