# Technical Service Bulletin

## 60 Rattle noise near central roof area

60 19 31 2054270/3 June 12, 2019. Supersedes Technical Service Bulletin Group 60 number 19-29 dated May 17, 2019 for reasons listed below.

Model(s)	Year	VIN Range	Vehicle-Specific Equipment
A6	2019	All	Not Applicable

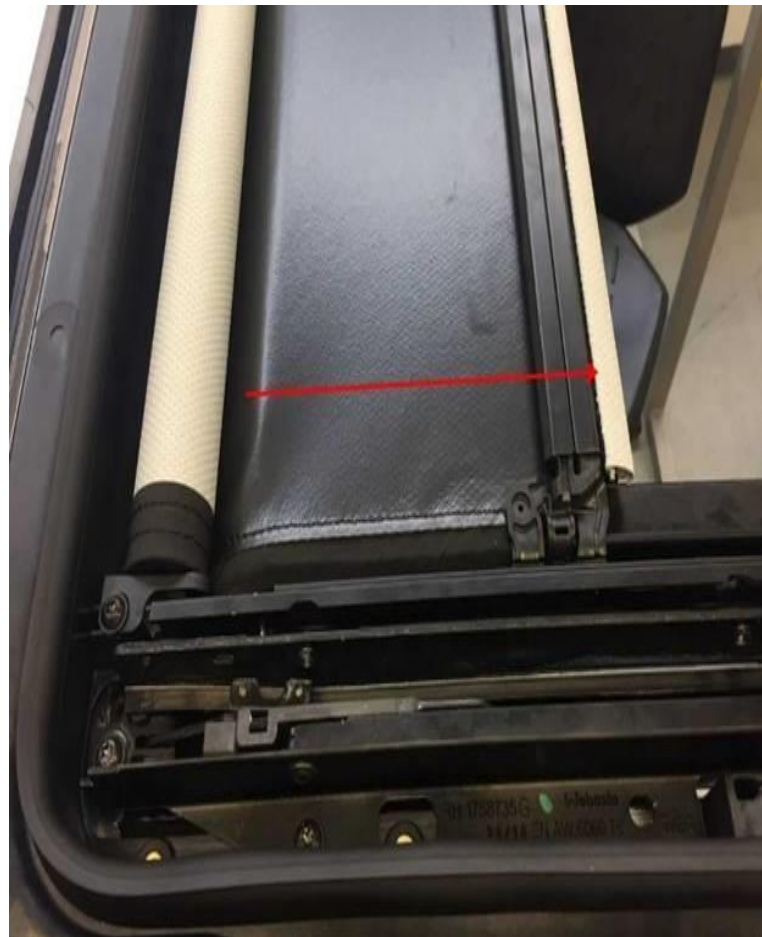
*Figure 1. Closing the roller shade.*

1. Remove the glass sunroof panel using the repair manual instructions.
2. Close the roller shade by about 20cm (Figure 1).

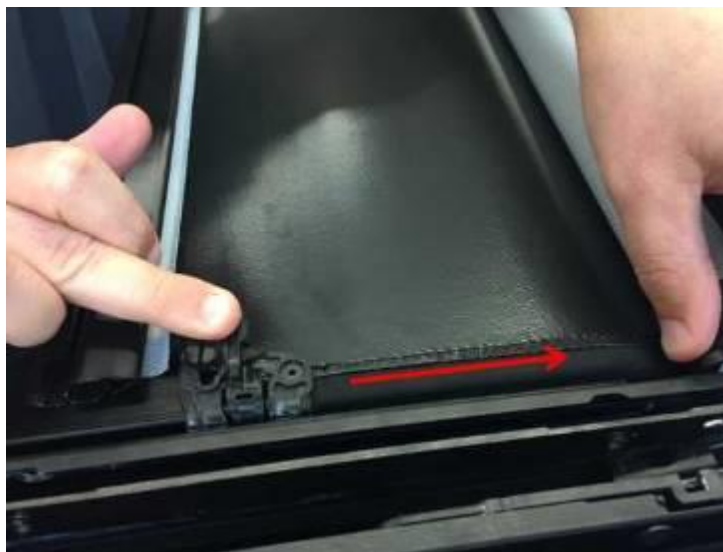
*Figure 2. Loosening the roller shade.*

3. Loosen the roller shade from the drive cable and push the material back until the bolts are exposed, then remove the bolts completely (Figure 2 and 3).

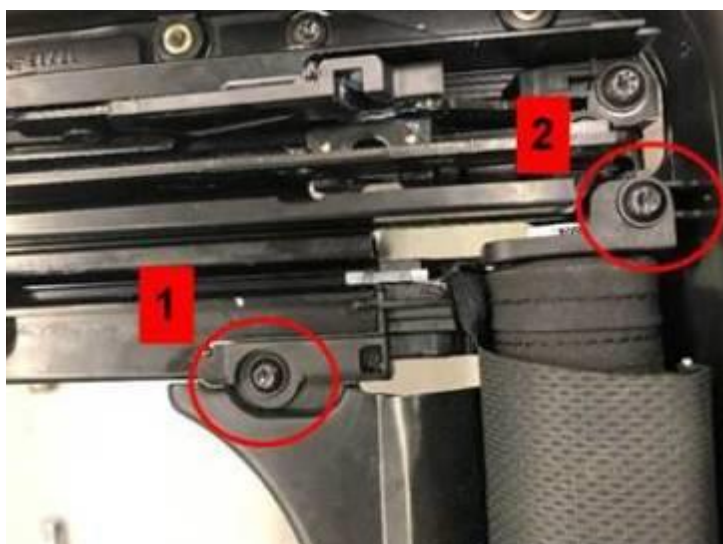
*Figure 3. Remove the bolts.*

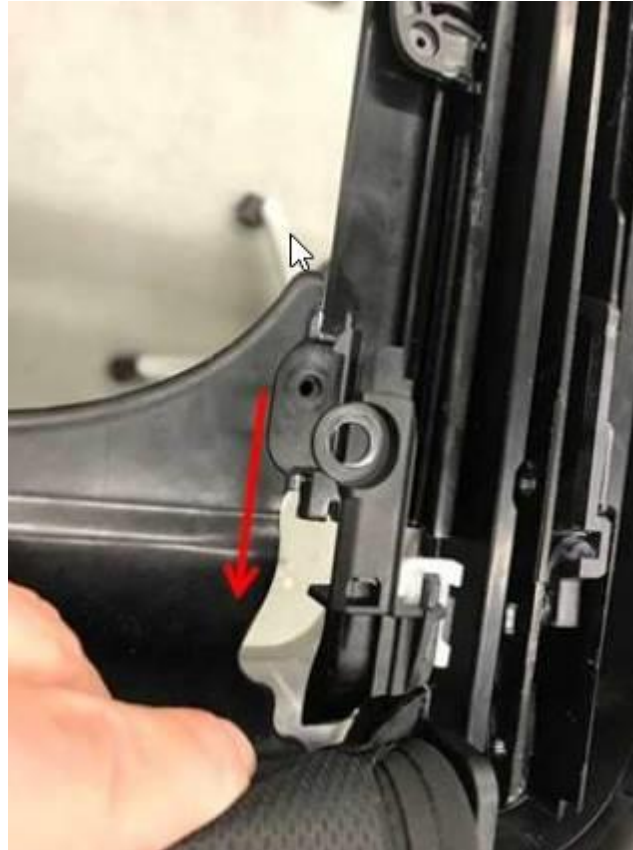
*Figure 4. Slide roller shade backward.*

4. Remove the roller shade by sliding it backward and clean the mounting points as shown in Figure 4 and 5. Use the cleaning solution D 009 401 04.

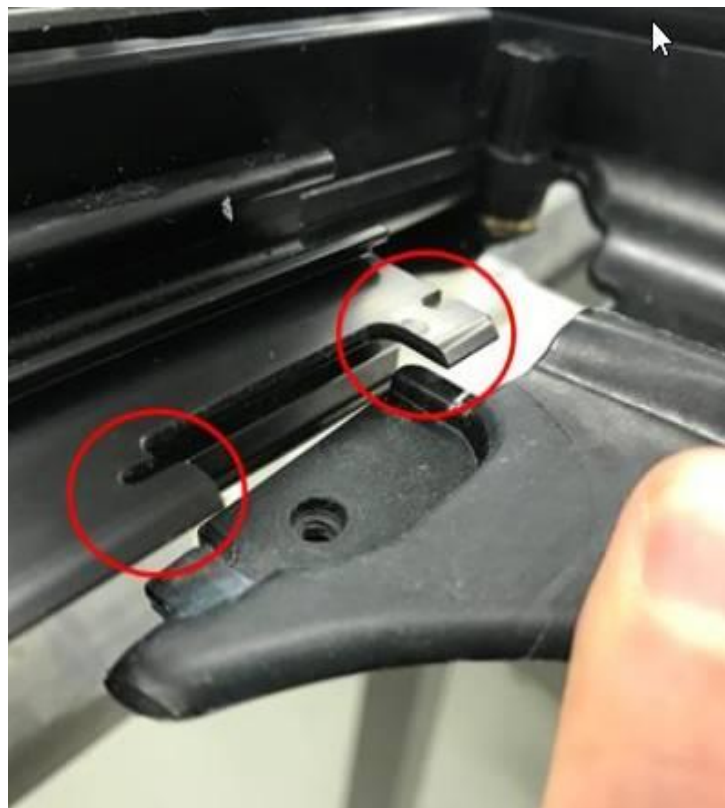
*Figure 5. Removing the roller shade.*

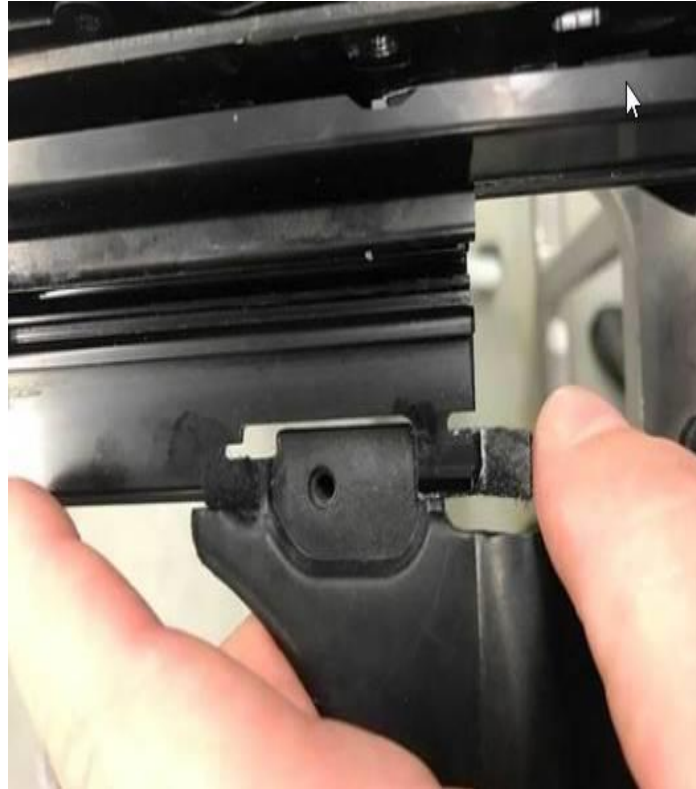
*Figure 6. Applying felt tape.*

5. Push down on the roller shade pan and starting from the bottom of the guide rail, apply the 1mm thick felt tape and fold them forward and over to the top of the guide rail (Figure 6 and 7).

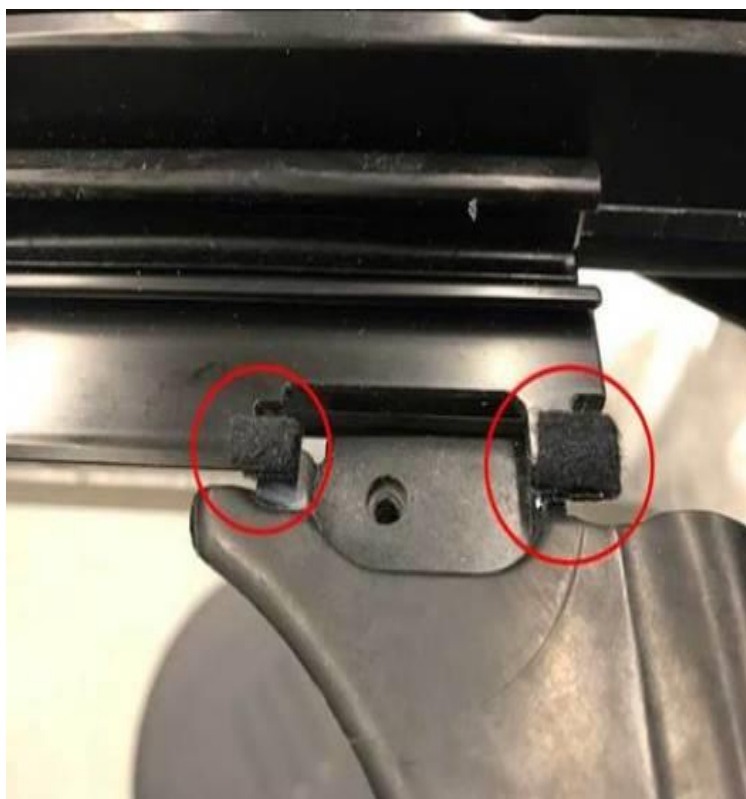
**Figure 7.** Apply felt tape on points shown.

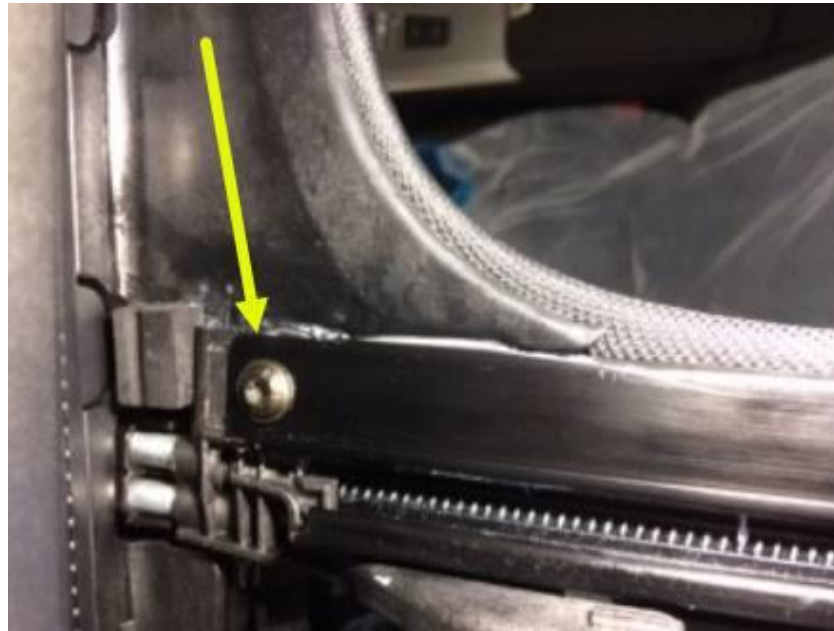
**Figure 8.** Loosen the bolt and apply lube paste between these panels and under the bolt head. Reinstall the bolt and torque to 5Nm.

7. On the front of the sunroof guide rail, loosen that bolt by 3mm. Lift the guide rail, closing the gap between the rail and the plastic head section. Apply lube paste G 060 567 A2 between the two panels and also under the head of the bolt on the guide rail. Be careful not to get the lube paste on the threads of the bolt. Reinstall the bolt and tighten to 5Nm. (Figure 8).
