SERVICE BULLETIN

| Classification: BT09-052g | Reference: NTB09-081g | Date: May 15, 2019 |

WINDSHIELD CRACKING

APPLIED VEHICLES: All Nissan models

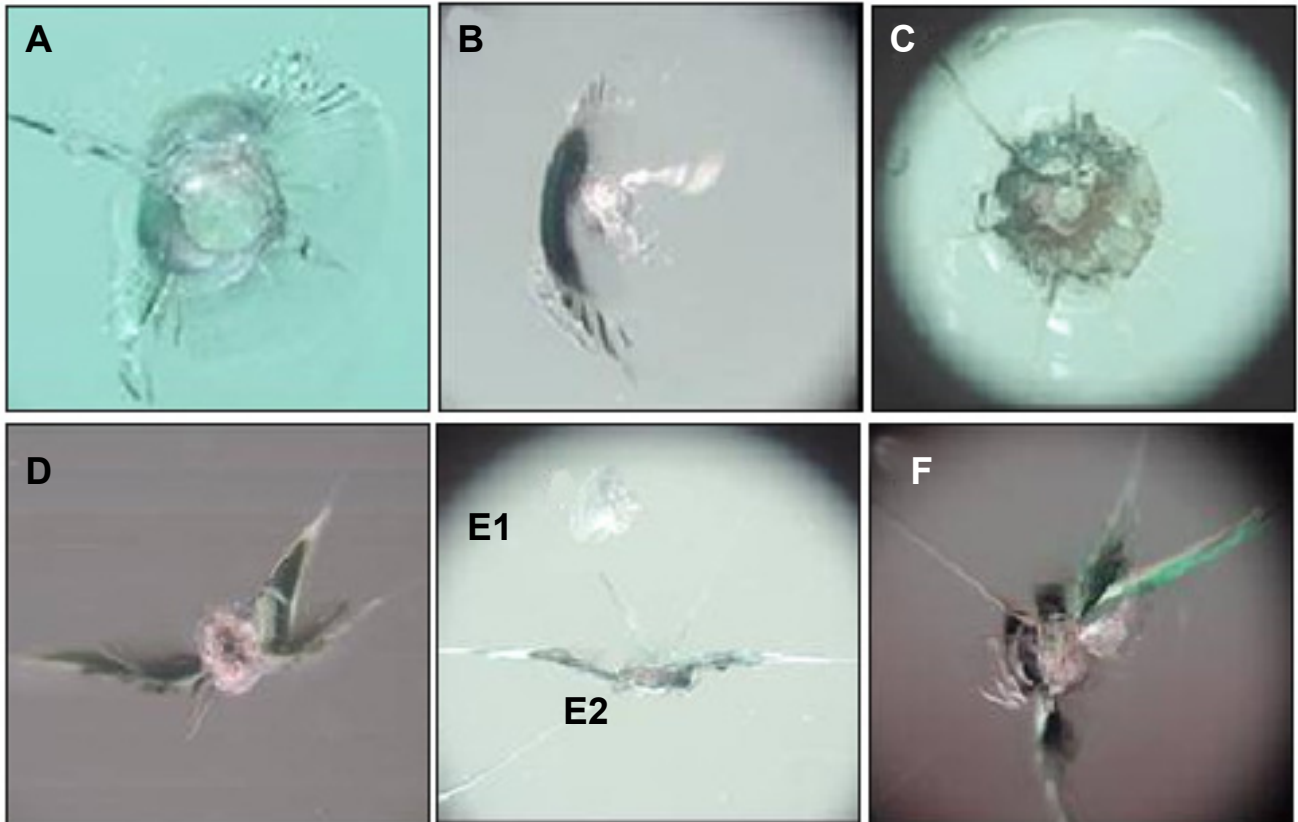
Most windshield damage that occurs due to impact is easily identified as shown below:

- Cone shaped break (A, B, C)
- Crush mark (D, E1, F)
- Star shape crack (C, D, E2, F).

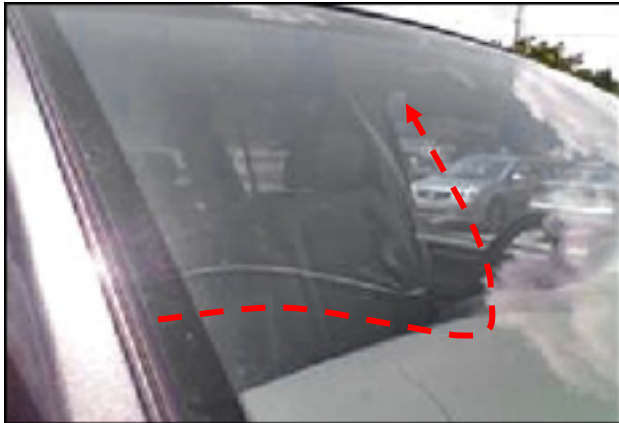
Single crack with **no** impact mark:
Warranty

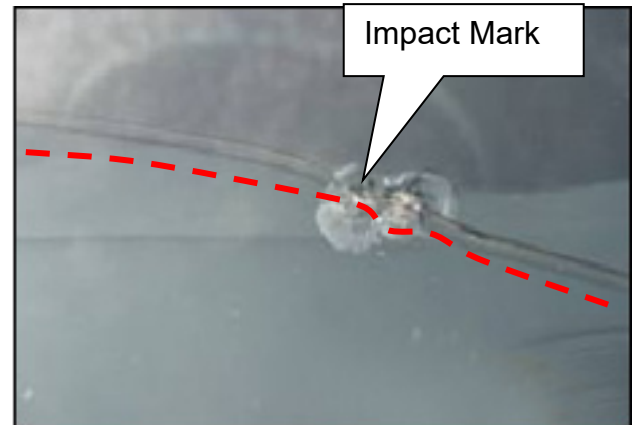
Single crack with impact mark:
Not Warranty

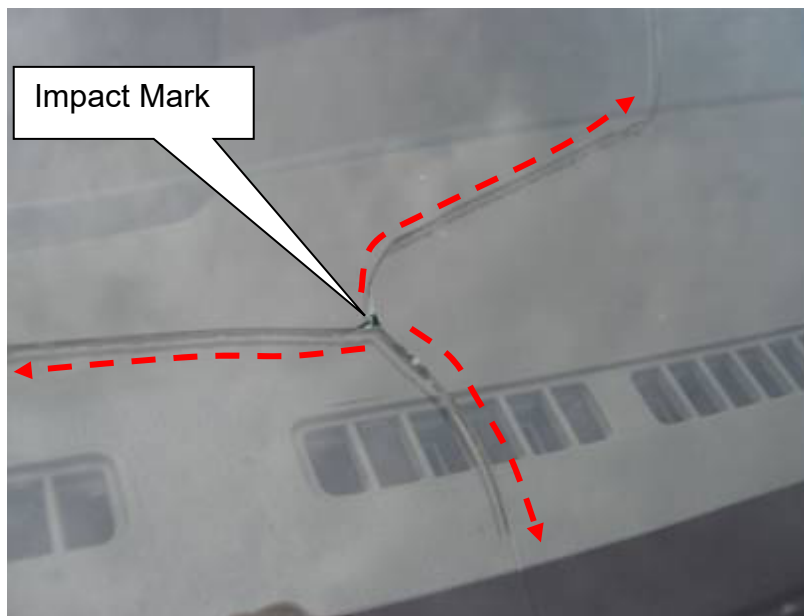
This type of crack is always caused by impact to the glass. The point of impact is located where the crack “branches out”.

Compound crack: **Not Warranty**

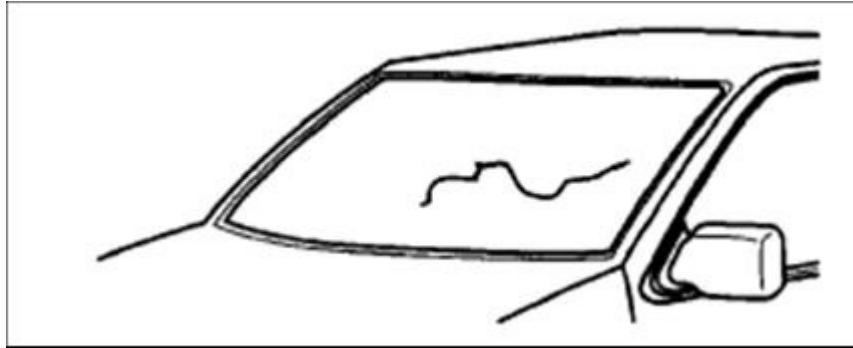
- These cracks are always caused by an impact to the glass and are not covered under warranty.

Cracks not reaching the edge: **Not Warranty**

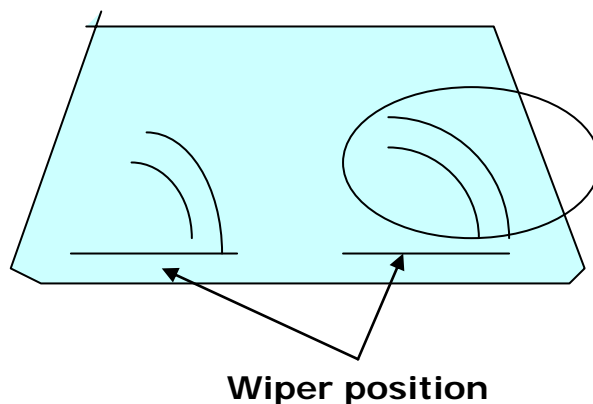
- Inspect the wiper paths (may be a single scratch of a group of scratches).
- Small scratches can cause a small rupture in the outer glass surface, which can lead to a crack from thermal conditions, vehicle vibration during driving, or wind pressure.

Scratch from sand/stone: **Not Warranty**

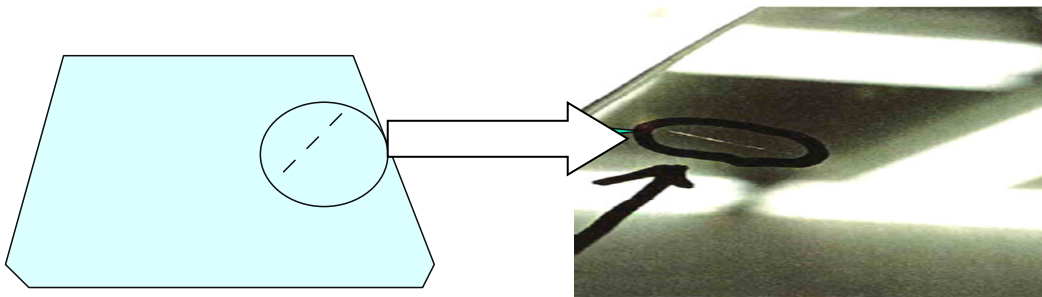
- Scratches can occur from metal objects such as keys and metal buttons. These scratches are typically sharp and can be found anywhere on the glass surface.
- Thoroughly examine the entire length of the crack to identify any scratch as a start point.
- Small scratches can cause a small rupture in the outer glass surface, which can lead to a crack from thermal conditions, vehicle vibration during driving, or wind pressure.

Scratch from metal objects: **Not Warranty**

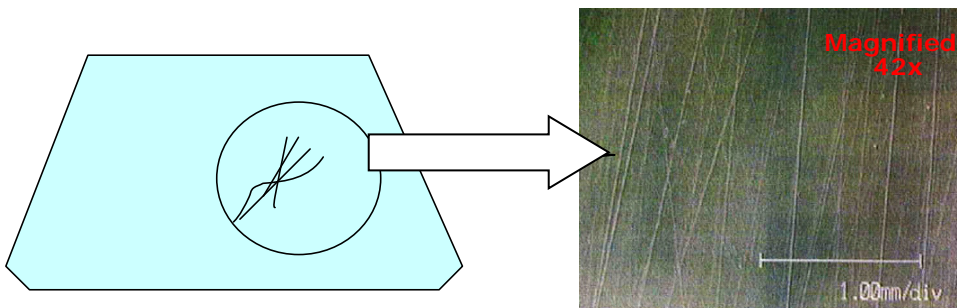
- Scratches can occur from wiping the glass with a towel that has sand particles or dirt on it.
- These scratches are typically long and have several scratches concentrated together.
- These scratches can be found anywhere on the glass surface.
- Thoroughly examine the entire length of the crack to identify any scratch as a start point.

Scratch from dirty towel/cloth: **Not Warranty**

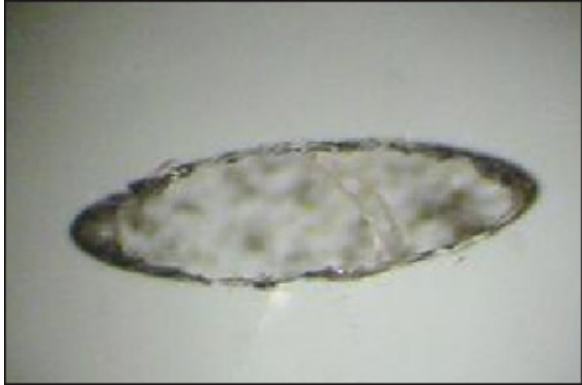
Open bubble – **Warranty**

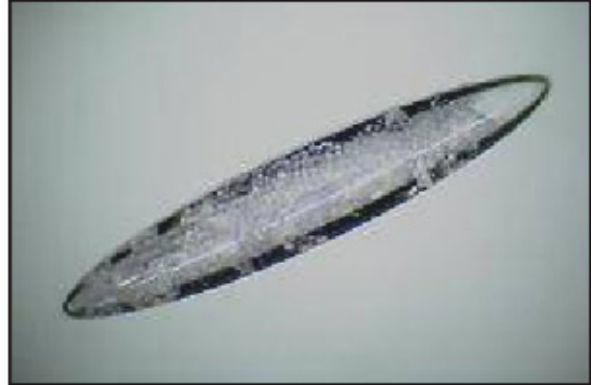
Surface blister - **Warranty**

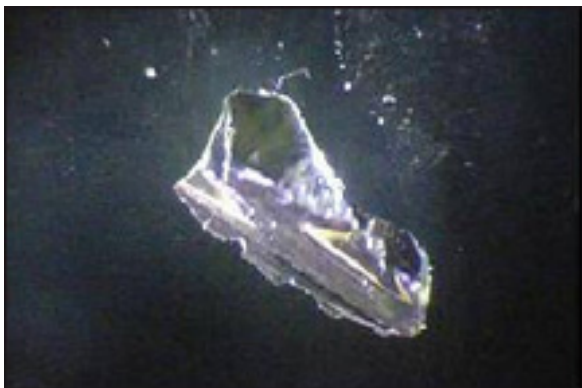
Adhesion chip – **Warranty**
(Can occur from a manufacturing issue such as adhesion of molding to the glass surface along the glass edge.)

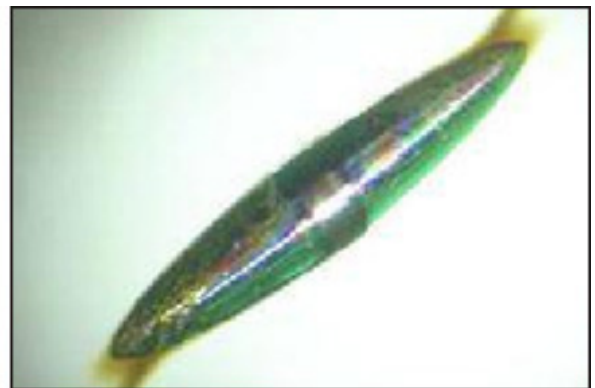
Surface blister – **Warranty**
