# SERVICE BULLETIN

Classification: EM17-004a	Reference: NTB17-053a	Date: May 14, 2019
------------------------------	--------------------------	-----------------------

## 2016-2017 TITAN/TITAN XD; FAN COUPLING TICK / KNOCK IN COLD AMBIENT TEMPERATURES (32°F (0°C) OR BELOW)

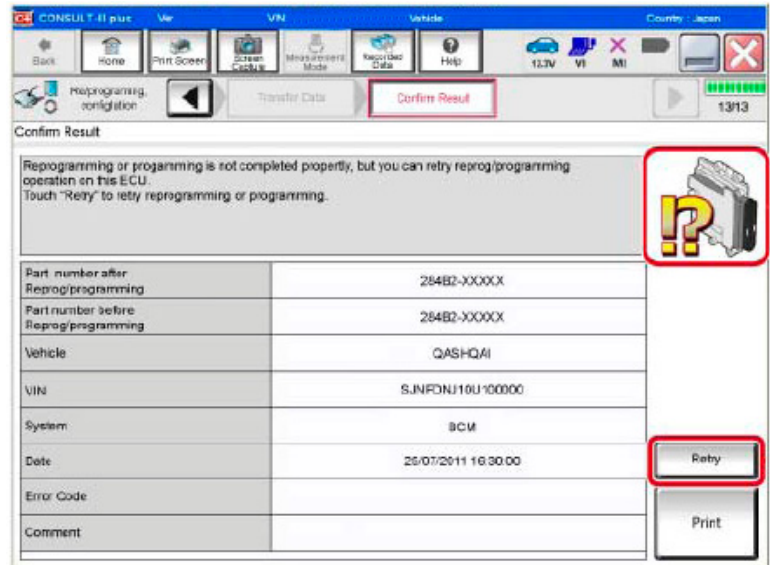
Figure 5

If reprogramming does not complete and the “!?” icon displays as shown in Figure 5:

- Check battery voltage (12.0–15.5 V).
- Ignition is ON, engine OFF.
- External Bluetooth® devices are OFF.
- All electrical loads are OFF.
- **Select retry and follow the on screen instructions.**
- “Retry” may not go through on first attempt and can be selected more than once.

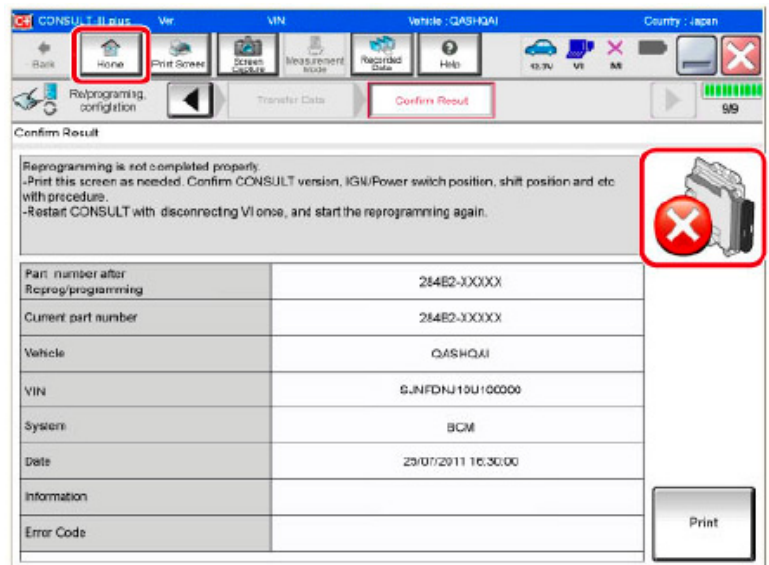
Figure 6

If reprogramming does not complete and the “X” icon displays as shown in Figure 6:

- Check battery voltage (12.0 – 15.5 V).
- CONSULT A/C adapter is plugged in.
- Ignition is ON, engine OFF.
- Transmission is in Park.
- All C-III plus / VI cables are securely connected.
- All C-III plus updates are installed.
- **Select Home, and restart the reprogram procedure from the beginning.**
