SERVICE BULLETIN

Classification: EC17-035	Reference: NTB18-018a	Date: May 14, 2019
-----------------------------	--------------------------	-----------------------

2013-2015 ALTIMA; ROUGH IDLE ON START UP

APPLIED VEHICLES: 2013-2015 Altima (L33)

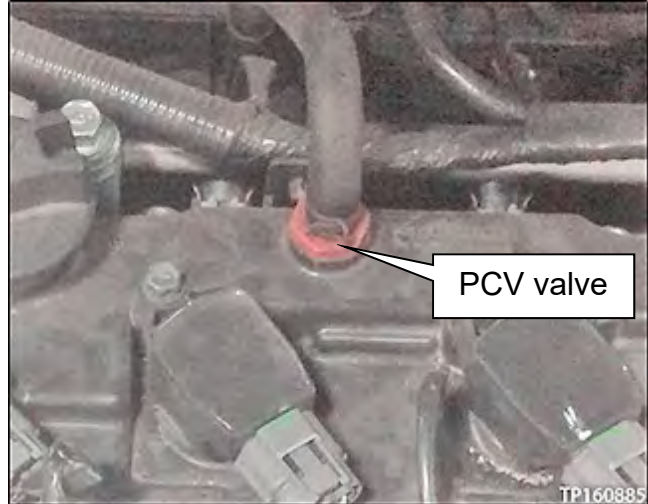
Figure A

2. If the PCV valve is **orange** in color, replace it.

3. If the vehicle's PCV valve is already **black** in color, do not replace it.

- See **PARTS INFORMATION**.
- Refer to the Electronic Service Manual (ESM), section **EC-Engine Control System**, for PCV valve replacement information.

NOTE: The new PCV valve is **black** in color.

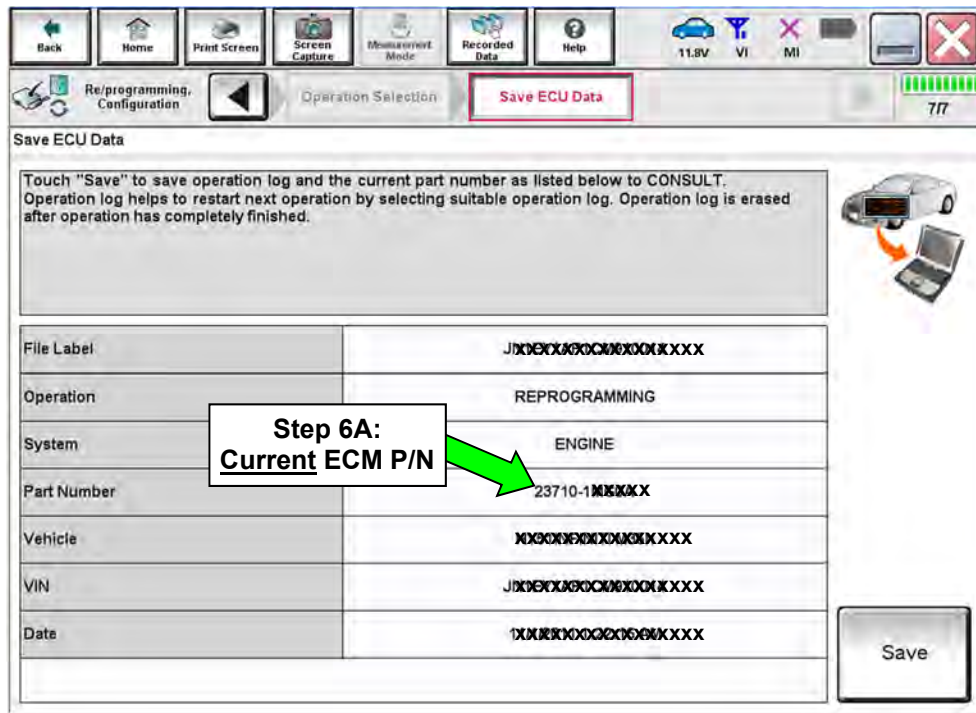
Figure 2

6. When you get to the screen shown in Figure 2, confirm this bulletin applies as follows.
 - A. Find the ECM **Part Number** and write it on the repair order.

- B. Compare the P/N you wrote down to the numbers in the **Current ECM Part Number** column in **Table A** (page 5).
 - If there is a match, continue with the reprogramming procedure.

- If there is not a match, close C-III plus and refer to ASIST for further diagnostic information.

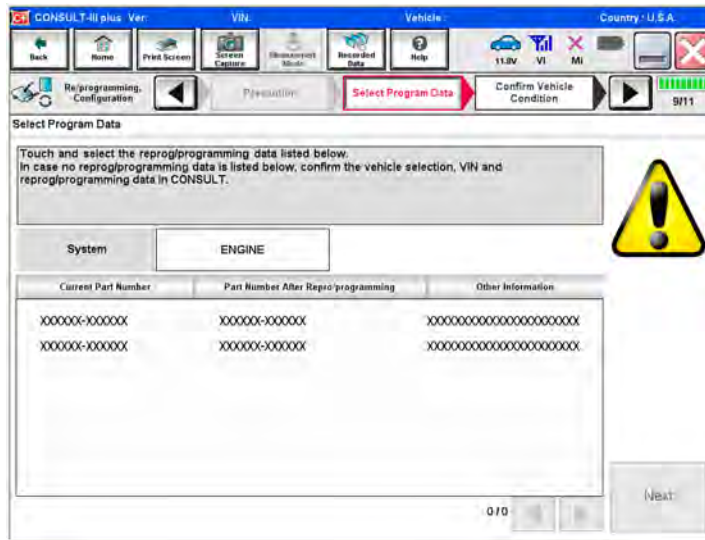
- In some cases, more than one new P/N for reprogramming is available.
 - If more than one new P/N is available, the screen in Figure 3 displays.
 - Select and use the reprogramming option that does **not** have the message “Caution! Use ONLY with NTBXX-XXX”.
- If you get this screen and it is blank (no reprogramming listed), it means there is no reprogramming available for this vehicle. Close C-III plus and refer back to ASIST for further diagnosis.

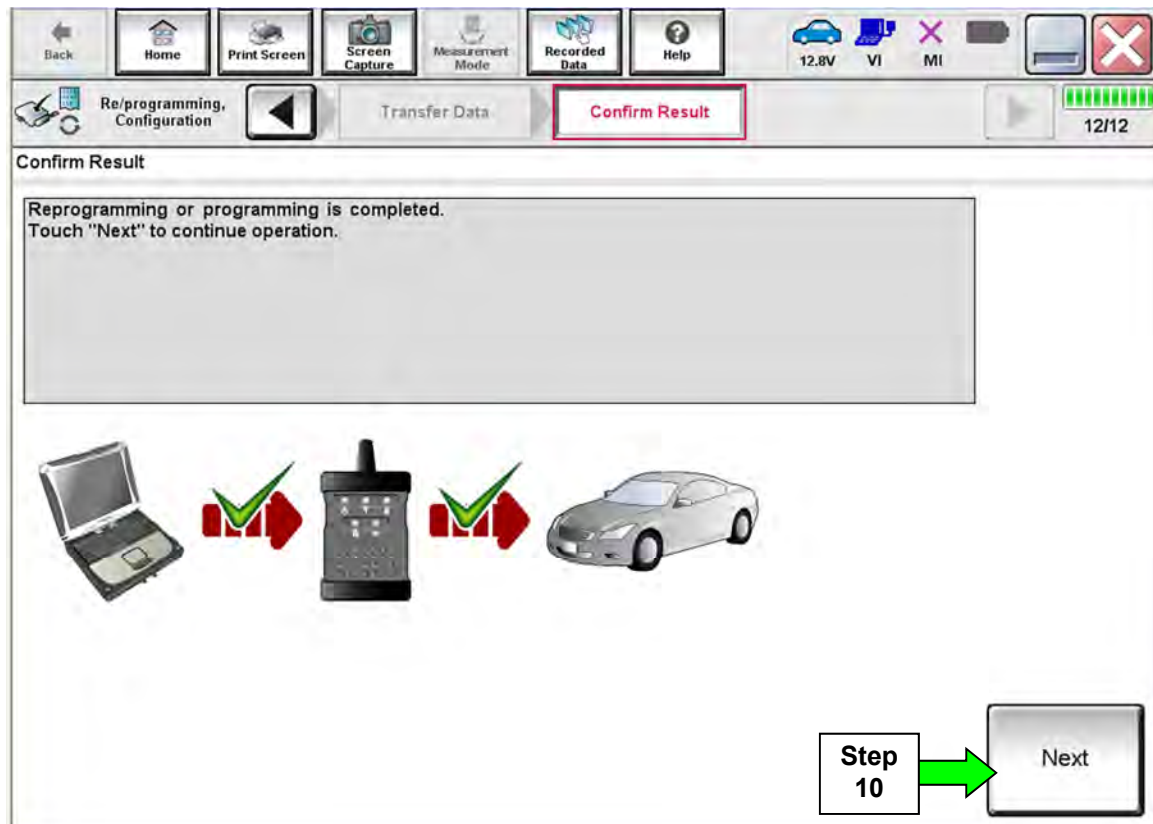
8. When the screen in Figure 5 displays, reprogramming is complete.

NOTE: If the screen in Figure 5 does not display (indicating that reprogramming did not complete), refer to ECM recovery on the next page.

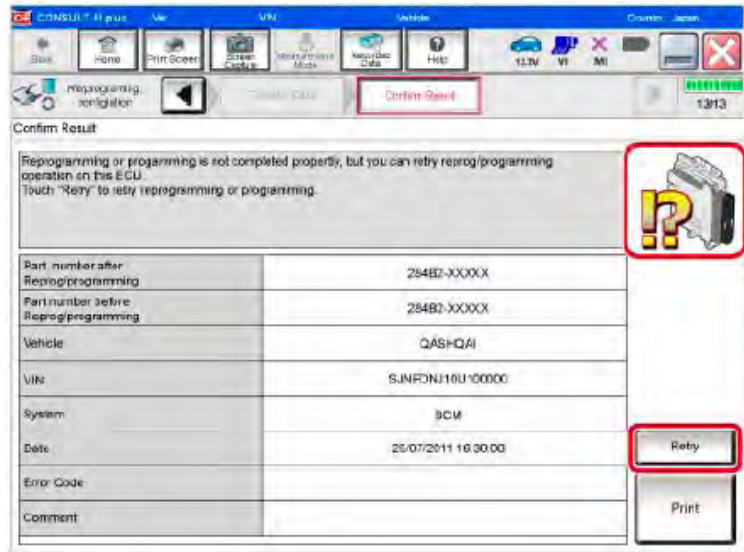
Figure 6

If reprogramming does not complete and the “!?” icon displays as shown in Figure 6:

- Check battery voltage (12.0 - 15.5 V).
- Ignition is ON, engine OFF.
- External Bluetooth® devices are OFF.
- All electrical loads are OFF.
- **Select retry and follow the on screen instructions.**
- **“Retry” may not go through on first attempt and can be selected more than once.**

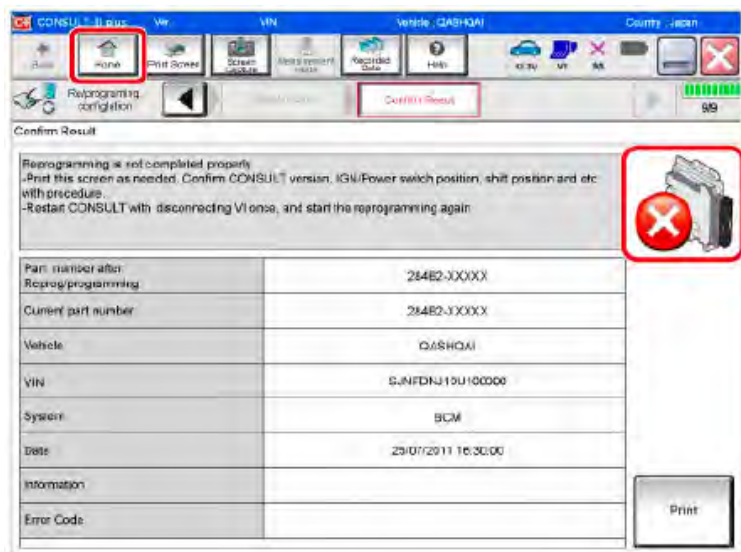
Figure 7

If reprogramming does not complete and the “X” icon displays as shown in Figure 7:

- Check battery voltage (12.0 - 15.5 V).
- CONSULT A/C adapter is plugged in.
- Ignition is ON, engine OFF.
- Transmission is in Park.
- All C-III plus / VI cables are securely connected.
- All C-III plus updates are installed.
- **Select Home, and restart the reprogram procedure from the beginning.**

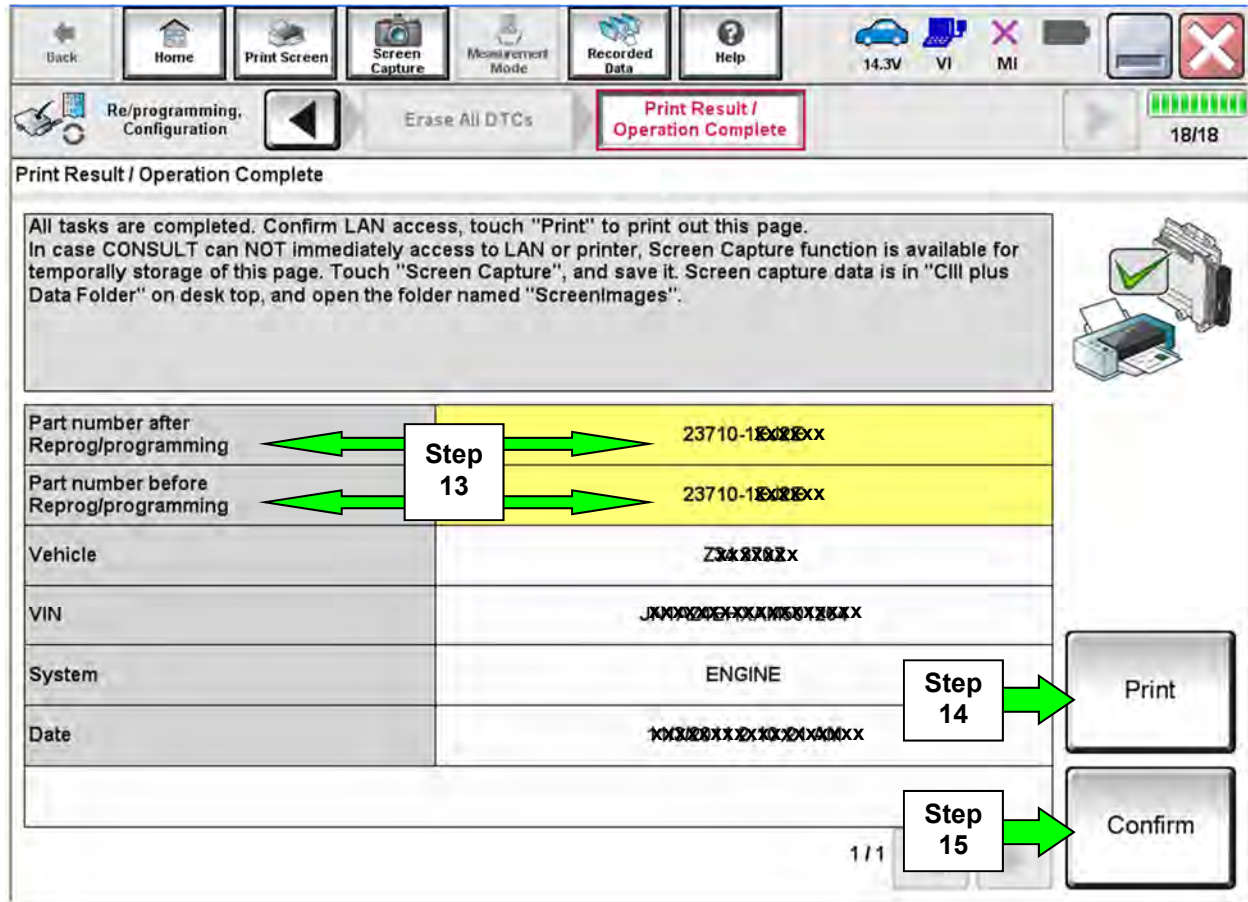
12. When the entire reprogramming process is complete, the screen in Figure 8 will display.
13. Verify the before and after part numbers are different.
14. Print a copy of this screen (Figure 8) and attach it to the repair order for warranty documentation.
15. Select **Confirm**.
