Subject: N182206500 - Service Update
Hood Ball Stud Bracket is Not Zinc Plated

Models: 2019 Cadillac CT6

Service Update

N182206500 Hood Ball Stud Bracket is Not Zinc Plated

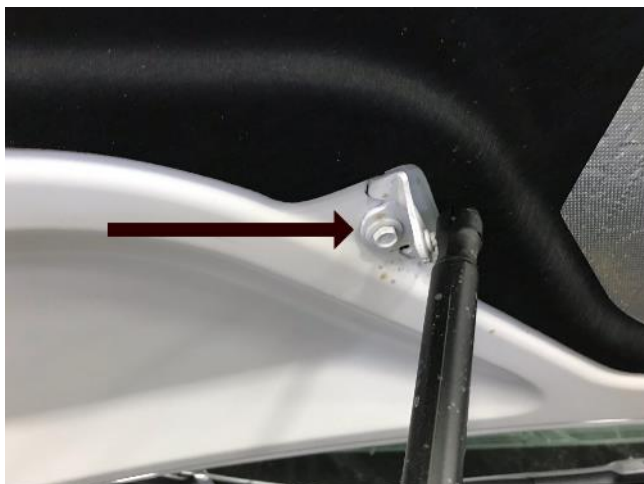
5286412

Condition	Certain 2019 model year Cadillac CT6 vehicles were built without required protective metal coating on the hood ball stud bracket. Over time, metal to metal contact may create a corrosion issue in which the ball stud bracket used to anchor the hood could cause visible rust.
Correction	Dealers are to replace the hood ball stud bracket.

3. Disconnect the hood struts at the hood stud ball brackets. Refer to *Hood Strut Replacement* in SI.
4. Remove the hood stud ball bracket bolts and brackets and discard.

5. Install the new hood stud ball brackets and bolts and torque to 10 Nm (89 lb in).
6. Connect the hood struts at the hood stud ball brackets. Refer to *Hood Strut Replacement* in SI.
7. Remove the hood support.
8. Remove the fender covers and close hood.
