GLOBAL SAFETY FIELD INVESTIGATIONS  
DCS5042  
URGENT - DISTRIBUTE IMMEDIATELY

Subject: N182182960 - Special Coverage  
Driver Seatbelt Anchor Pretensioner Cable Fracture

Models: 2014-2017 Chevrolet Impala

## N182182960 Driver Seatbelt Anchor Pretensioner Cable Fracture

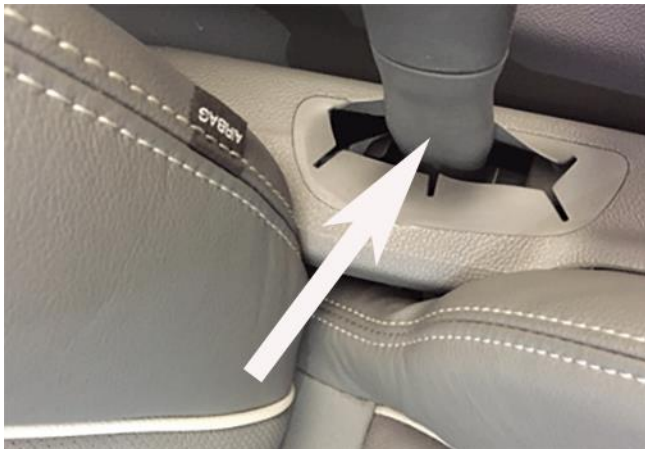
5205929

1. Move the driver seat to the full forward and full down position.
2. Inspect the seat belt tensioner cable cover for damage. Inspect the complete cable cover from the base of the cable to the latch. Damage includes any splits, holes or cracks.

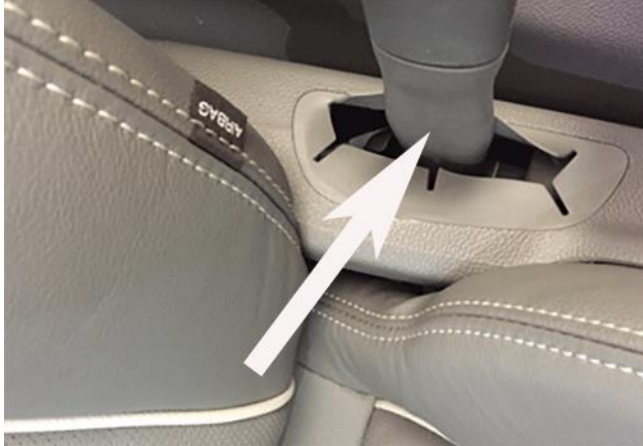
2. Flex the seat belt in an outboard direction and look on inboard side of driver seat seatbelt anchor cover for damage. Inspect the complete cable cover from the base of the cable to the buckle.

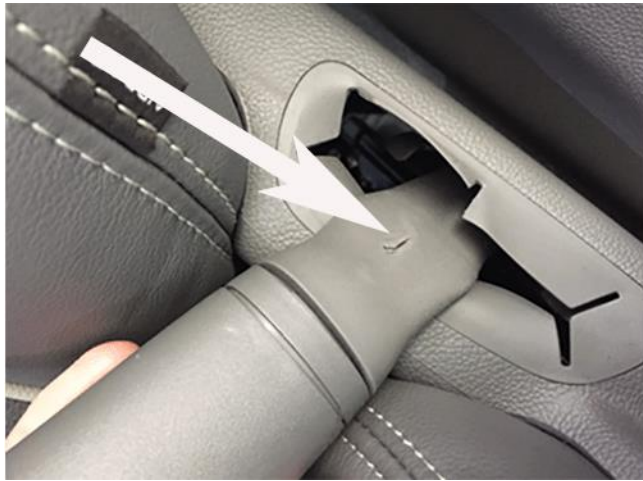
3. Flex the seat belt to the inboard side and look on outboard side of driver seat seatbelt anchor cover for damage.

This damage will be in the form of holes (1) or splitting (2).

- If **any damage** is found, take the vehicle to the dealer for service.
- If no damage is found, the special coverage condition is not present on the vehicle at this time.
