Subject: N172130462-01 - Customer Satisfaction Program  
Loss of Propulsion Due to Low Cell Voltage

Models: 2014 - 2015 Chevrolet Volt  
2014 - 2015 Cadillac ELR

# Customer Satisfaction Program

## N172130462 (18217) Loss of Propulsion Due to Low Cell Voltage

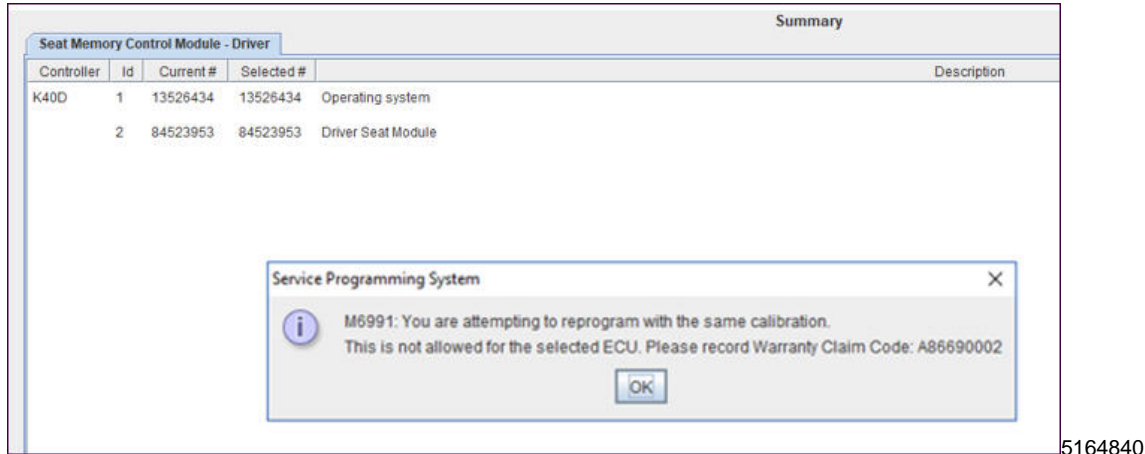
**Note:** If the Same Calibration/Software Warning is noted on the SPS Summary screen, record the warranty claim code (WCC) and select OK and follow screen instructions. The WCC is located in the Service Programming System dialogue box of the SPS Summary screen. No further action is required. Refer to the Warranty section of the bulletin.
