TECHNICAL INFORMATION

| Bulletin # | Date | Page |
|---|---|---|
| MAS001850 | 06/05/2019 | 1/11 |

MODELLI: M161 Levante

OGGETTO: Diagnostic guide for sealing the body due water infiltration.

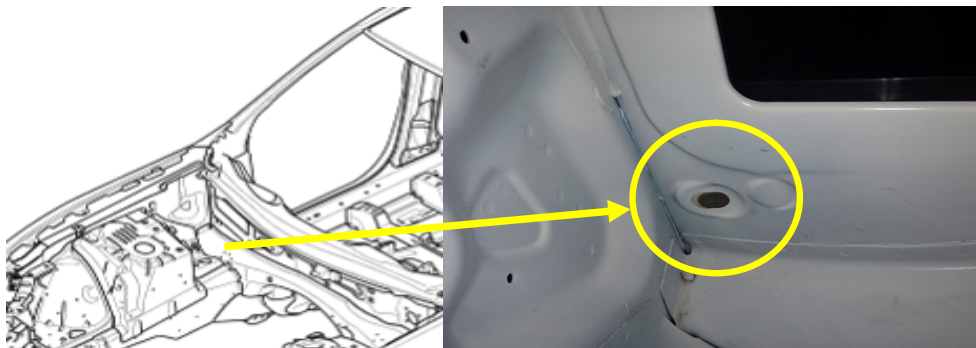
A.1.1. Engine bulkhead - Adhesive cap

- Is the adhesive cap missing?
- Is the adhesive cap damaged?
- Is the adhesive cap not in correct position?
- Are present two adhesive caps (internal side and external side)?

INFO: Introduced double adhesive cap on the right side: date 27/07/2016.

ACTION: If one of these tests will be KO tests, it will be necessary to seal the opening.

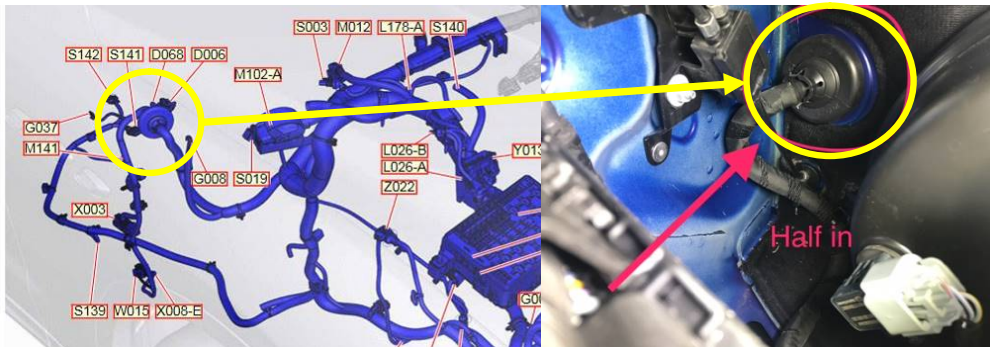
A.1.2. Engine wiring harness grommet on bulkhead

- The grommet has been detected to be out of its seat

INFO: Introduced a specific test in plant from 15/03/2017.

ACTION: If the check is KO, it will be necessary to reposition the grommet. If necessary, also proceed to seal the area.

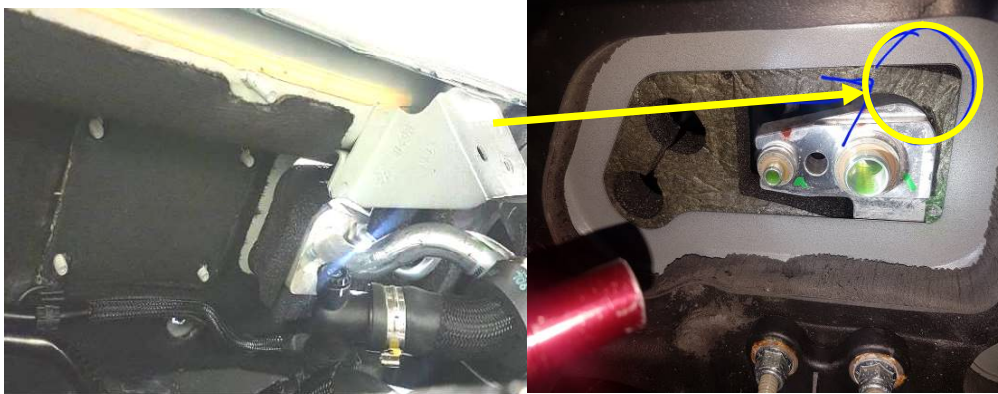
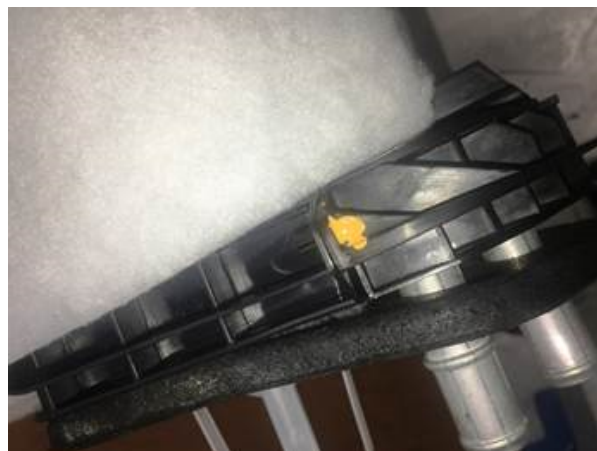
A.1.3. HVAC Aperture

- Is the seal of heater box damaged in section? There is a Gap?

INFO: Specific Check introduced in plant to verify correct seal coupling during assembly from 22/03/2018 (chassis 302155): Yellow dot added to trace certified parts.

ACTION: If the check is KO, it will be necessary to replace the seal.

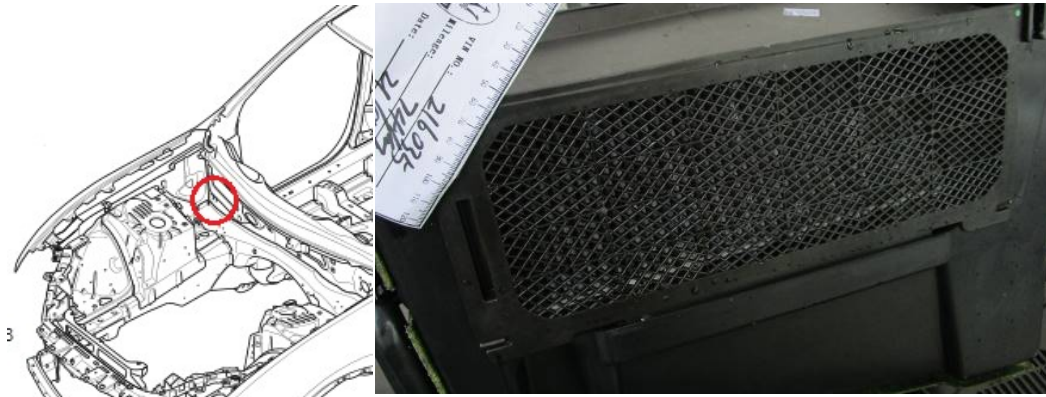
A.1.4. Seal on anti-pollen filter.

- Is present seal on anti-pollen filter?

INFO: Introduced a specific test in plant from Feb 17.

ACTION: If the check is KO, it will be necessary to fit a new seal.

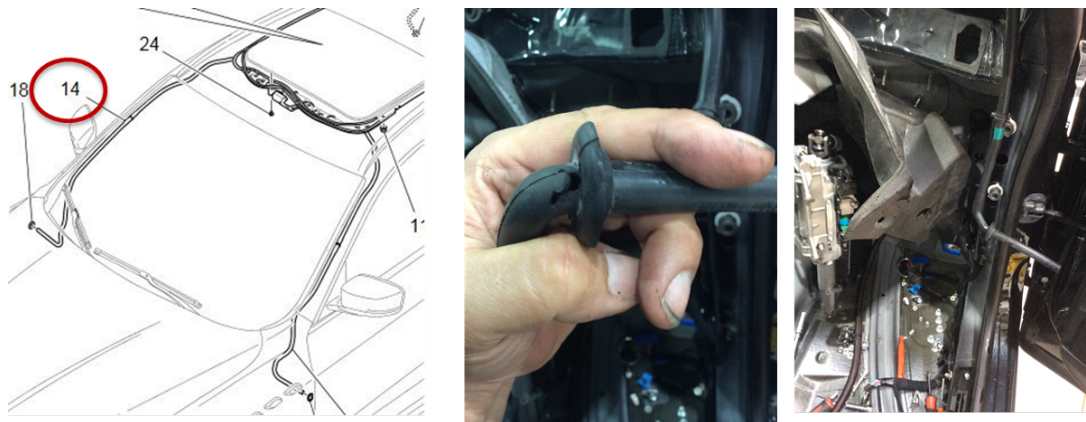
A.1.5. Sunroof drain pipes

- Is drainpipe split and /or detached?

INFO: Specific check (RH side and water drain pipes): date 13/02/2017

ACTION: If the check is KO, it will be necessary to fit again the pipe or replace if damaged.
