Maserati Technical Bulletin

Date: May 30, 2019
Bulletin No.: MAS001885 – MTB 19-10 –
Sedan_Levante Coolant Crossover Pipe
Service Campaign: 384
Supersedes: n/a
Section: Engine, cooling system, pipes

SERVICE CAMPAIGN # 384

SUBJECT: Coolant Crossover Pipe

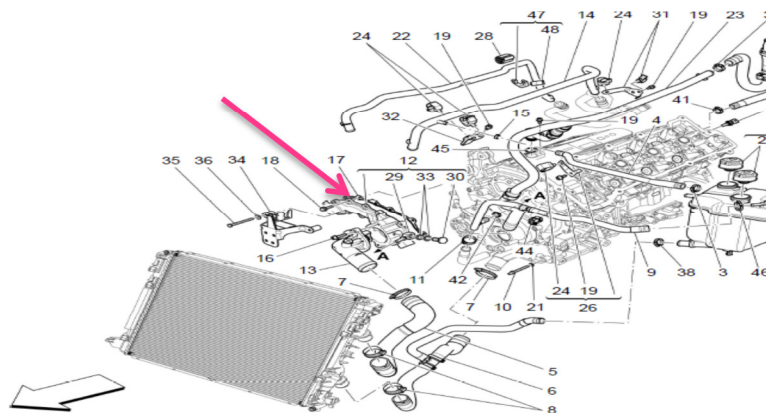
Fig.2

Maserati Quattroporte, Ghibli and Levante vehicles with V6 engines (Fig.1), are involved in a Service Campaign to check and if necessary, replace the Cooling system crossover pipe (#17 in Fig.2) due to a possible leak.

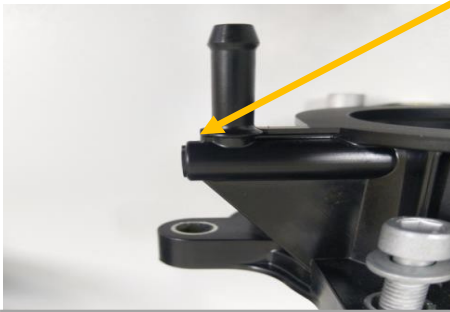
Ultra-Sonic weld Cap

MASERATI has been informed that some engines had a coolant crossover pipe that could lead to a coolant leak from a plug that is glued in place rather than ultra-sonic welded in place as shown below.

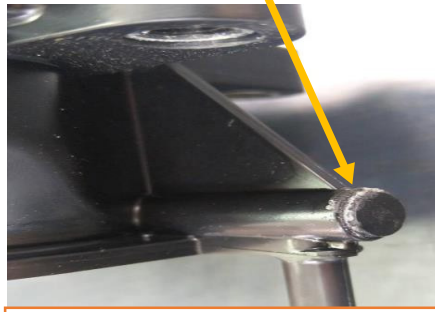
Glued Cap

The glued cap will have traces of glue (see above) and must be replaced with a crossover pipe that has an "Ultra-sonic welded cap. (no traces of glue)

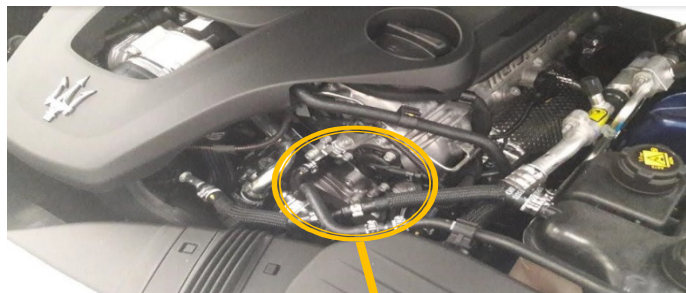
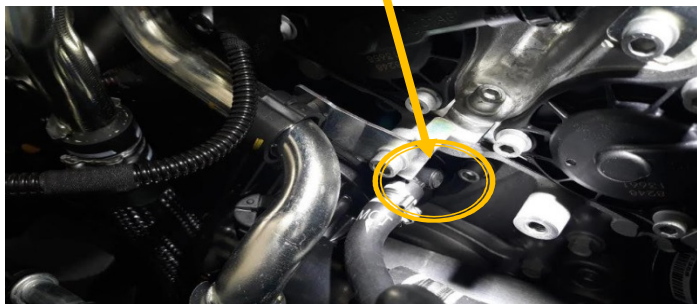
1. Open the hood and locate the cap on the crossover pipe as shown below.

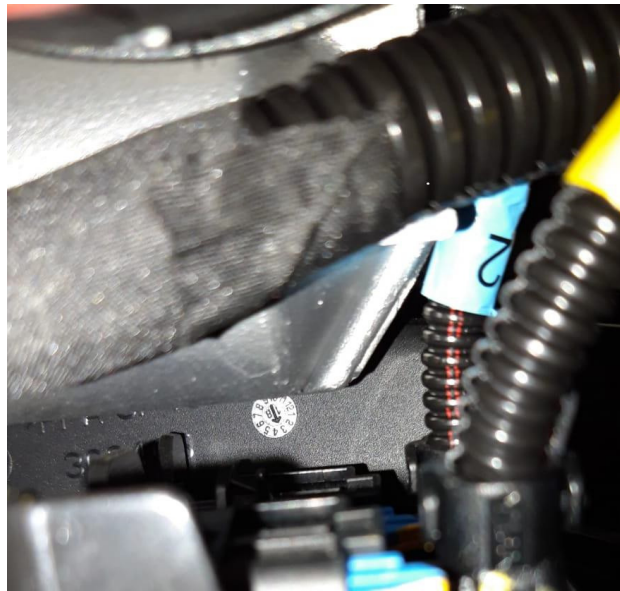
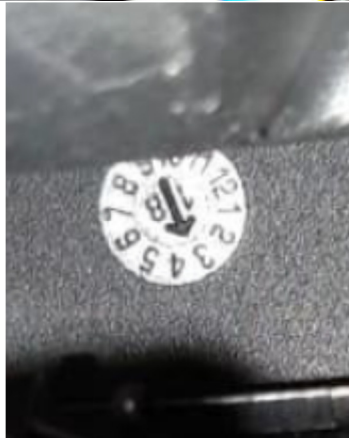
2. Check if the CAP is (Ultra-Sonic Welded) or (Glued). You can recognize the defective cap due traces of glue. Refer to the pictures on Page 2.
3. Also, check the date printed on the body of the crossover pipe near the crossover bracket as shown below.
 - If the production date is 03/18 the pipe must be replaced.
 - A BOL report must be entered with pic's attached and a PHD must be submitted with the BOL number to order parts.
 - If the production date is anything other than 03/18, the pipe is OK and will not need to be replaced.
