**JOB AID
FOR
SPECIAL SERVICE CAMPAIGN K0B
MILLIMETER WAVE RADAR SENSOR**

**CERTAIN:
2018 – 2019 TACOMA
2018 – 2019 TUNDRA**

VEHICLES WITH MODIFICATIONS

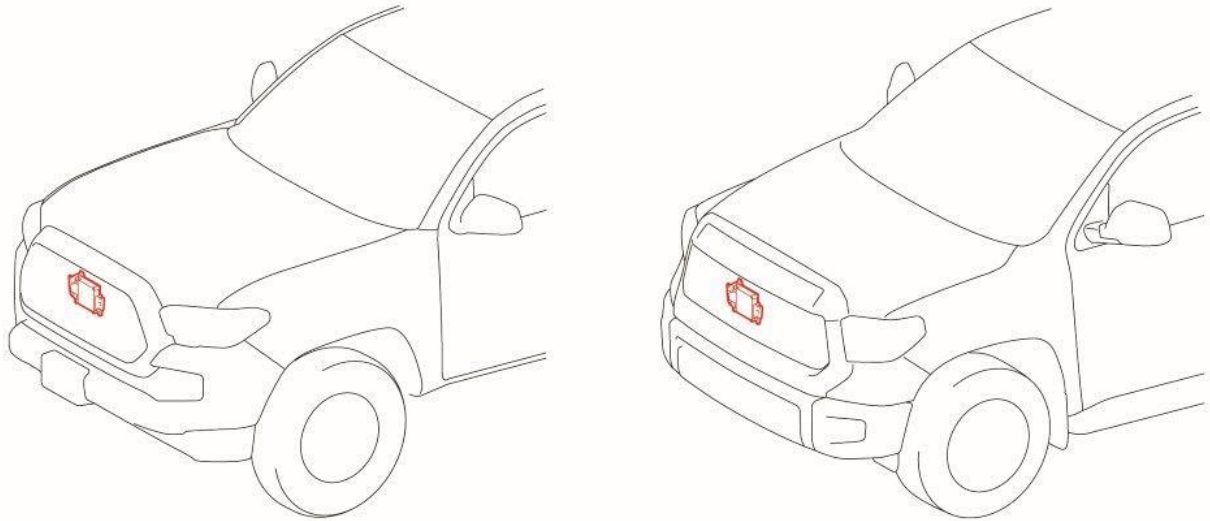
The involved vehicles are equipped with a Pre-Collision System (PCS) that may automatically apply the brakes if the system detects a potential collision. Due to the mounting of one of the system's sensors, it is possible for water to enter the sensor. This can lead to PCS deactivation or inadvertent brake activation resulting in limited deceleration for a short duration of time.
