SERVICE BULLETIN

EL19-011
 NTB19-042
 May 22, 2019

AEB WARNING LIGHT BLINKING

APPLIED VEHICLES: 2019 Altima (L34) 2015-2019 Murano (Z52)

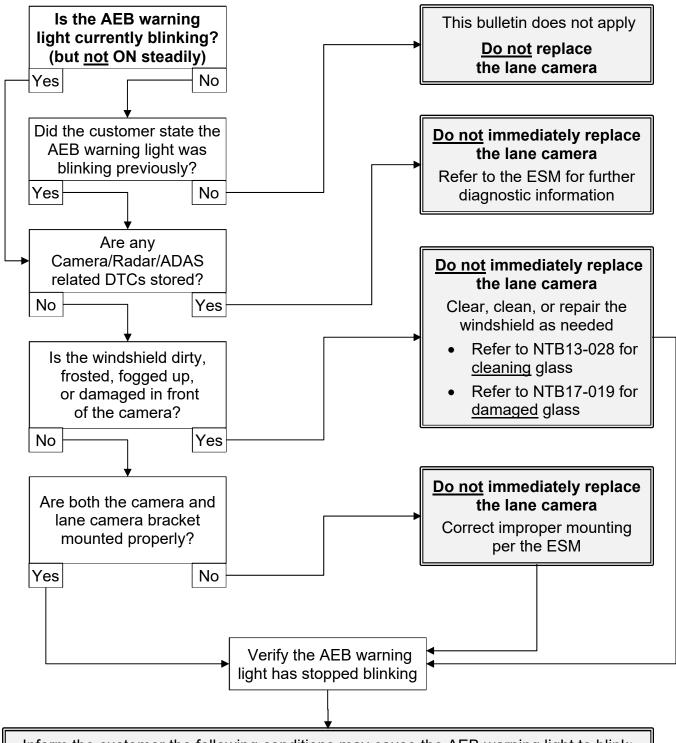
FLOW CHART

If the AEB warning light is blinking (but not illuminated steadily) or the customer states it is blinking, and there are no related DTCs, inspect the windshield.

- When contamination or foreign material adhere to the lane camera viewing window on the windshield
- When driving while it is snowing or when frost forms on the lane camera viewing window on the windshield
- When the lane camera viewing window on the windshield is temporarily fogged up

Inform the customer the following conditions may cause the AEB warning light to blink:

- When contamination or foreign material adhere to the lane camera viewing window on the windshield
- When driving while it is snowing or when frost forms on the lane camera viewing window on the windshield
- When the lane camera viewing window on the windshield is temporarily fogged up

Explain to the customer the difference between contamination detection and a malfunction
