LTB01030NAS5

TECHNICAL BULLETIN

Squeak/Rubbing Noise From Front Right of Vehicle While Driving

MODEL:	MODEL YEAR:	VIN:	ASSEMBLY PLANT:
Discovery Sport (LC)	2015 Onwards	000001 Onwards	Halewood
Range Rover Evoque (LV)	2012-2019	000001-999999	Halewood

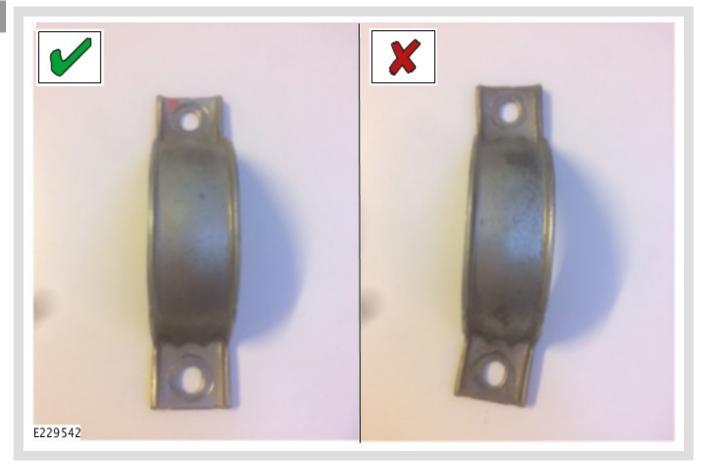
- 1 Visually inspect the halfshaft bearing cap for signs of distortion or damage (X).
- **2** Visually inspect the front right halfshaft bearing for metallic particles around the bearing cap and bearing assembly.
- **3** Rotate the front right wheel and visually inspect the front right half shaft outer bearing race for rotation when rotating the road wheel.
- **4** Rotate the front right wheel to inspect for harshness and/or a squeak or rubbing noise from the halfshaft bearing to confirm this is the cause of the Customer concern.
 - If all of the above concerns are not evident, do not continue with this
 Technical Bulletin Workshop Procedure.
 - If any of the above concerns are identified, go to Step 3.

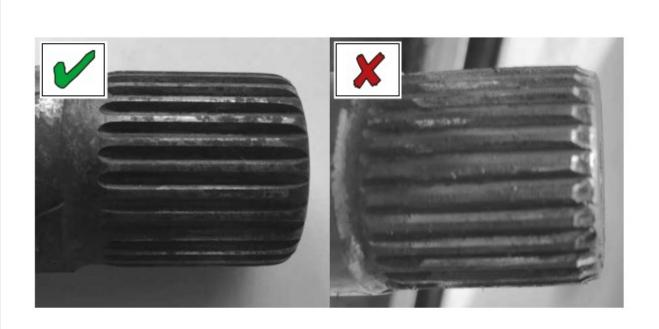
E229544

- 1 If the splines are damaged (X), go to Step 5.
- **2** If the splines are not damaged (\checkmark) , go to Step 4.

Remove the front right halfshaft for inspection (see TOPIx Workshop Manual section 205-04: Driveline - Front Drive Halfshafts - Removal and Installation).

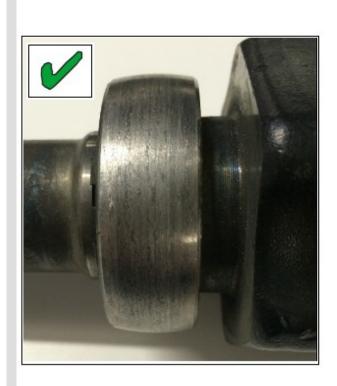
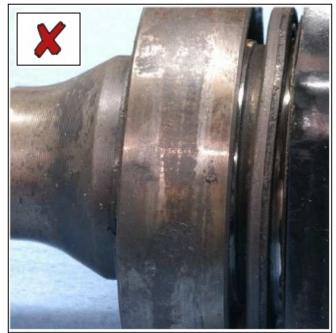
E202643

Slight scoring to the outer race of the bearing (\checkmark) is acceptable.

Visually inspect the condition of the halfshaft bearing and bearing housing.

- If bearing rotation is not harsh or noisy and the bearing is not badly scored (√), go to Step 7.
- If bearing rotation is harsh or noisy and/or the bearing is badly scored (X), go to Step 5.
