TECHNICAL BULLETIN

29 MAY 2019

419-02

'Smart key not found' Message Displayed and Poor Smart key Operation

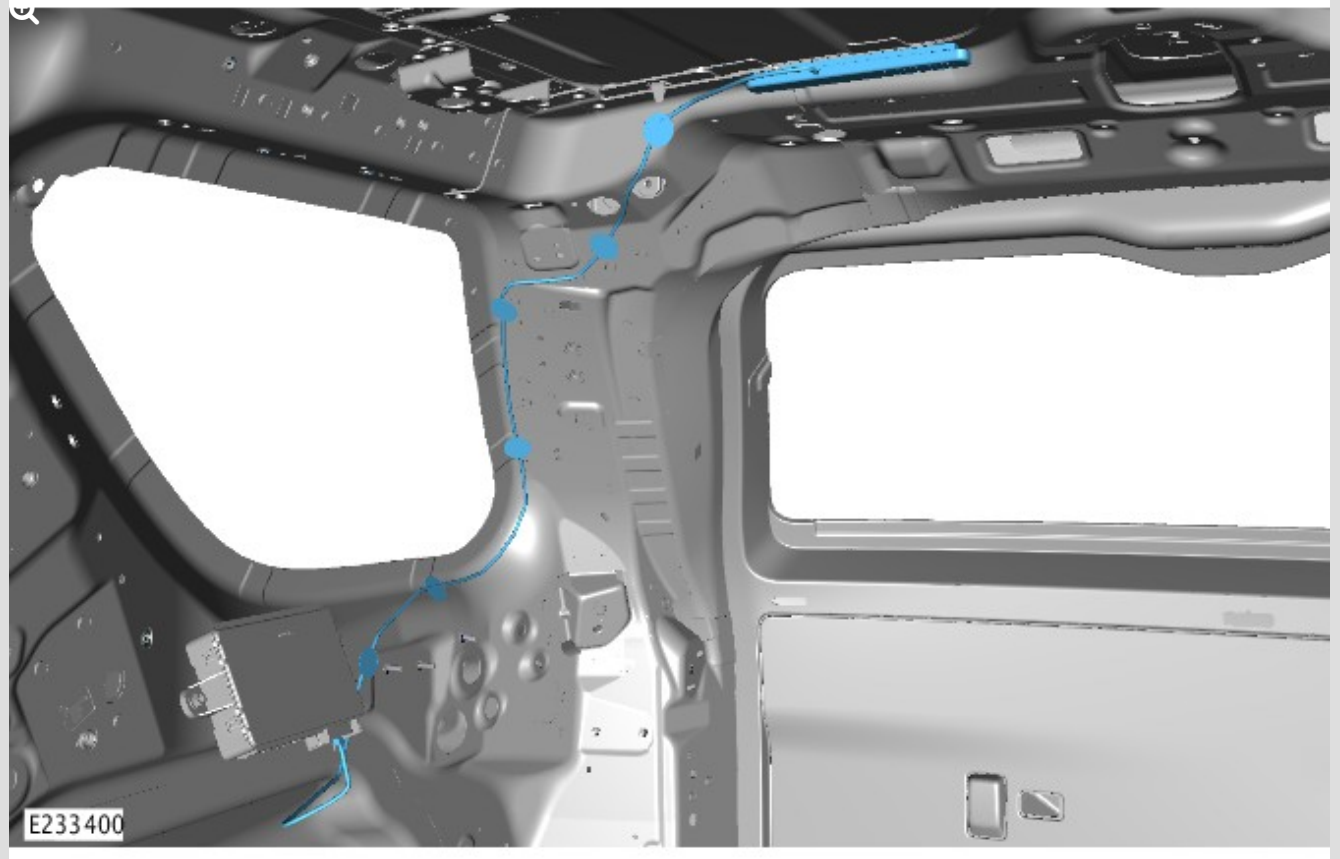
Discovery: Coaxial cable wiring harness route.

4 Verify that the coaxial cable from the Radio Frequency (RF) antenna to the Remote Function Actuator (RFA) is correctly routed, secured in position, and is not trapped. Inspect the condition of the connectors and the connector pins between the RF antenna and RFA for damage. Make sure that connections are secure. Refer to the Service Information section above for wiring harness routes and locations.

- If the coaxial cable is damaged, incorrectly routed, or trapped, go to Step 7.
- If the coaxial cable and/or connectors and connector pins are damaged, go to Step 6.
- If the coaxial cable is incorrectly routed or trapped, but no damage has occurred, go to Step 5.

Route the coaxial cable as shown in the Service Information section above and secure in place with adhesive pads to make sure the cable will remain in its position.

Renew the RF antenna and Coaxial cable.

- 1 Route the coaxial cable as shown in the Service Information section above; secure in place with adhesive pads to make sure the cable will remain in position
- 2 When all tasks are finished, go to Step 7

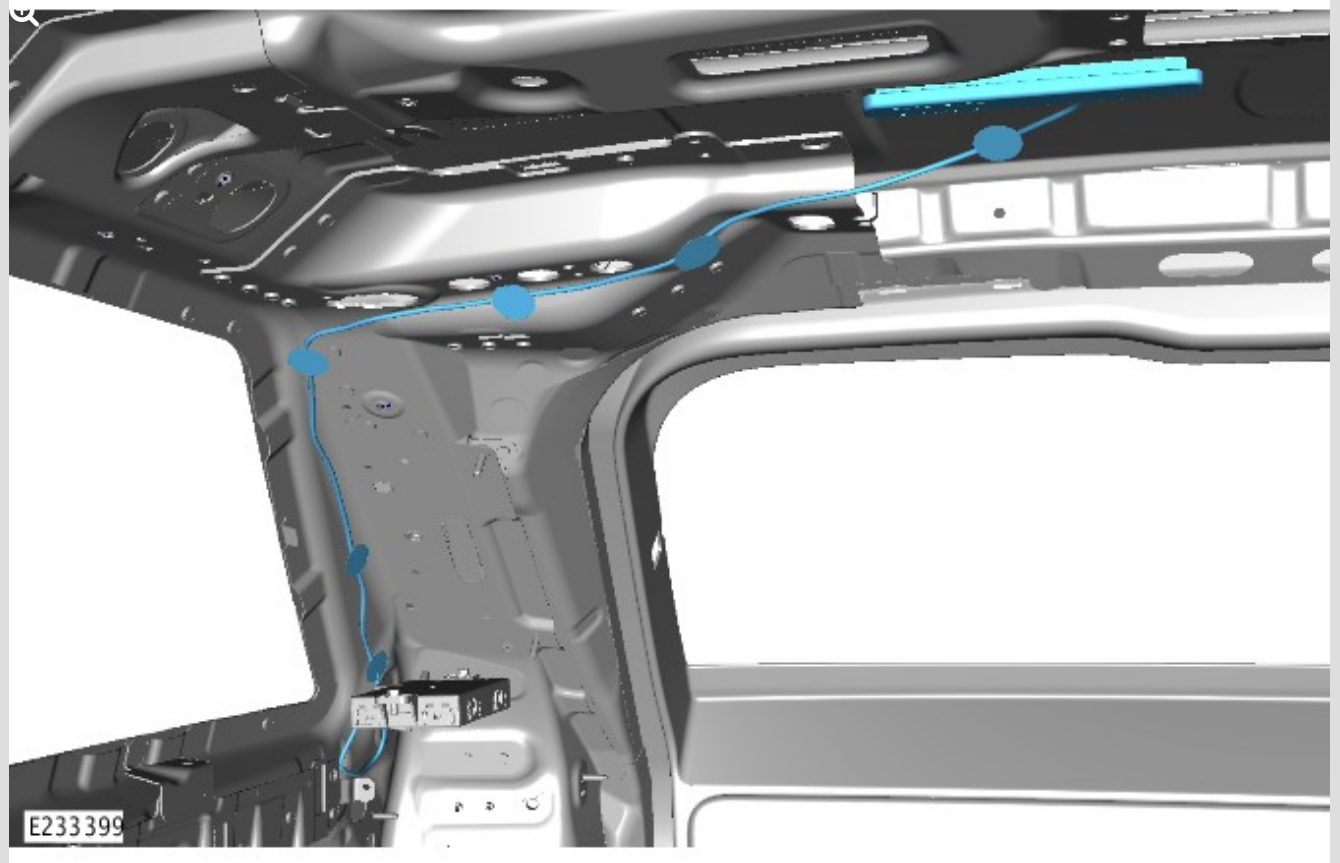
Range Rover Sport: Coaxial cable wiring harness route.

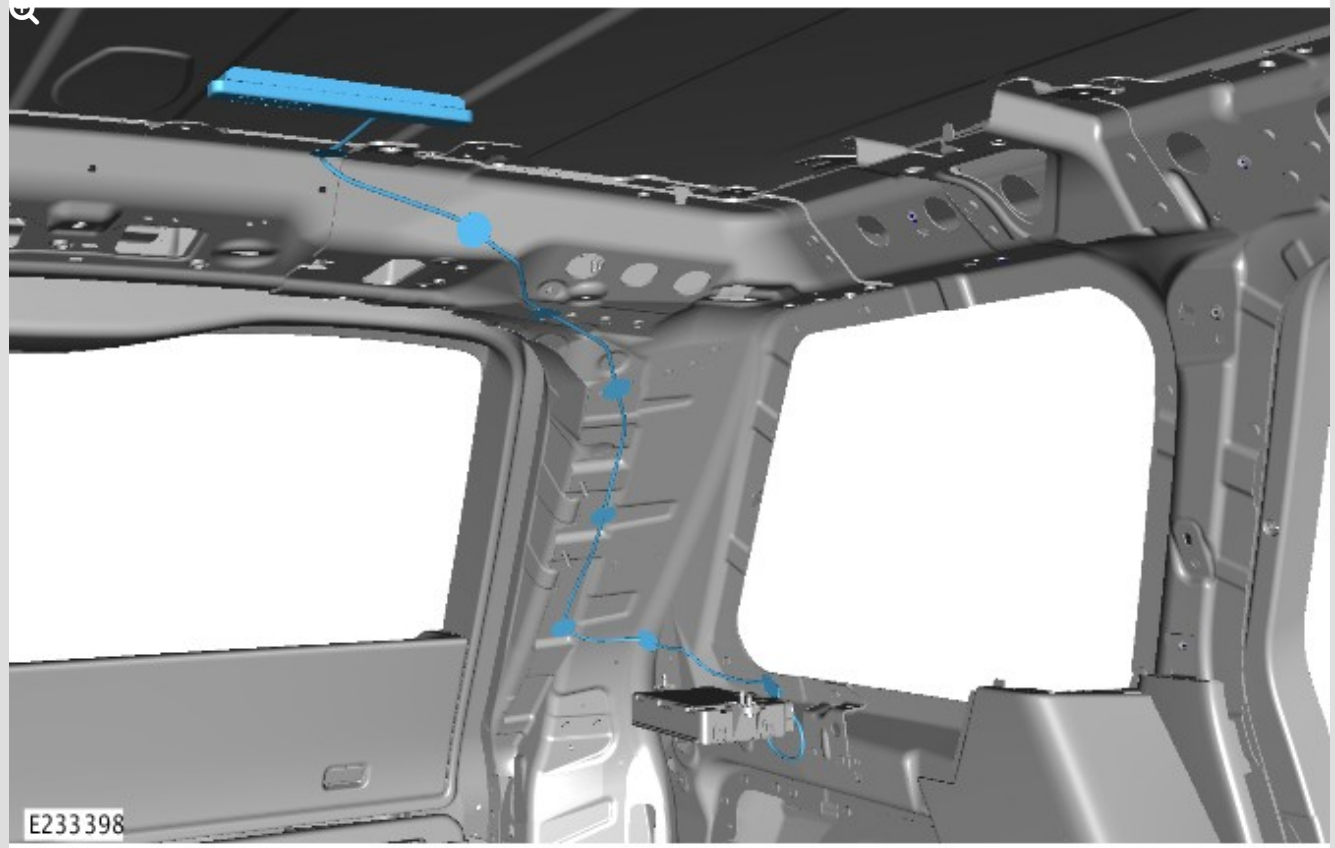
Range Rover: Coaxial cable wiring harness route.

Verify that the coaxial cable from the Radio Frequency (RF) antenna to the Remote Function Actuator (RFA) is correctly routed, secured in position, and is not trapped. Inspect the condition of the connectors and the connector pins between the RF antenna and RFA for

damage. Make sure that connections are secure. Refer to the Service Information section above for wiring harness routes and locations.

- If the coaxial cable is damaged, incorrectly routed, or trapped, go to Step 7.
- If the coaxial cable and/or connectors and connector pins are damaged, go to Step 6.
- If the coaxial cable is incorrectly routed or trapped, but no damage has occurred, go to Step 5.

Route the coaxial cable as shown in the Service Information section above and secure in place with adhesive pads to make sure the cable will remain in its position.

Renew the RF antenna and Coaxial cable.

- 1 Route the coaxial cable as shown in the Service Information section above; secure in place with adhesive pads to make sure the cable will remain in position
- 2 When all tasks are finished, go to Step 7
