## LATEST VEHICLE CONCERN FIXES

| Wind Noise From Sunroof | Discovery 18MY |

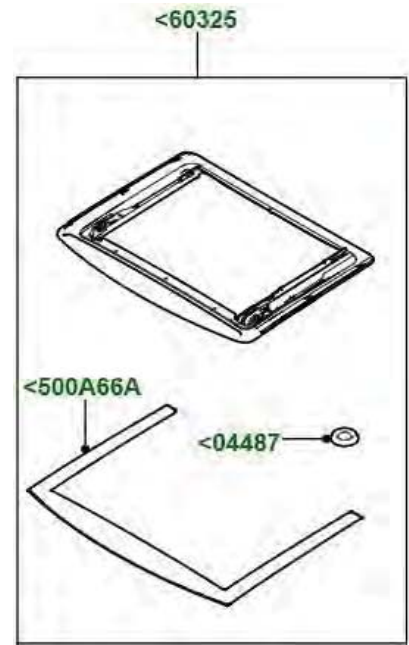
| Wind Noise From Sunroof | Discovery 18MY |
|---|---|
| <p><u>Customer Voice:</u></p> <ul style="list-style-type: none"><li>– A customer may complain of a wind type noise emanating from the sunroof area while driving.</li></ul> <p><u>Technical Description:</u></p> <ul style="list-style-type: none"><li>– This may be caused by a sunroof trim seal that has become displaced or a roof opening panel that is not adjusted properly.</li></ul> <p><u>Status:</u></p> <ul style="list-style-type: none"><li>– Should a customer express a concern, please inspect the sunroof trim panel seal fitment to ensure it has not dropped down, also inspect the roof opening panel for proper alignment with the roof trim panel.</li><li>– Should the sunroof trim seal appear to be dropped down, please submit an EPQR for the concern with pictures showing the area of the seal that has dropped down, then push the seal back into position using a suitable tool.</li></ul> | <p>The diagram illustrates the components of a sunroof assembly. At the top, a rectangular sunroof panel is labeled with the part number &lt;60325. Below it, a cross-section view shows the sunroof trim seal, labeled &lt;500A66A, which is designed to fit into a channel on the roof opening panel. A small circular fastener, labeled &lt;04487, is shown securing the seal into the panel.</p> |
