JOB AID FOR SPECIAL SERVICE CAMPAIGN K0B MILLIMETER WAVE RADAR SENSOR

**CERTAIN:
2018 – 2019 TACOMA
2018 – 2019 TUNDRA**

VEHICLES WITH MODIFICATIONS

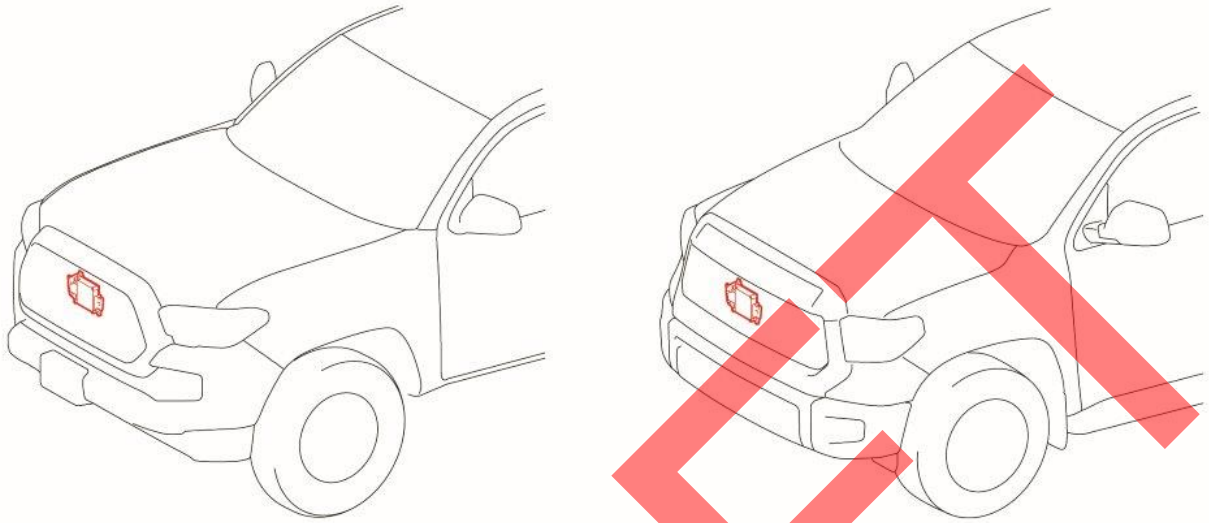
The involved vehicles are equipped with a Pre-Collision System (PCS) that may automatically apply the brakes if the system detects a potential collision. Due to the mounting of one of the

system's sensors, it is possible for water to enter the sensor. This can lead to PCS deactivation or inadvertent brake activation resulting in limited deceleration for a short duration of time.
