# Multimedia System Enhancements Phase 3 (Panasonic)

**Service Category** Audio/Visual/Telematics

**Section** Navigation/Multi Info Display

Lexus navigation is now available with additional features such as Apple CarPlay® and Amazon Alexa™ for applicable 2018 – 2019 model year Lexus vehicles. Follow the Software Update Procedure in this bulletin to install these new features.

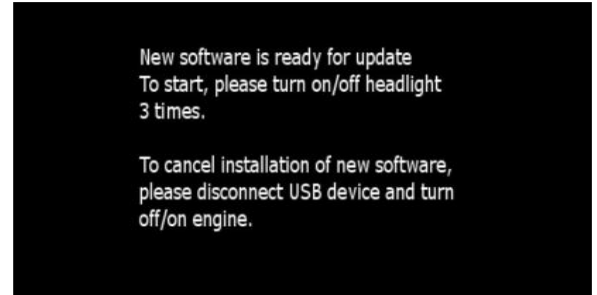
Figure 1.

- When the “New software is ready for update” screen appears, cycle the headlights ON/OFF three times within 3 seconds.

- This user interaction occurs approximately 13 minutes after beginning the software update.
- If a red screen appears, remove the USB flash drive, verify ALL downloaded files are present on the USB flash drive, cycle the vehicle OFF/ON, and begin the procedure again.

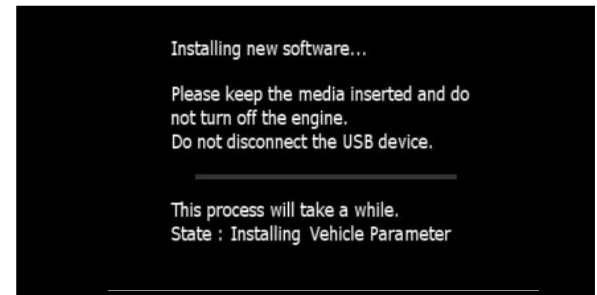
Figure 2.

- Once the “Installing new software...” screen appears, do NOT turn the vehicle off or remove the USB flash drive. This will cause damage to the head unit.

The head unit will reboot several times during this process.

**If a red or green screen appears, cycle “IG-OFF” and “IG-ON.” If the head unit does NOT boot up after “IG-OFF” and “IG-ON,” replace the head unit.**

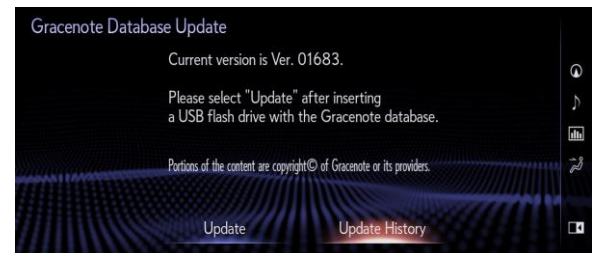
**Figure 4.**

16. Select Setup, scroll down, and select Gracenote Database Update.  
Verify the Gracenote Database version is 01683.

If the version does NOT match, replace both the head unit and MEU.
