Multimedia System Enhancements - Phase 3 (Panasonic)

Service Category Audio/Visual/Telematics

YEAR(S)	MODEL(S)	ADDITIONAL INFORMATION
2018	Camry, Camry HV, Sienna

Entune™ 3.0 Premium Audio is now available with additional features such as Apple CarPlay® and Amazon Alexa™ for 2018 model year Camry, Camry Hybrid, and Sienna vehicles. Follow the Software Update Procedure in this bulletin to install these new features.

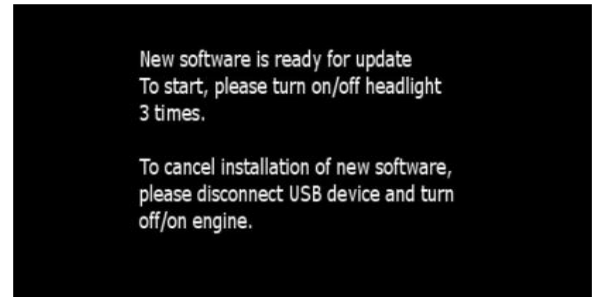
Figure 1.

12. When the “New software is ready for update” screen appears, cycle the head lights OFF/ON three times within 3 seconds.

- This user interaction occurs approximately 9 minutes after beginning the software update on vehicles equipped with Entune™ 3.0 Audio Plus and 14 minutes if equipped with Entune™ 3.0 Premium Audio.
- If a red screen appears, remove the USB flash drive, verify ALL downloaded files are present on an empty USB flash drive, cycle the vehicle OFF/ON, and begin the procedure again.

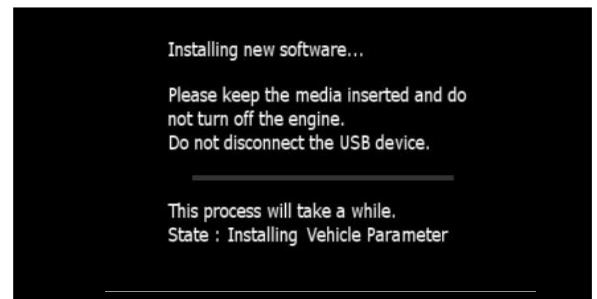
Figure 2.

13. Once the “Installing new software...” screen appears, do NOT cycle “IG-OFF” or remove the USB flash drive. This will cause damage to the head unit.

If a red screen appears, cycle "IG-OFF" and "IG-ON." If the head unit does NOT boot up, replace the head unit and MEU. If the head unit boots up but the map does NOT display, replace the MEU only.

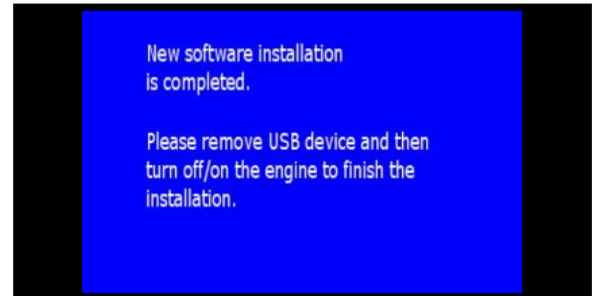
Figure 3.

- Once the blue “New software installation is completed” screen appears, remove the USB flash drive.

Leaving the USB flash drive inserted while cycling the ignition will start the update process again.

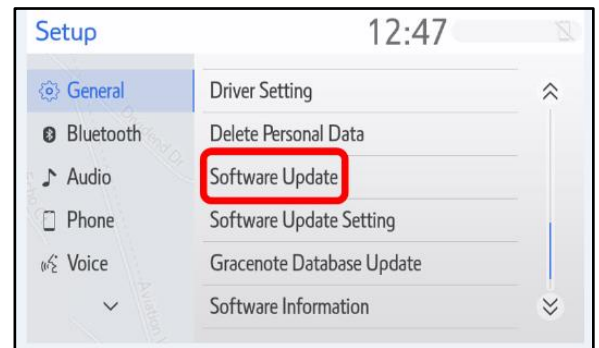
Figure 4.

- Press the Menu button on the radio faceplate, then select Setup, scroll down and select Software Update.

- Verify that the software version is the same as the table shown.

If the software versions do NOT match, replace the corresponding component.

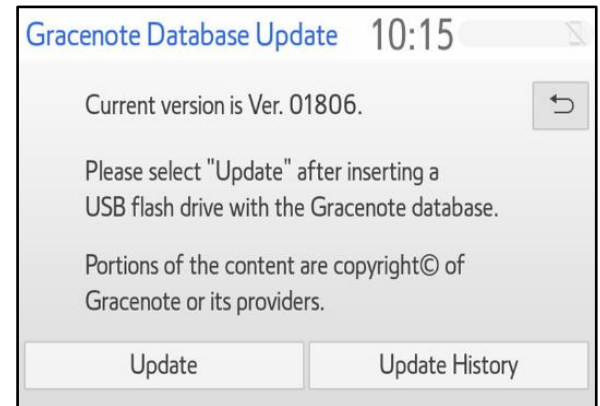
Figure 5.

18. Select Menu, then Setup, and scroll down and select Gracenote Database Update.
Verify the Gracenote Database version is 01806.
If the version doesn't match, replace both the head unit and MEU.
