SI B33 02 19  
Rear Axle

## POOR DIRECTIONAL STABILITY

| I12 (i8 Coupe) | I15 (i8 Roadster) | | |

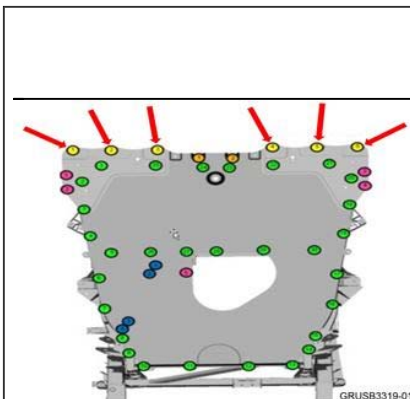
The drivability/steering behavior appears inconsistent.

Rear axle stiffening plate.

3. With the vehicle on an alignment rack so that the vehicle is resting on all 4 wheels, retighten the 30 M8 bolts (shown in green) for the stiffening plate on the rear axle module.

- Loosen each bolt (shown in green) by approx. 45 degrees, then retighten with 28 Nm
- Do not proceed to the next bolt until the previous one has been torqued

Note: The 30 M8 ISA bolts **DO NOT HAVE WASHERS.**

- Do not replace the M8 bolts

4. Replace the 6 M10 Torx bolts as shown (red arrows) and tighten them with 56 Nm + 90°.

- Replace and tighten one bolt at a time
