CHECK CONTROL MESSAGE (CCM) DRIVING COMFORT RESTRICTED

G05 (X5 Sports Activity Vehicle)	G07 (X7 SAV)
----------------------------------	--------------

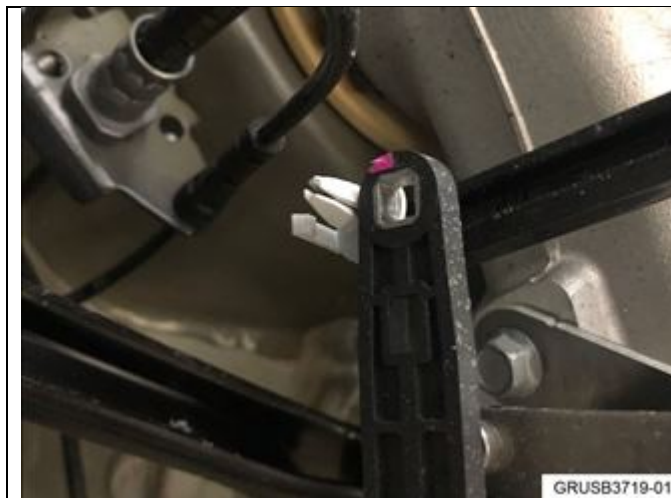
The ride height sensor linkage became disconnected.
