SI B41 02 19
Body

DELIVERY STOP: INSPECTION OF C-PILLAR

This Service Information bulletin replaces SI B51 12 19 dated April 2019

G05 (X5 SAV)			
--------------	--	--	--

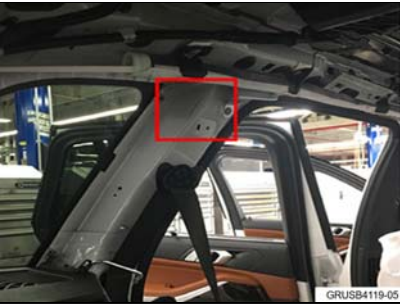
2. Inspect the C-pillar for a crack in the area circled.

Note: If a crack is present, it will be located on the upper back side of the C-pillar, facing the luggage compartment area.

For a better inspection, use a flashlight to illuminate the C-Pillar through the access hole shown by the arrow to the left.
