SI B54 05 19
Special Roofs

BUTYL ON ROOF AROUND REAR SUNROOF GLASS

G07 (X7 Sports Activity Vehicle)			
----------------------------------	--	--	--

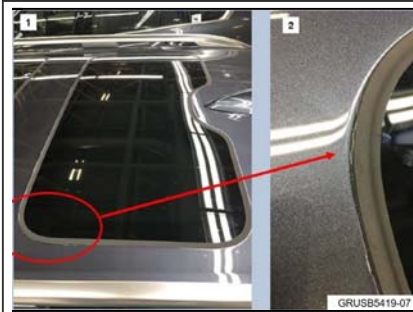
Excess butyl sealant has leaked out from underneath the seal of the rear stationary sunroof glass.

Exposure to normal ambient heat can cause the factory-applied sunroof butyl to expand and leak out from around the rear sunroof glass.

Peel off the excess butyl from around the perimeter of the rear stationary sunroof glass.

Only remove the excess butyl that has emerged from the seal edges. Do not remove butyl that is still in place under the seal.
