SI B61 07 19
General Electrical Systems

SERVICE ACTION: BODY DOMAIN CONTROLLER REPLACEMENT

F39 (X2 Sports Activity Coupe)	F48 (X1 Sports Activity Vehicle)		
--------------------------------	----------------------------------	--	--

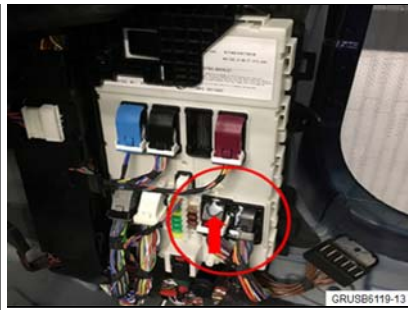
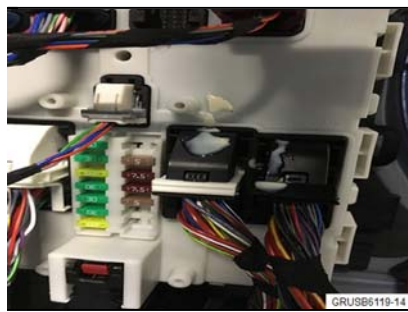
<ol style="list-style-type: none"> 1. Access the BDC as described in Repair Instructions REP 61 35 278 "Remove/install Body Domaine Controller (BDC)".
--	---

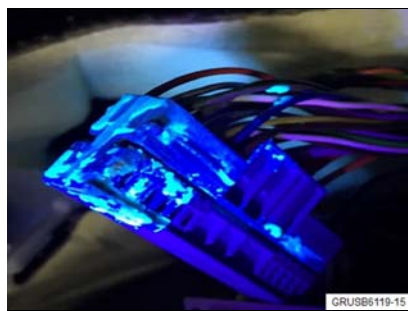
During vehicle production, there is the possibility that the cavity preservation wax leaked from the body and dripped onto the Body Domain Controller (BDC) and its wiring harness connector. The BDC is located inside the vehicle, in the front passenger footwell.

A new cavity preservation wax charge was used with a lower viscosity. The wax can creep downwards especially when the vehicle is exposed to high ambient temperatures.

2. Perform visual inspection of BDC and connectors looking for cavity wax.

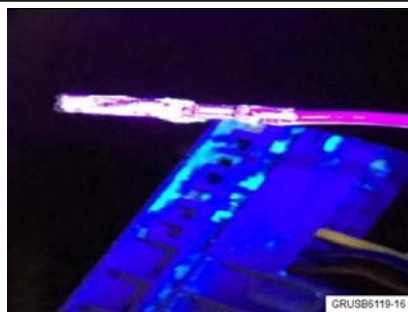
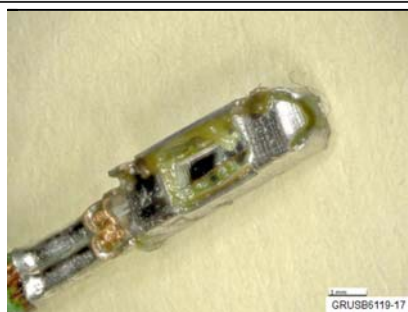
3. Check connectors A258*3B and A258*2B with an ultraviolet lamp for contamination.

4. If the connector housing, socket housing and pins are contaminated per the two photos at left, then they will need to be replaced.

Replace the BDC control unit and renew the contaminated connector and pins. If a connector is contaminated, renew all pins in connector.
