TIS Service Bulletin Page 1 of 5

May 2019 Technical Service

DELIVERY STOP: REWORK TAIL LIGHTS

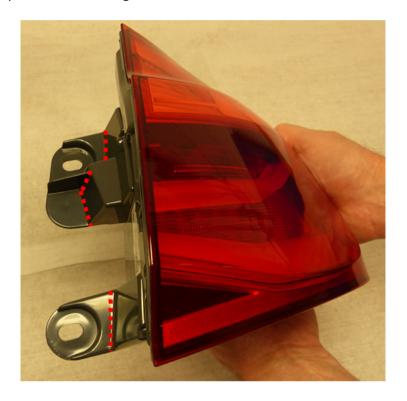
1. After removal of damaged tail lights, ensure that the damage does not extend beyond the dotted lines shown below. If cracking extends closer to the tail light housing then the dotted line, or if the mounting tab is completely broken off of the tail light housing beyond the dotted line, the tail light will require replacement following the instructions within the SI B.
