## REAR LIGHTING/TRUNK CHECK CONTROL MESSAGES DISPLAY

| G20 (3 Series Sedan) |
| Produced until<br>February 20, 2019 |

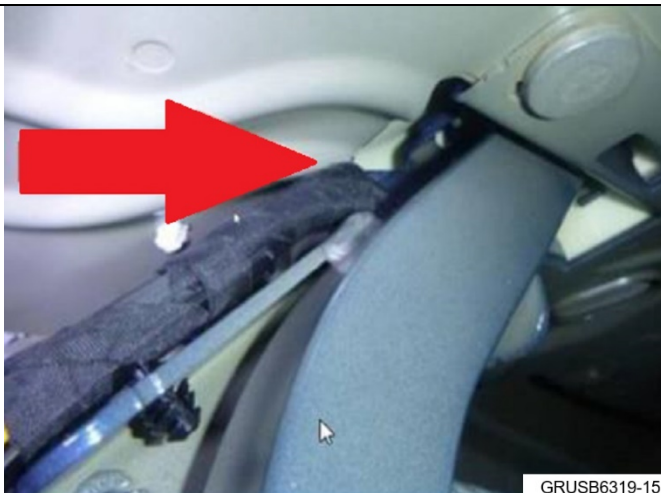
GRUSB6319-15

A sharp edge of the trunk lid hinge may damage the wiring harness.

2. Closely inspect the wiring harness (arrow) in the area of the right trunk hinge for any signs of damage or chafing against the trunk hinge.

| | <p>4. If available, replace the damaged wiring harness with repair harness PN 61 12 9 835 604.</p> <p>If the repair harness is not yet available, the original vehicle wiring should be repaired as needed.</p> <p>Refer to Repair Instructions 61 00 "Notes on handling wiring harness and cables".</p> |
