APPLE PAY WALLET- POP-UP WINDOW APPEARS IN THE IPHONE DISPLAY

This Service Information bulletin replaces SI B84 01 19 **dated March 2019**

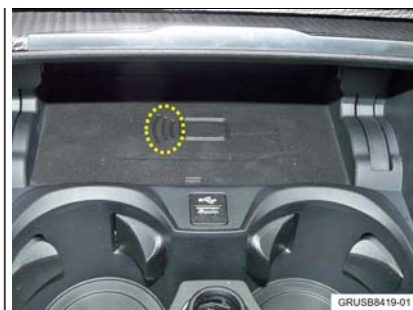
NFC only; no wireless charging.

- NFC is indicated by the 3 curved lines (circled) to the left of the cell phone outline

G20 shown; other models similar.

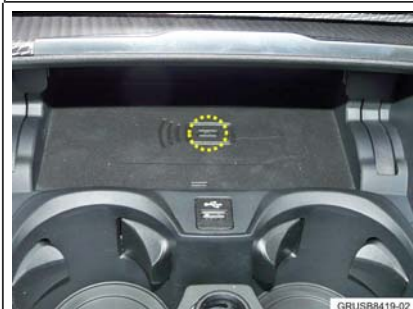
NFC and wireless charging.

- Wireless charging capability is indicated by the “lightning bolt” icon (circled) within the cell phone outline
