SI M51 16 16  
BodyMay 2019  
Technical Service

## CAVITY PROTECTION WAX LEAKING OUT OF HOOD

### MODEL

F56 (MINI Cooper, Cooper S Hardtop 2 Door)	F56 (MINI Cooper, Cooper S Hardtop 2 Door)	F60 (MINI Countryman)	
--	--	-----------------------	--

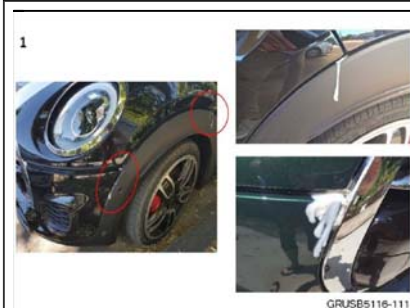
Cavity protection applied to underside of hood is leaking out onto wheel arch trim and grille.

Improper application of Cavity Protection Wax during vehicle production.

Remove the current cavity protection, and reapply it more accurately.
