CONVERTIBLE TOP WILL NOT COMPLETELY STOW

This Service Information bulletin replaces SI B54 03 17 dated February 2019.

F57 (MINI Convertible)

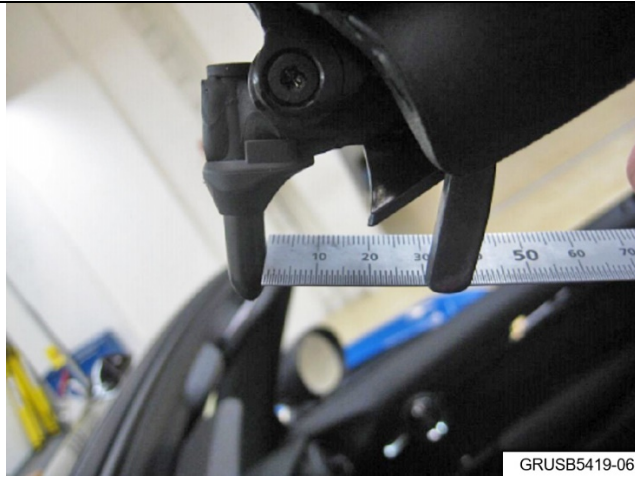
GRUSB5419-06

Is the distance less than 28mm on either side?

1. **UPDATE!** Open the folding top half way to gain access to the stowage lock (gripper hook). Measure the distance of the hook to the centering pin.

YES: Replace the folding top assembly following repair instructions REP 54 34 105 – “Replacing complete convertible top” and retest.

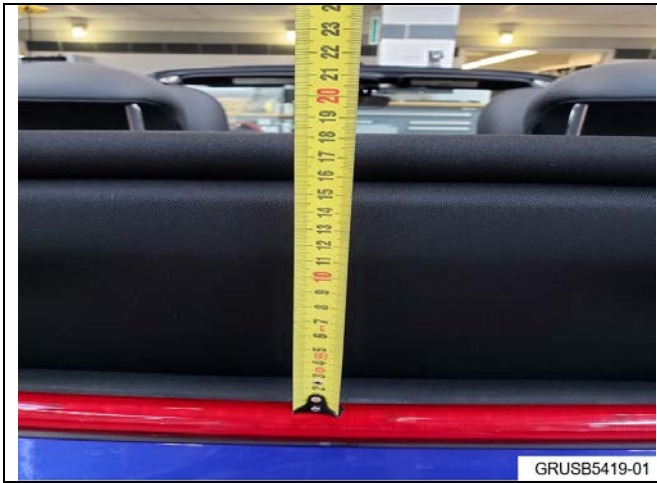
Ensure that the height is greater than 178.5mm after adjustment. 178.5mm is the minimum height allowable after adjustment.

7. Measure the height of the stowed convertible top as shown to the left.

Measure the distance from the top of the 3rd brake light to the highest point directly in the center of the stowed convertible top.
