June 18, 2019

Version 3

Warranty Extension: 2017-18 CR-V: Software Update with A/C Control Unit Replacement; DTC P0300, P0301, P0302, P0303, P0304, or P0172; Whirling Noise from Engine

Supersedes 19-032, dated April 5, 2019, to revise the information highlighted in **yellow**.

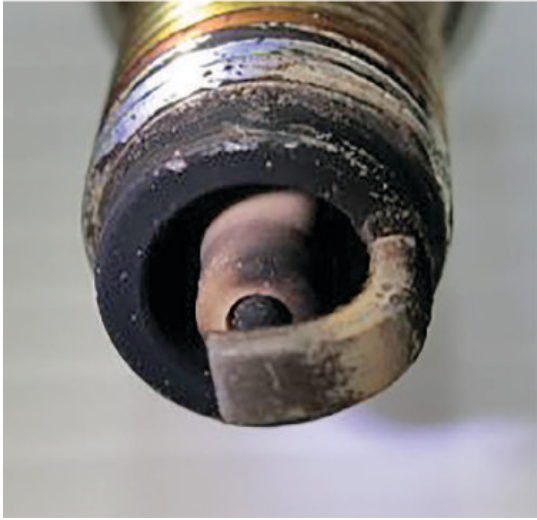
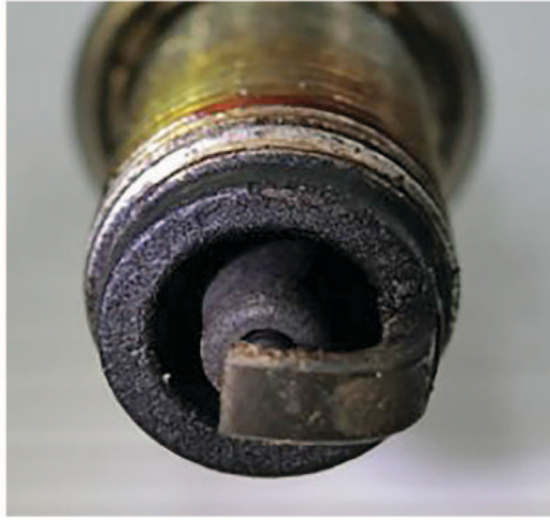
1. In some cases, the DTCs may return. If this happens, inspect the spark plugs.

- If the spark plugs are OK, the procedure is complete. Continue with normal troubleshooting.
 - If the spark plugs are fouled, go to step 2.
2. Replace the spark plugs per service information and check for stored DTCs.

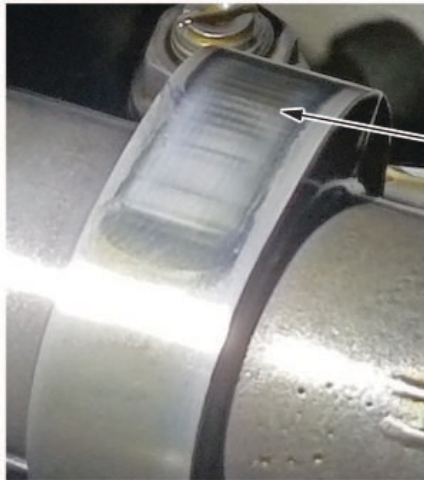
**NO GOOD**

The cam surface has ridges and a "cloudy" appearance.

- If the camshafts appear similar to the no good photo, go to step 8.
 - If the camshafts appear similar to the good photo, this bulletin does not apply. Continue with normal system troubleshooting.
8. Take a photo of the cam lobe, then follow the directions in the parts catalog when ordering the necessary parts.

Please send photos of failed camshafts to PART_RELEASE@AHM.HONDA.COM to receive approval and release parts.
