Technical Service Bulletin

| GROUP CAMPAIGN | NUMBER 19-01-017H |
| DATE MAY 2019 | MODEL(S) TUCSON (TL) |

SUBJECT: TPMS VALVE CAP AND STEM REPLACEMENT (SERVICE CAMPAIGN 954)

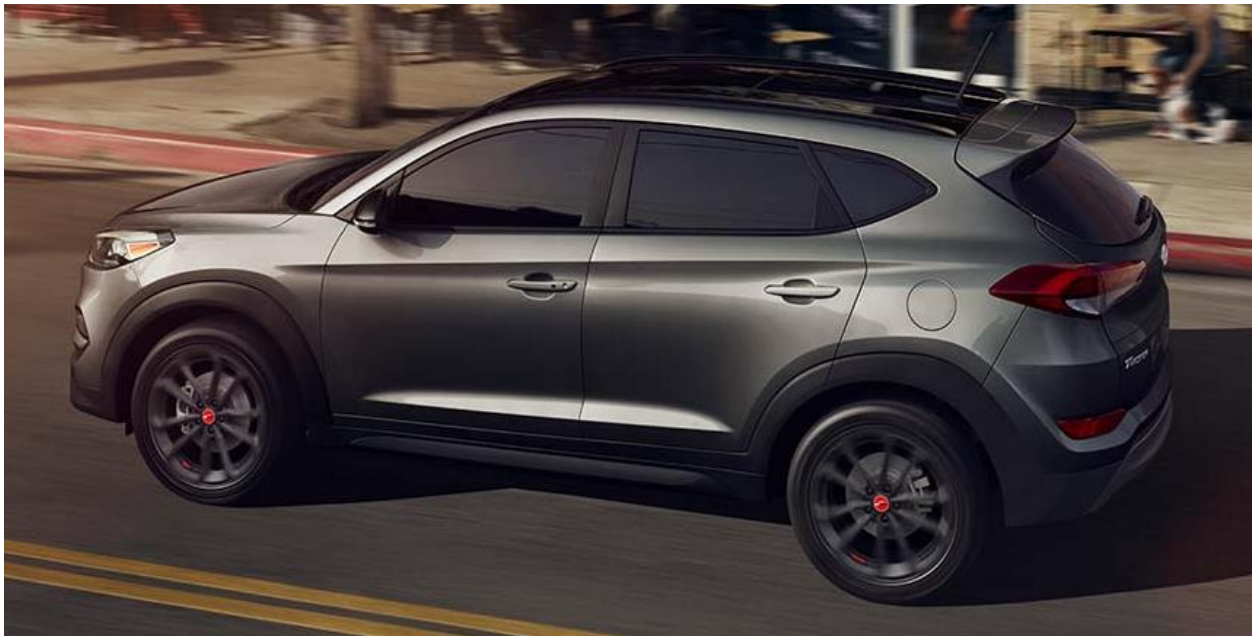
This bulletin provides information on replacing the Tire Pressure Monitoring System (TPMS) valve stem cap and/or valve stem on 2017 model year Night edition Tucsons. The aluminium valve cap might corrode onto the valve stem making it difficult to remove the cap to inflate tires or check tire pressure.

1. Remove all four red aluminum valve caps from the TPMS valve stem and discard. Install four new black plastic valve caps.
2. If any of the valve caps cannot be removed, lift the vehicle and remove the tire and wheel assemblies with the corroded valve stem/cap.
