Title	Automated Manual Transmission (AMT) Clutch Failures At Service Replacement; New Clutch Found To Be Damaged When Unboxed Or Fails Soon After Replacement
-------	---

Mack Model	AN - Anthem , CHU - Pinnacle, Axle back , CXU - Pinnacle, Axle front , GR - Granite , GU - Granite , PI - Pinnacle
-------------------	--

Volvo Model	VNL , VNM , VNR , VNX , VAH , VHD
--------------------	-----------------------------------

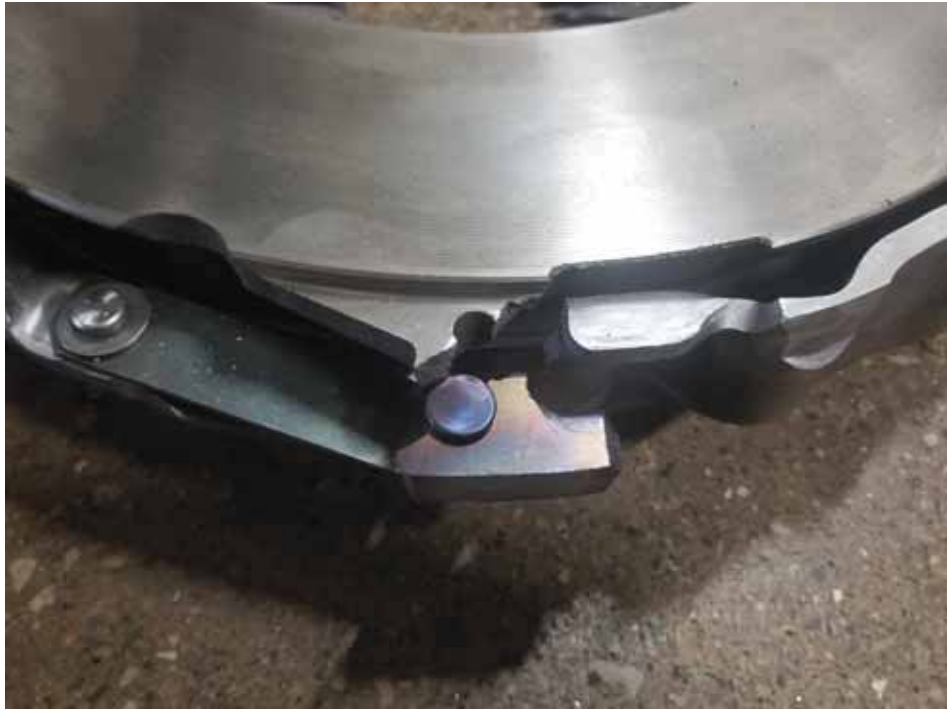
Cause	A new clutch that is replaced in the aftermarket may be found damaged when removed from packaging, or experience failure shortly after installation. This situation is likely to occur before the vehicle leaves the shop or during the first test drive after replacement. It has been determined that this issue arises due to damage that occurs during shipping and handling of the new part. Damage of this nature normally occurs to the tabs shown in the photo below:
-------	---

- The box should be inspected for damage before opening and if damage is found the clutch should be inspected to make sure the tabs shown in the picture above are not cracked or broken from shipping and handling.

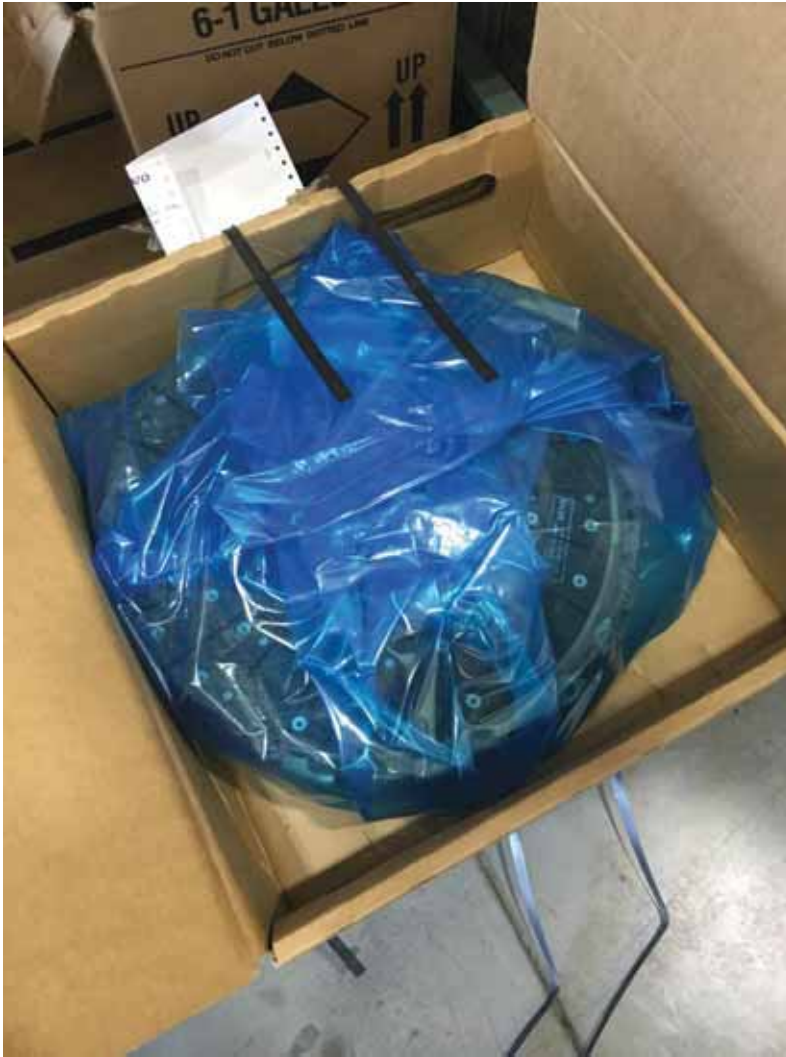
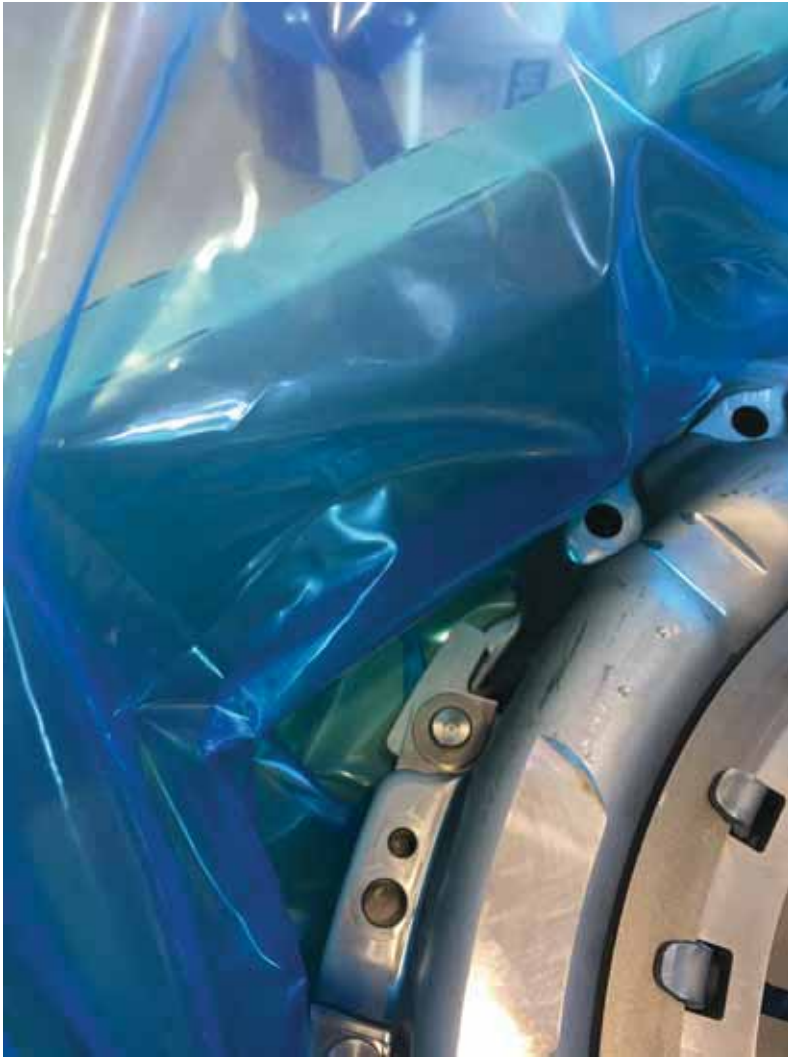
- When inspecting the clutch, if the tabs are aligned in the box along the box sides they are more likely to get damaged in shipping and handling. If they are aligned in the corners of the box as shown below they are less likely to be damaged.

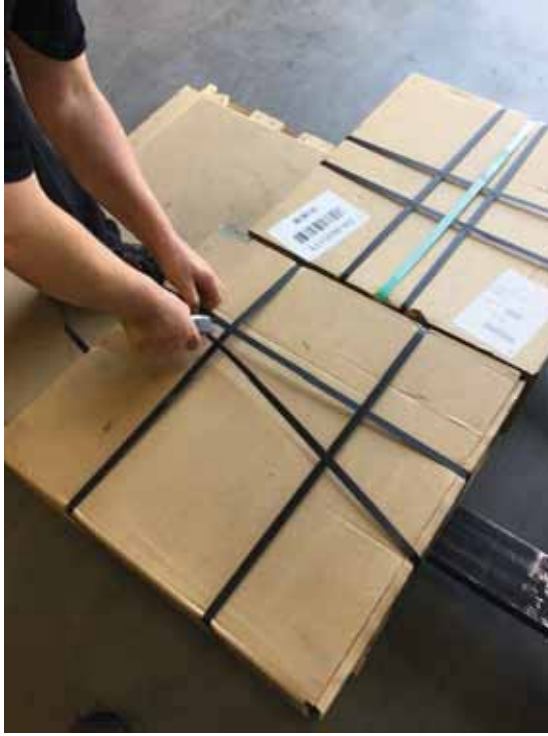
Correct

- **Clutches should always be stored flat on the shipping pallet and never on edge. Damage to the clutch may result from the on edge storage.**
