# Technical Journal

TITLE:  
**12V battery message, and DTC CEM - B129F96**

<b>REF NO:</b> TJ 34241.2.0	<b>ISSUING DEPARTMENT:</b> Technical Service	<b>CAR MARKET:</b> United States and Canada	
<b>PARTNER:</b> 3 US 7510 Volvo Car USA		<b>ISSUE DATE:</b> 2019-05-15	<b>STATUS DATE:</b> 2019-05-28
<b>FUNC GROUP:</b> 3730	<b>FUNC DESC:</b> Cable system, front	Page 1 of 3

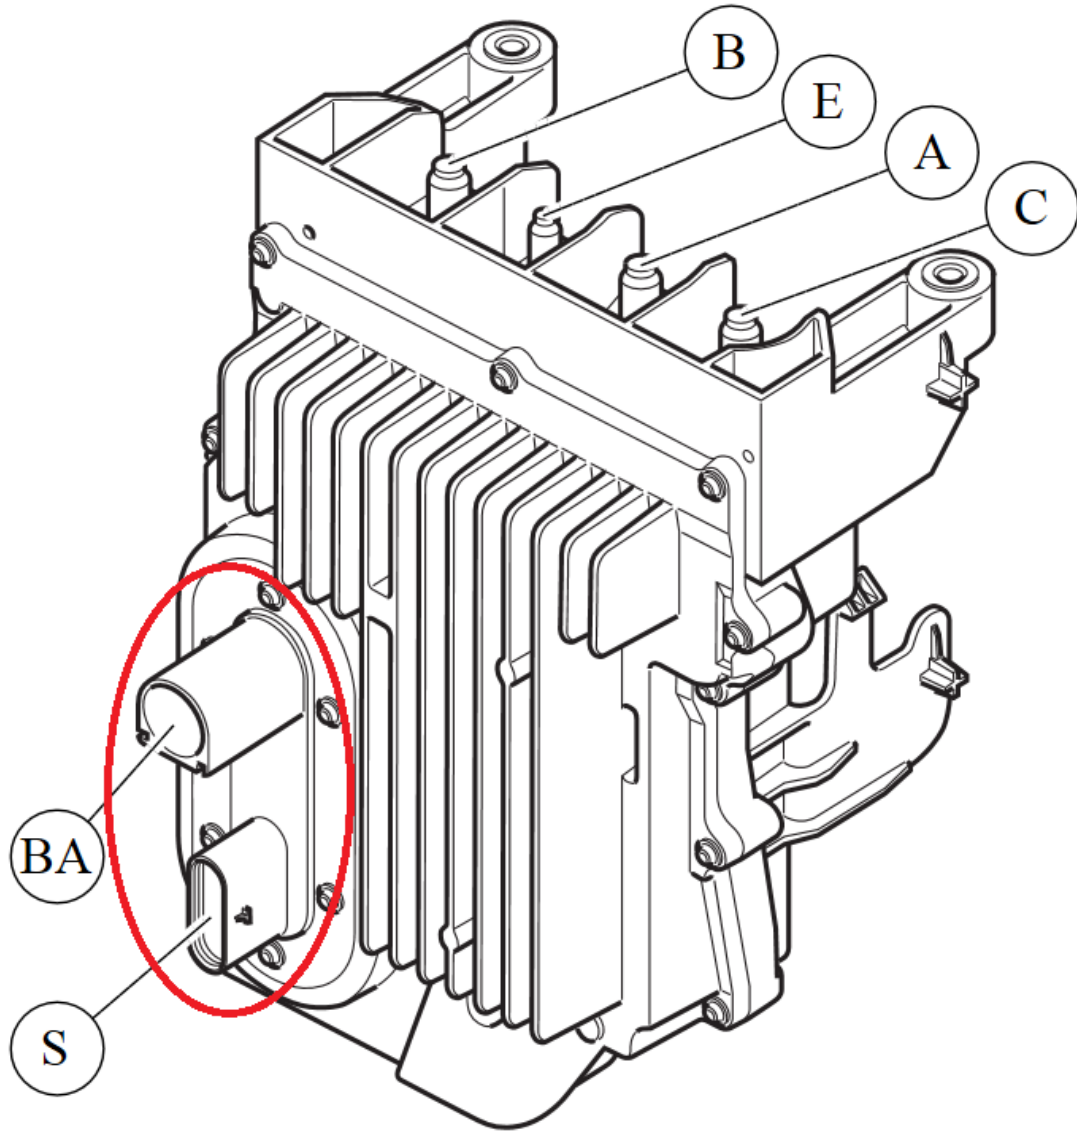
File Name	File Size
BCSM connectors TJ 34241.pdf	0.1298 MB

If the DIM message “12V battery charge fault” is displayed and DTC *CEM - B129F96* is permanent, please follow the instructions under “Service”.

- Ensure that the main battery is charged and the alternator is charging.
- Check the voltage of the support battery and charge if necessary, **if less than 11 volts it must be removed from the vehicle and charged for 8 hours/overnight.**
- Remove the lower connector (S) on the BCSM for 15 minutes (See attachment). This will reset the BCSM and the internal flash memory.
- Reconnect the BCSM.
- Erase all DTC's.
- Ensure that the stop/start sequences are working as intended and are repeatable, if the DTC does not reoccur the vehicle is OK.
- If the DTC reoccurs please follow the instructions under Vehicle Report.
