Technical Service Bulletin

Topic	Mulsanne steering shimmy/vibration - 21 Inch wheels only (USA)
Market area	United States E05 Bentley USA and rest America (6E05)
Brand	Bentley
Transaction No.	2030349/3
Level	EH
Status	Released for publishing
Release date	May 20, 2019

Bentley Mulsanne

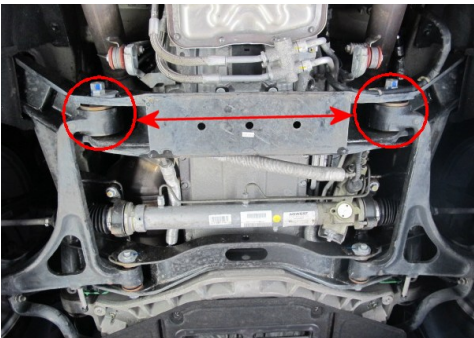
Figure 1

Referring to Figure 1, from VIN SCBBA63Y9BC016115 the front suspension lower lever inner rear bushes with a higher damping frequency were fitted at the time of production.

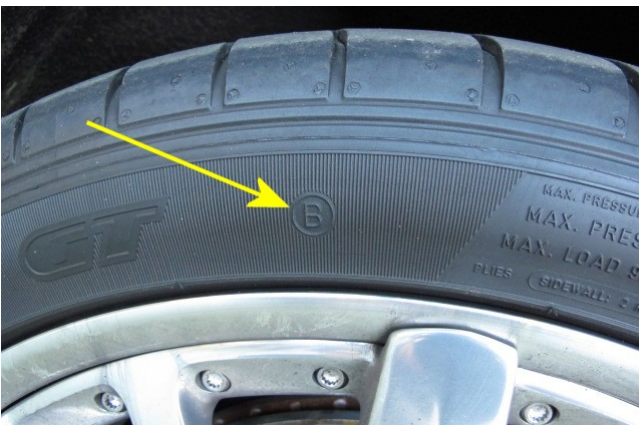
- Dunlop SP Sportmaxx GT 265/40/21 with the part number 3Y0 601 313H or higher
- To ensure correct specification the Bentley Mulsanne tyre has a 'B' stamped on the sidewall as shown in Figure 2

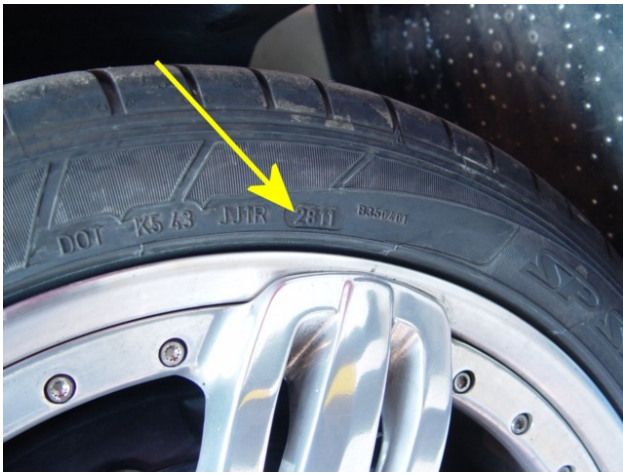
Referring to Figure 3, check the date of manufacture code, the code must be on or after 2011, this code translates as week 20 of the year 2011 hence 2011, Figure 3 shows 2811 which is week 28 year 2011.

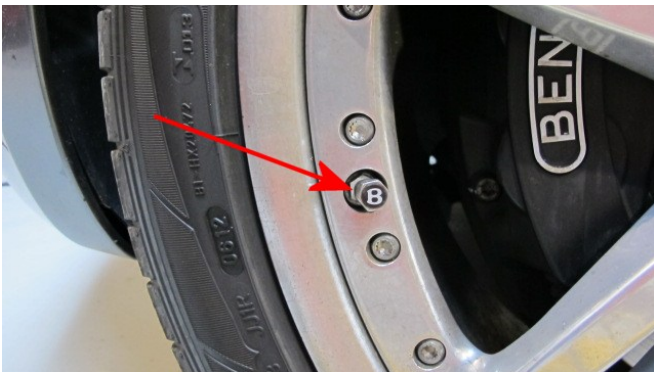
Figure 4

Does the vehicle have accessory valve caps fitted as shown in Figure 4? If Yes please ensure the force match and balance process is always conducted with accessory valve caps fitted

IMPORTANT: Apply a thin smear of silicon based grease for example Dow Corning high vacuum grease to the external threads of the valve stem prior to fitting the accessory valve cap. Grease should be applied any time the cap is removed and the grease is not evident

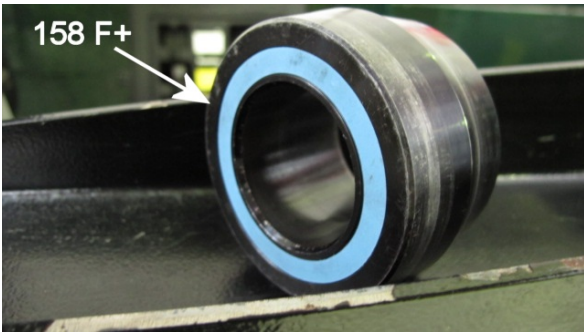
Figure 5

- For applicable Hunter machines, it is imperative that the adaptor cone with part number 158 F+ with a light Blue coloured face as shown in Figure 5.
- The cone must be fitted on the spindle as shown in Figure 6 ensuring the light Blue face of the cone is facing towards the end of the spindle

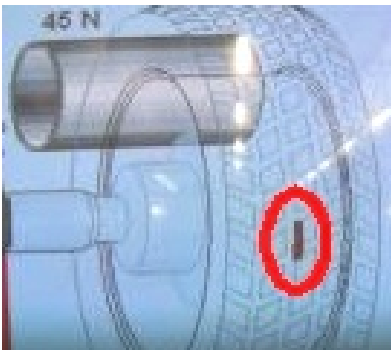
Figure 7

- Once the force matching process is complete, the assembly high spot is identified with a brown dash (Figure 7).

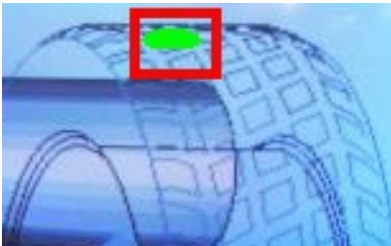
Figure 8

- Rotate the assembly on the spindle until the high point is at 12 o'clock and the Brown dash turns to Green (Figure 8).

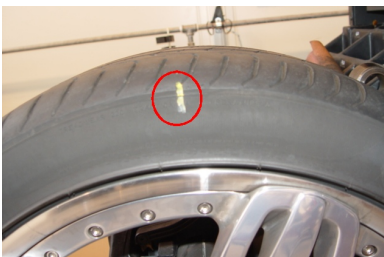
Figure 9

- Mark the RFV high point with a paint pen or similar (Figure 9) this will be required when refitting the wheels
