Technical Service Bulletin

Topic	Accessory valve caps - Difficult to remove
Market area	Bentley: worldwide (2WBE)
Brand	Bentley
Transaction No.	2033864/5
Level	EH
Status	Released for publishing
Release date	May 20, 2019

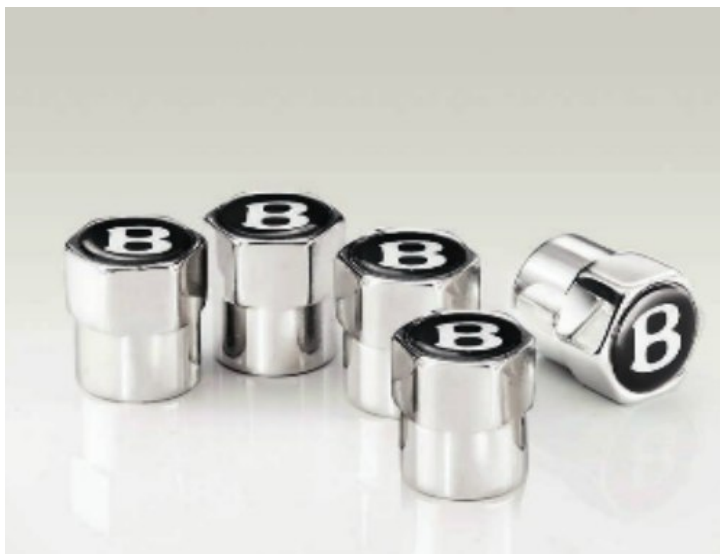
Unable to remove Accessory valve caps, Figure 1 shows an example of the caps

We have observed instances where the caps have been difficult to remove once fitted, the issue is caused by corrosion.

The valve stem itself is made from aluminium and the accessory valve caps are chromium plated brass, it is possible under certain environmental conditions, particularly winter road salt, for corrosion to take place between these dissimilar metals.

The solution is to apply a thin smear of silicon-based grease, such as Dow Corning high vacuum grease, to the external threads of the valve stem prior to fitting the accessory valve cap. Grease should be applied any time the cap is removed and grease is not evident
