| Topic | Bentayga - Battery Energy Control Module 2 software update (ASW 09.03) (SC16/27) |
| Campaign number | EA65 |
| Type | Service Campaign |

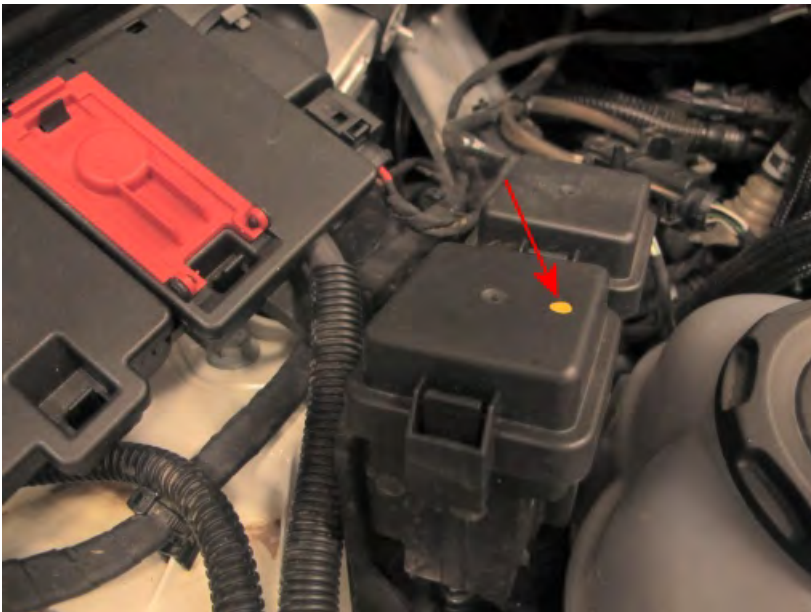
Figure 7

If the vehicle is not already listed as repaired in the "Repair history" (in Elsa Pro), check for the presence of a yellow campaign completion mark on the top of the relay box adjacent to the right hand bonnet hinge (see Figure 7) should neither be evident carry out the required work in accordance with these instructions
