**SERVICE BULLETIN**

**APPLICABILITY:** 2015-19 Legacy and Outback 2.5L **NUMBER:** 07-153-19  
**SUBJECT:** Ignition Coil Cap Now Available as Service Part **DATE:** 05/07/19

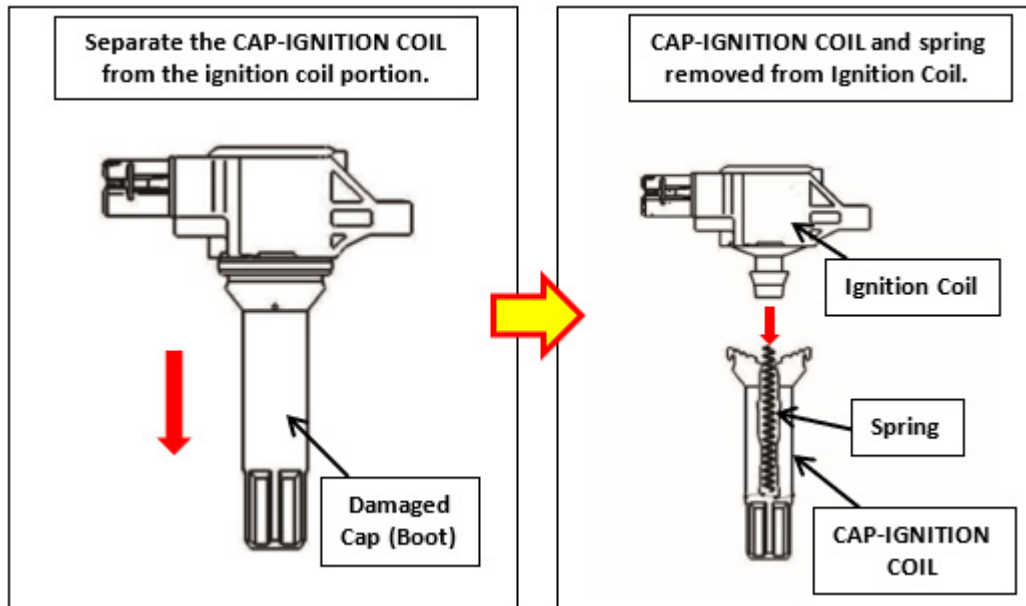
**1) Removal of CAP-IGNITION COIL:**

This service bulletin announces availability of the cap portion (a.k.a. spark plug boot) as a service part separate from the complete ignition coil assembly. If the cap portion as shown in the illustrations below is damaged during removal or replacement, it is no longer necessary to replace the complete ignition coil assembly.

The part number for the new CAP- IGNITION COIL is **22489AA040**.
